Contract #: 04-0120F4Cty: SF/ALA Rte: 80 PM: 13.2/13.9File #: 69.25B**QUALITY ASSURANCE -- NON-CONFORMANCE REPORT****Location:** Changxing Island, Shanghai, China**Report No:** NCR-000782**Prime Contractor:** American Bridge/Fluor Enterprises, a JV**Date:** 01-Jul-2010**Submitting Contractor:** Zhenhua Port Machinery Company, Ltd (ZPMC), Changxing Island**NCR #:** ZPMC-0744**Type of problem:**

Bridge No: 34-0006**Component:** SEG11AE, X151C to EP170A at PP96**Reference Description:** Missed UT Indication**Description of Non-Conformance:**

To:	AMERICAN BRIDGE/FLUOR, A JV 375 BURMA ROAD OAKLAND CA 95607	Date:	05-Jul-2010
Dear:	Mr. Charles Kanapicki	Contract No:	04-0120F4 04-SF-80-13.2 / 13.9
Attention:	Mr. Thomas Nilsson Project/Fabrication Manager	Job Name:	SAS Superstructure
Subject:	NCR No. ZPMC-0744	Document No:	05.03.06-000743
Reference Description:	Missed UT Indication

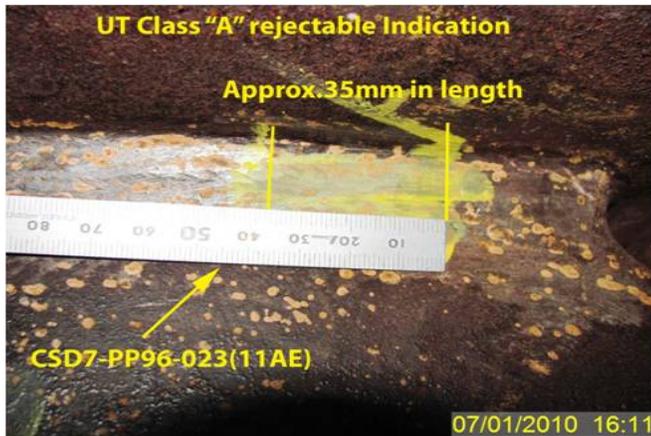
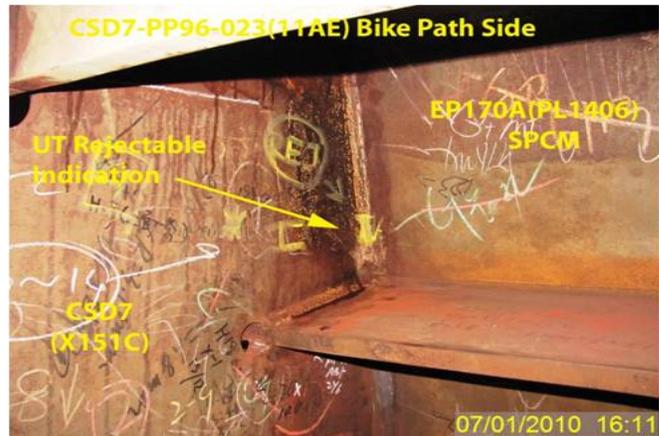
During the Quality Assurance Ultrasonic Testing (UT) review of welds located on Orthotropic Box Girder (OBG) segment 11AE, QA discovered the following issues:

- One (1) longitudinal linear indication measuring approximately 35mm in length.
- The indication dbS rating is a +4.
- The Y distance for this indication is 35 mm from bottom cope hole.
- Material thickness is 20mm.
- The depth of the indication is approximately 12mm.
- The weld is identified as CSD7-PP96-023 at Bike Path side, panel point (PP) 96.
- The weld was a Fillet Weld according to approved shop drawing but due to excessive root gap, ZPMC has changed the joint to a Complete Joint Penetration (CJP) "T" joint.
- This joint connects the Corner Assembly Diaphragm (X151C) to Edge Plate EP170A (PL1406A).
- The weld is designated as Seismic Performance Critical Material (SPCM).
- The indication is clearly marked on or near the weld.
- Segment 11AE is located at outside near trial Assembly Area.

The Notice of Witness Inspection (NWIT) No. is 006079. The indication is located in an area previously tested and accepted by ZPMC Quality Control (QC) personnel. As per the contract documents, ZPMC's QC personnel are required to perform hundred (100%) percent UT inspection of this weld.

AWS D1.5-02 Section 6; Table 6.3 specifies a class “A” indication as having a rating of 10dbs and under for material thicknesses 8mm through 20mm.

ZPMC has repaired the missed indication and is providing NDT records to show the weld is acceptable. ZPMC QA has discussed this missed indication with ZPMC's NDT department head to express the unacceptable trend. Based on this ZPMC requests closure of this NCR.

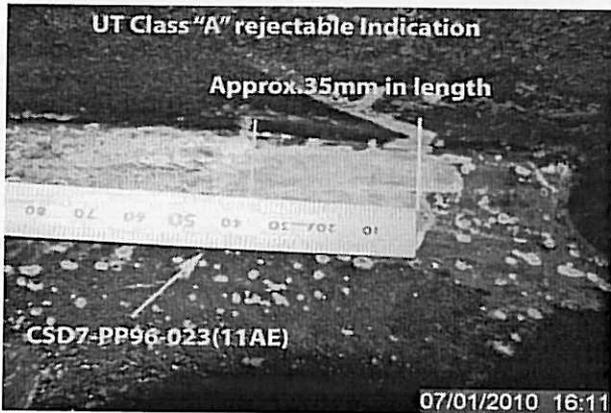
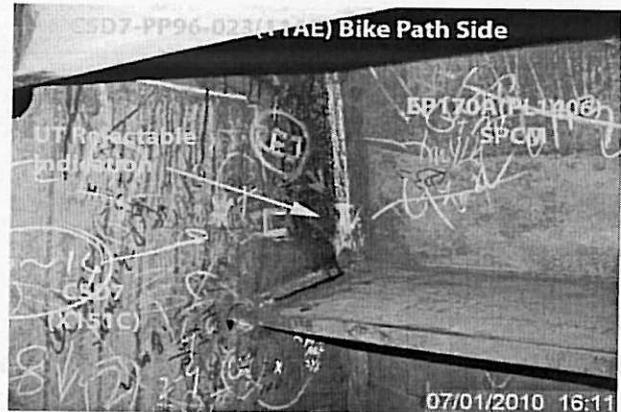
During the Quality Assurance Ultrasonic Testing (UT) review of welds located on Orthotropic Box Girder (OBG) segment 11AE, QA discovered the following issues:

- One (1) longitudinal linear indication measuring approximately 35mm in length.
- The indication dbS rating is a +4.
- The Y distance for this indication is 35 mm from bottom cope hole.
- Material thickness is 20mm.
- The depth of the indication is approximately 12mm.
- The weld is identified as CSD7-PP96-023 at Bike Path side, panel point (PP) 96.
- The weld was a Fillet Weld according to approved shop drawing but due to excessive root gap, ZPMC has changed the joint to a Complete Joint Penetration (CJP) "T" joint.
- This joint connects the Corner Assembly Diaphragm (X151C) to Edge Plate EP170A (PL1406A).
- The weld is designated as Seismic Performance Critical Material (SPCM).
- The indication is clearly marked on or near the weld.
- Segment 11AE is located at outside near trial Assembly Area.

The Notice of Witness Inspection (NWIT) No. is 006079. The indication is located in an area previously tested and accepted by ZPMC Quality Control (QC) personnel. As per the contract documents, ZPMC's QC personnel are required to perform hundred (100%) percent UT inspection of this weld.

AWS D1.5-02 Section 6; Table 6.3 specifies a class "A" indication as having a rating of 10dbs and under for material thicknesses 8mm through 20mm.

Repair said indication and perform NDT required to verify weld quality.

Contractor supplied post repair NDT documentation verifying weld is in conformance with Contract weld quality requirements. Contractor has also taken action directly with NDT Technicians to avoid similar issues in the future.
