Contract #: 04-0120F4Cty: SF/ALA Rte: 80 PM: 13.2/13.9File #: 69.25B**QUALITY ASSURANCE -- NON-CONFORMANCE REPORT****Location:** Changxing Island, Shanghai, P.R. China**Report No:** NCR-000783**Prime Contractor:** American Bridge/Fluor Enterprises, a JV**Date:** 02-Jul-2010**Submitting Contractor:** Zhenhua Port Machinery Company, Ltd (ZPMC), Changxing Island**NCR #:** ZPMC-0745**Type of problem:**

Reference Description: Missed MT indication: Cross Bracing gusset plate to Doubler**Description of Non-Conformance:**

Job Name: SAS Superstructure
Document No: 05.03.06-000740

Report No: NCR-000783

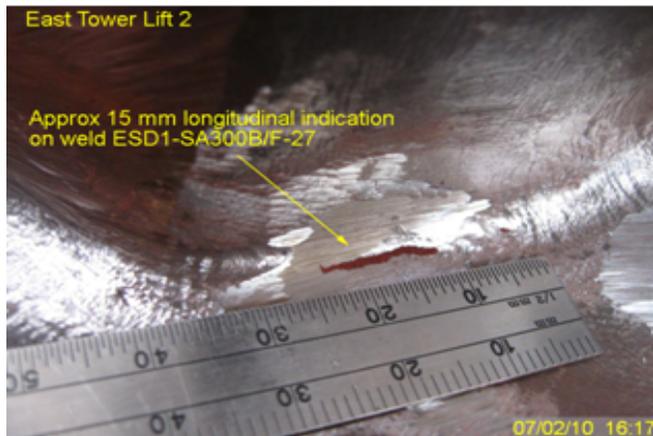
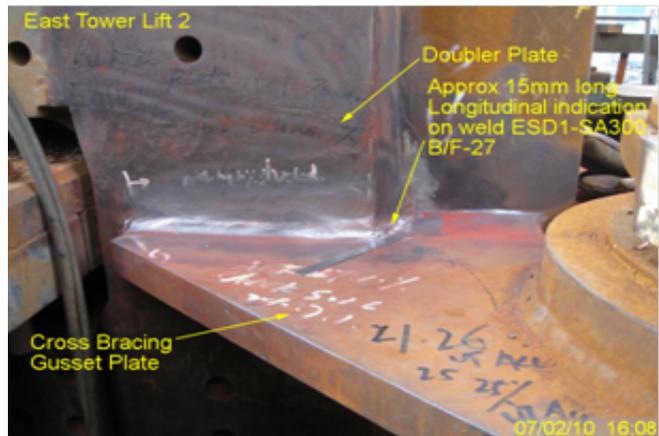
During Magnetic Particle Testing (MT) review of welds on East Tower Lift 2, Quality Assurance Inspector (QA) discovered the following issues:

- One Longitudinal crack indication measuring approximately 15mm in length.
- The member is identified as Cross Bracing gusset plate to Doubler plate
- The weld is identified as ESD1-SA300B/F-27.
- The weld is a Partial Joint Penetration (PJP) weld, joining the Cross Bracing gusset plate to Doubler plate.
- The member is Seismic Performance critical Member (SPCM).
- The member is located in Tower Trial Assembly.

The Notice of Witness Inspection Number (NWIT) is 06106. The indication is located within the area that has been previously tested and accepted by ZPMC Quality Control (QC) personnel. As per the contract documents, ZPMC's QC personnel are required to perform 100% MT inspection of this weld.

For further information, please see the attached pictures below.

Reference Resolution: ZPMC has repaired the indications missed and is submitting the CWR and NDT used at the time.

ZPMC has repaired the indications missed and is submitting the CWR and NDT used at the time. ZPMC has discussed this issue with both their inspectors and productions staff to eliminate the indications during production and also after during inspection. Based on this ZPMC requests closure of this NCR.

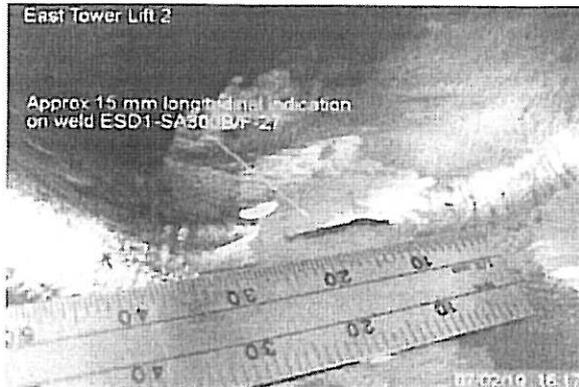
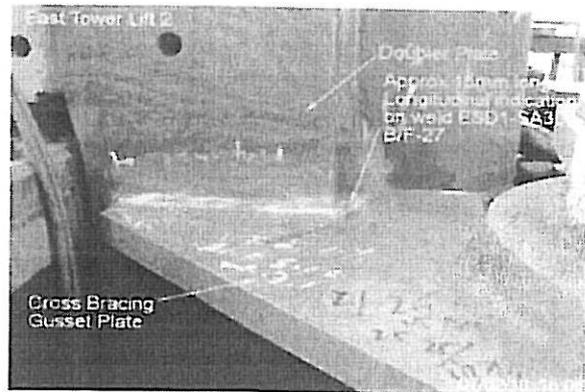
During Magnetic Particle Testing (MT) review of welds on East Tower Lift 2, Quality Assurance Inspector (QA) discovered the following issues:

- One Longitudinal crack indication measuring approximately 15mm in length.
- The member is identified as Cross Bracing gusset plate to Doubler plate
- The weld is identified as ESD1-SA300B/F-27.
- The weld is a Partial Joint Penetration (PJP) weld, joining the Cross Bracing gusset plate to Doubler plate.

-The member is Seismic Performance critical Member (SPCM).

-The member is located in Tower Trial Assembly.

The Notice of Witness Inspection Number (NWIT) is 06106. The indication is located within the area that has been previously tested and accepted by ZPMC Quality Control (QC) personnel. As per the contract documents, ZPMC's QC personnel are required to perform 100% MT inspection of this weld.

For further information, please see the attached pictures below.

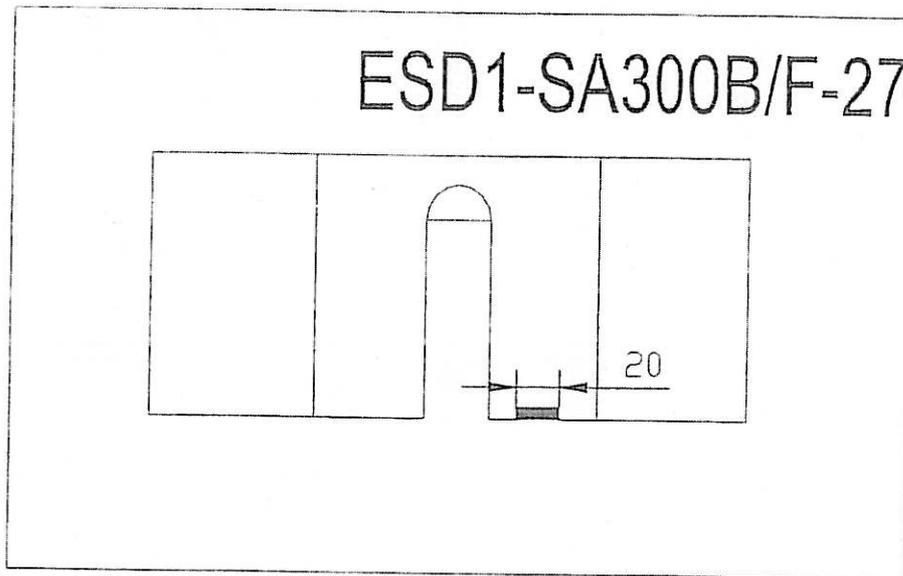
Draft of Welding Discontinuity:

The crack was found at east tower 2nd lifting strut plate weld (ESD1-SA300B/F-27), and need to repair.

Remark: repair area in shadow.

1. 火焰加热时, 水汽没有完全的去除或者这个区域预热不够;
1. Moisture wasn't completely removed during drying operation (preheating) or the area wasn't preheated sufficiently.

1. QC /CWI shall monitor and direct all gouging, grinding and welding during the repair procedure.
2. Remove defects by gouging and /or grinding. If gouging is used, preheat the repair area to a minimum temperature of 65°C.
3. Prepare excavation according to the approved repair WPS.
4. Grind the repair area to a smooth and shiny surface.
5. Verify that no defects are present by VT and MT prior to weiding.
6. Clean excavation of all loose debris and MT powder.
7. Weld according to the approved WPS.
8. Preheat and maintain interpass temperature control in accordance to the approved WPS.
9. QC shall ensure all slag has been removed prior to the deposition of the next pass.
10. Blend the weld repaired areas into the adjacent weld or base metal by grinding.
11. Perform VT, MT and UT inspection to the repaired areas.

1. QC shall verify sufficient preheat has been applied, to remove moisture, prior to welding.

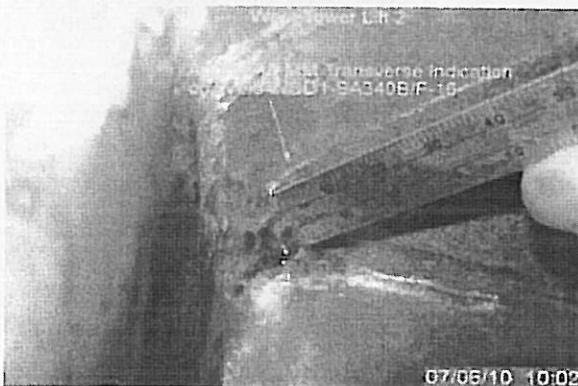
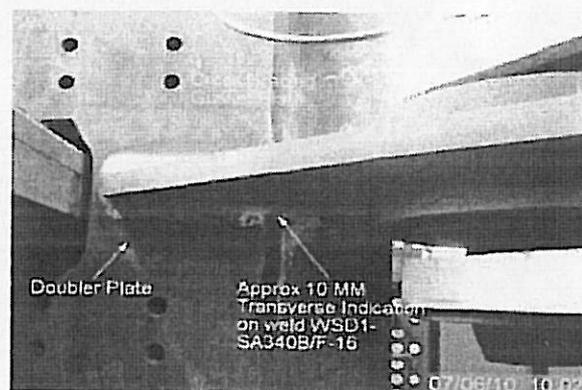
-One transverse indication (crack) measuring approximately 10mm in length in PJP weld between gusset plate and doubler plate

The Notice of Witness Inspection Number (NWIT) is #06134. The indication is located within the area that has been previously tested and accepted by ZPMC Quality Control (QC) personnel. As per Contract, 100% MT inspection is required for this weld.

Please refer to attached photos below.

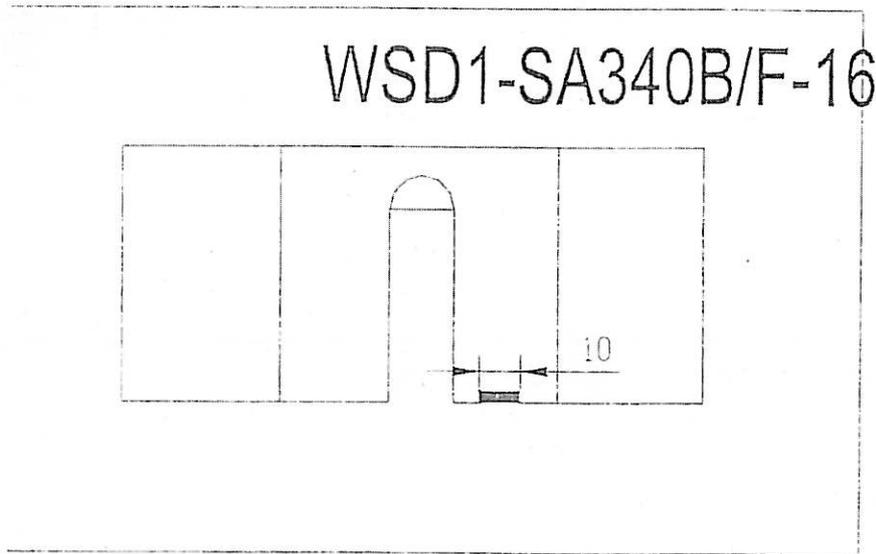
Draft of Welding Discontinuity

The crack was found at west tower 2nd lifting 53m strut plate weld WSD1-SA340B/F-16, 10mm in length, and needed to repair.

注: 阴影部位为堆焊区域。Remark: repair area in shadow.

1. 火焰加热时, 水汽没有完全的去掉或者这个区域预热不够;
1. Moisture wasn't completely removed during drying operation (preheating) or the area wasn't preheated sufficiently

1. QC /CWI shall monitor and direct all gouging, grinding and welding during the repair procedure.
2. Remove defects by gouging and /or grinding. If gouging is used, preheat the repair area to a minimum temperature of 65°C.
3. Prepare excavation according to the approved repair WPS.
4. Grind the repair area to a smooth and shiny surface.
5. Verify that no defects are present by VT and MT prior to weiding.
6. Clean excavation of all loose debris and MT powder.
7. Weld according to the approved WPS.
8. Preheat and maintain interpass temperature control in accordance to the approved WPS.
9. QC shall ensure all slag has been removed prior to the deposition of the next pass.
10. Blend the weld repaired areas into the adjacent weld or base metal by grinding.
11. Perform VT, MT and UT inspection to the repaired areas.

1. QC shall verify sufficient preheat has been applied, to remove moisture, prior to welding.
