Contract #: 04-0120F4Cty: SF/ALA Rte: 80 PM: 13.2/13.9File #: 69.25B**QUALITY ASSURANCE -- NON-CONFORMANCE REPORT****Location:** Changxing Island, Shanghai, China**Report No:** NCR-000784**Prime Contractor:** American Bridge/Fluor Enterprises, a JV**Date:** 03-Jul-2010**Submitting Contractor:** Zhenhua Port Machinery Company, Ltd (ZPMC), Changxing Island**NCR #:** ZPMC-0746**Type of problem:**

Reference Description: Missed MT Indication Discovered by Quality Assurance (QA)**Description of Non-Conformance:**

QUALITY ASSURANCE -- NON-CONFORMANCE REPORT

Dear: Mr. Charles Kanapicki
Job Name: SAS Superstructure

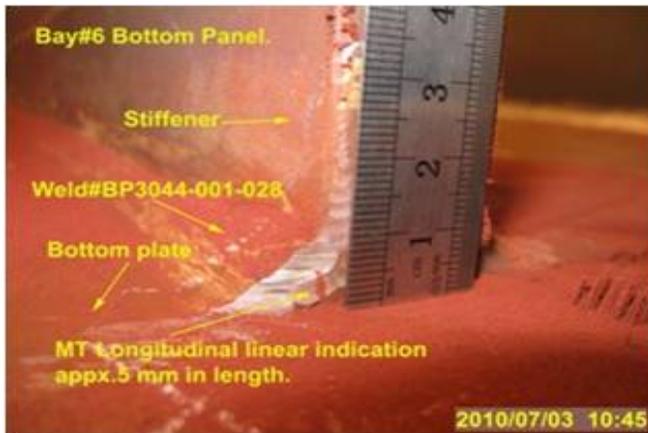
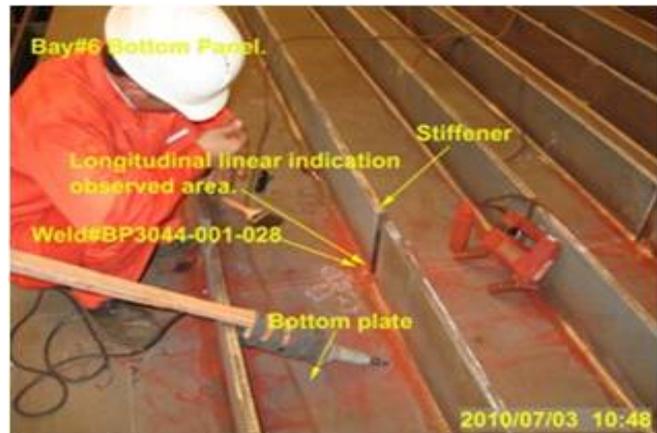
During Quality Assurance Magnetic Particle Testing (MT) review of welds located on Orthotropic Box Girder (OBG) Bottom Panel (BP) BP3044A, (QA) discovered the following issue:

- One (1) Longitudinal Linear indication measuring approximately 5 mm in length.
- The weld is identified as: BP3044-001-028.
- The weld is a fillet weld joining Bottom plate (PL3232A) to Stiffener plate.
- The fillet weld size measured to be 9 mm.
- The "Y" location is approximately 0 from the nearest end of the weld.
- BP3044A is located in the OBG Sub assembly Bay # 6.

The Notice of Witness Inspection Number (NWIT) is 06109. The indication is located within the area that has been previously tested and accepted by ZPMC Quality Control (QC) personnel. As per the contract documents, ZPMC QC personnel are required to perform 10% MT inspection of these welds.

AWS D1.5 2002 figure 6.8 – “Specifies for fillet weld sizes between 6mm and 13mm the maximum discontinuity length is approximately 2mm to 4mm”.

AWS D1.5 2002 Section 6.26.2 – Welds that are subject to MT in addition to visual inspection shall have no cracks.

ZPMC has issued an internal NCR and has discussed preventative measures with the ABF QCM. ZPMC has attached the acceptable MT report after repair. ZPMC requests closure of this NCR.

ZPMC has issue an internal NCR to address this issue and ZPMC QA personnel have talked with the head of the NDT department. The missed indications have been repaired and were tested to be acceptable. ZPMC is providing the NDT records and is requesting closure of this NCR.

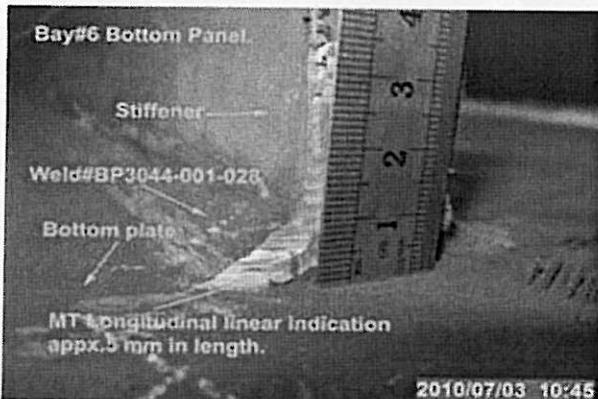
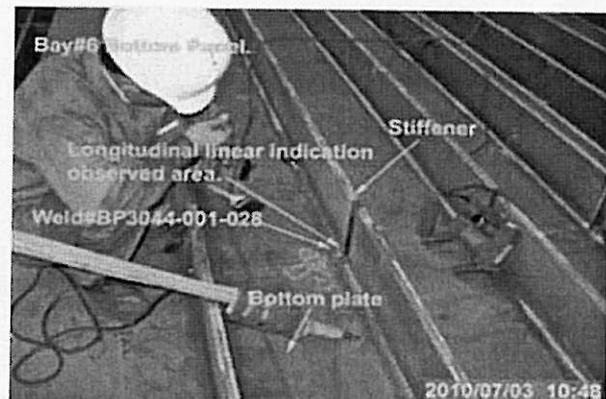
During Quality Assurance Magnetic Particle Testing (MT) review of welds located on Orthotropic Box Girder (OBG) Bottom Panel (BP) BP3044A, (QA) discovered the following issue:

- One (1) Longitudinal Linear indication measuring approximately 5 mm in length.
- The weld is identified as: BP3044-001-028.
- The weld is a fillet weld joining Bottom plate (PL3232A) to Stiffener plate.
- The fillet weld size measured to be 9 mm.
- The "Y" location is approximately 0 from the nearest end of the weld.
- BP3044A is located in the OBG Sub assembly Bay # 6.

The Notice of Witness Inspection Number (NWIT) is 06109. The indication is located within the area that has been previously tested and accepted by ZPMC Quality Control (QC) personnel. As per the contract documents, ZPMC QC personnel are required to perform 10% MT inspection of these welds.

AWS D1.5 2002 figure 6.8 – “Specifies for fillet weld sizes between 6mm and 13mm the maximum discontinuity length is approximately 2mm to 4mm”.

AWS D1.5 2002 Section 6.26.2 – Welds that are subject to MT in addition to visual inspection shall have no cracks.

Repair said indication and perform NDT required to verify weld quality.

Contractor supplied post repair NDT documentation verifying weld conforms with Contract weld quality requirements. An internal NCR was also issued by ZPMC in regards to this issue.
