Quality Assurance and Source Inspection

Contract #: 04-0120F4Cty: SF/ALA Rte: 80 PM: 13.2/13.9File #: 69.25B**QUALITY ASSURANCE -- NON-CONFORMANCE REPORT****Location:** Changxing Island, Shanghai, China**Report No:** NCR-000785**Prime Contractor:** American Bridge/Fluor Enterprises, a JV**Date:** 03-Jul-2010**Submitting Contractor:** Zhenhua Port Machinery Company, Ltd (ZPMC), Changxing Island**NCR #:** ZPMC-0747**Type of problem:****Welding****Concrete****Other****Welding****Curing****Procedural****Bridge No:** 34-0006**Joint fit-up****Coating****Other****Component:** Traveler Rail Welds 20TR2-004-011, -016-004**Procedural****Procedural****Description:****Reference Description:** Missed MT Indications by QC**Description of Non-Conformance:**

NON-CONFORMANCE REPORT TRANSMITTAL

| Attention: | Mr. Thomas Nilsson Project/Fabrication Manager | Job Name: | SAS Superstructure |

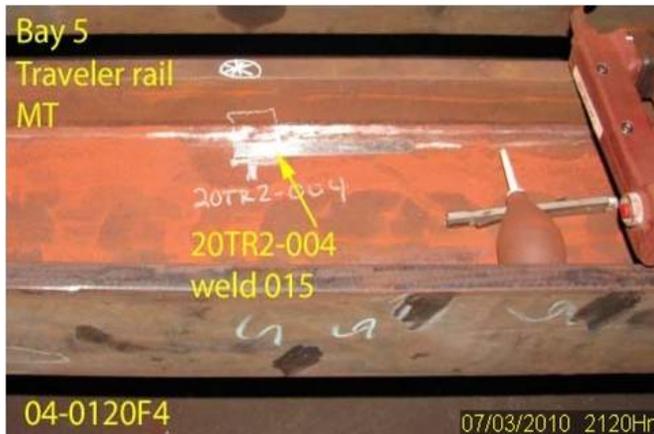
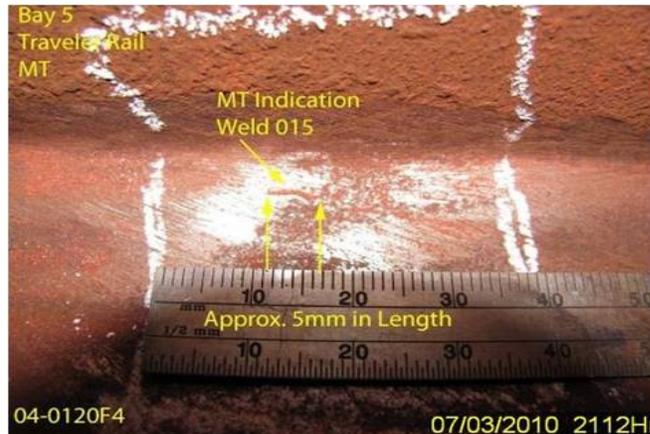
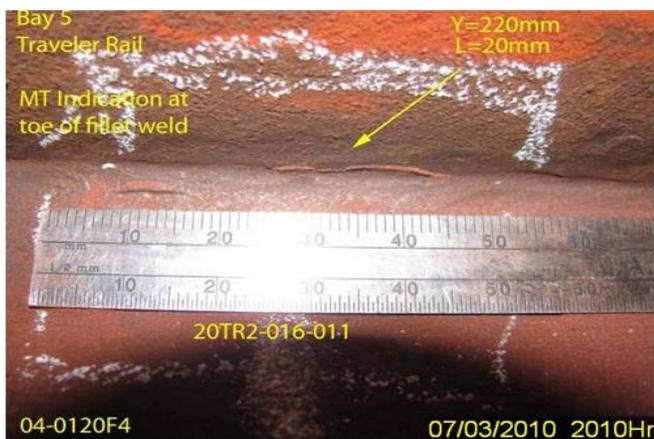
- Weld identified as: 20TR2-004-011.
- One Longitudinal Linear crack indication was missed by ZPMC measuring approximately 5mm.
- The "Y" location is approximately 220mm directly across from the end of weld 015.
- Weld identified as: 20TR2-016-004.
- One Linear crack indication was missed by ZPMC measuring approximately 20mm.
- The "Y" location is approximately 520mm from the end of weld 015.
- The welds are fillet welds joining flange to web.
- The fillet weld size measured to be 6 mm.
- Traveler Rails are located in the OBG Sub assembly Bay#5.

The Notice of Witness Inspection Number (NWIT) is 06113. The indication is located within the area that has been previously tested and accepted by ZPMC Quality Control (QC) personnel.

AWS D1.5 2002 Section 6 figure 6.8 – specifies for fillet weld sizes up to 6mm the maximum discontinuity length is approximately 1.6mm.

AWS D1.5 2002 section 6.26.2 – “Welds that are subject to RT or Magnetic particle Testing (MT) in addition to visual inspection shall have no cracks...”

Propose a resolution for the identified non-conformance with revised procedures to prevent future occurrences.,A response for the resolution of this issue is expected within 7 days.

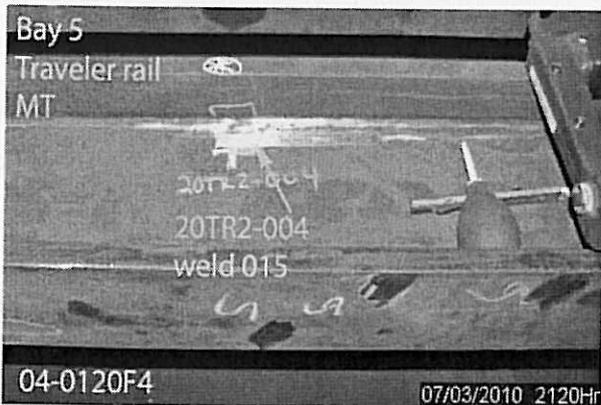
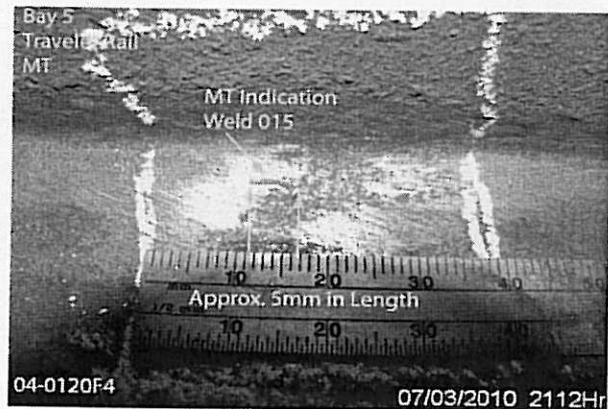
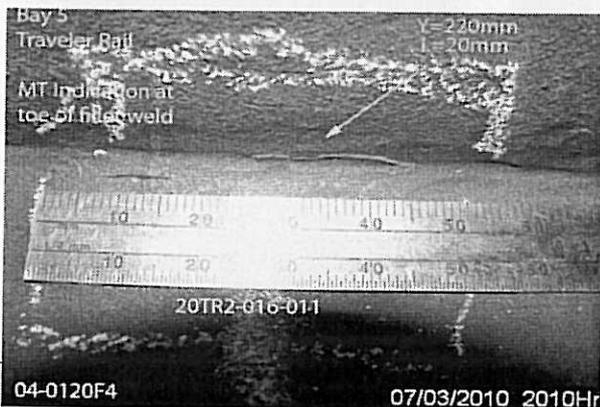
- Weld identified as: 20TR2-004-011.
- One Longitudinal Linear crack indication was missed by ZPMC measuring approximately 5mm.
- The "Y" location is approximately 220mm directly across from the end of weld 015.
- Weld identified as: 20TR2-016-004.
- One Linear crack indication was missed by ZPMC measuring approximately 20mm.
- The "Y" location is approximately 520mm from the end of weld 015.
- The welds are fillet welds joining flange to web.
- The fillet weld size measured to be 6 mm.
- Traveler Rails are located in the OBG Sub assembly Bay#5.

The Notice of Witness Inspection Number (NWIT) is 06113. The indication is located within the area that has been previously tested and accepted by ZPMC Quality Control (QC) personnel.

AWS D1.5 2002 Section 6 figure 6.8 – specifies for fillet weld sizes up to 6mm the maximum discontinuity length is approximately 1.6mm.

AWS D1.5 2002 section 6.26.2 – “Welds that are subject to RT or Magnetic particle Testing (MT) in addition to visual inspection shall have no cracks...”

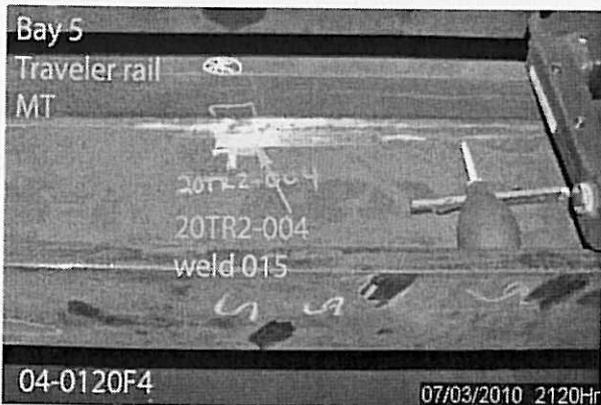
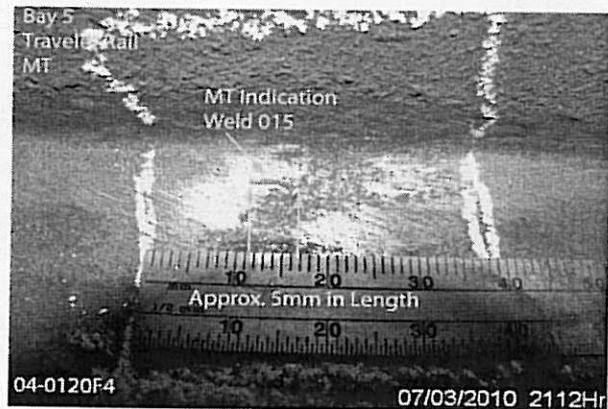
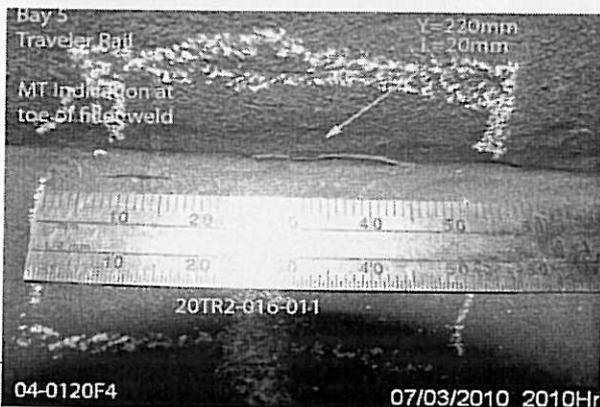
- Weld identified as: 20TR2-004-011.
- One Longitudinal Linear crack indication was missed by ZPMC measuring approximately 5mm.
- The "Y" location is approximately 220mm directly across from the end of weld 015.

- Weld identified as: 20TR2-016-004.
- One Linear crack indication was missed by ZPMC measuring approximately 20mm.
- The "Y" location is approximately 520mm from the end of weld 015.
- The welds are fillet welds joining flange to web.
- The fillet weld size measured to be 6 mm.
- Traveler Rails are located in the OBG Sub assembly Bay#5.

The Notice of Witness Inspection Number (NWIT) is 06113. The indication is located within the area that has been previously tested and accepted by ZPMC Quality Control (QC) personnel.

AWS D1.5 2002 Section 6 figure 6.8 – specifies for fillet weld sizes up to 6mm the maximum discontinuity length is approximately 1.6mm.

AWS D1.5 2002 section 6.26.2 – “Welds that are subject to RT or Magnetic particle Testing (MT) in addition to visual inspection shall have no cracks...”

Repair said indication and perform NDT required to verify weld quality.

Contractor supplied post repair NDT documentation verifying weld is in conformance with Contract weld quality requirements. Contractor has also issued an internal NCR in regards to this issues in order to avoid similar issues in the future.
