**DEPARTMENT OF TRANSPORTATION**

Contract #: 04-0120F4Cty: SF/ALA Rte: 80 PM: 13.2/13.9File #: 69.25B**QUALITY ASSURANCE -- NON-CONFORMANCE REPORT****Location:** Changxing Island, Shanghai, PR China**Report No:** NCR-000787**Prime Contractor:** American Bridge/Fluor Enterprises, a JV**Date:** 06-Jul-2010**Submitting Contractor:** Zhenhua Port Machinery Company, Ltd (ZPMC), Changxing Island**NCR #:** ZPMC-0749**Type of problem:****Welding****Concrete****Other****Welding****Curing****Procedural****Bridge No:** 34-0006**Joint fit-up****Coating****Other****Component:** Doubler plate to Infill Plate**Procedural****Procedural****Description:****Reference Description:** Missed UT indication**Description of Non-Conformance:**

**Job Name:** SAS Superstructure  
**Document No:** 05.03.06-000745

**Reference Description:** Missed UT indication/Tower/Lift 2 Infill Plate

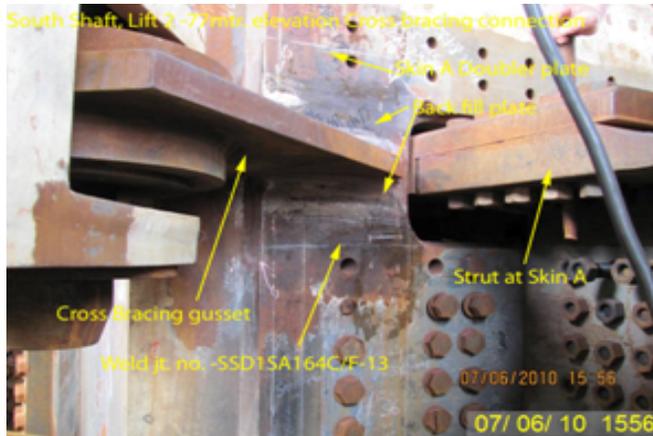
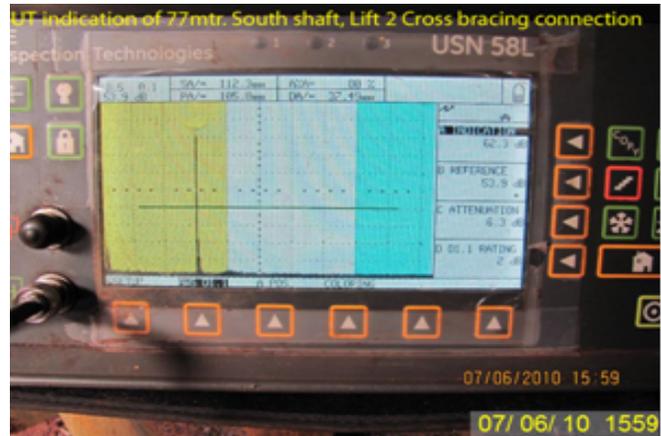
During random 10% verification of Ultrasonic Testing (UT) of Doubler Plate to Infill Plate, Quality Assurance Inspector (QA) discovered the following issues:

- One Class "B" non-conforming longitudinal indication measuring approximately 60 mm in length found in CJP weld between doubler plate and infill plate, at 77m level of South Shaft, Lift 2.
- The weld is identified as SSD1-SA164C/F-13.
- The discontinuity rating is Class "B" reject.
- Depth of the discontinuity is approximately 37mm from Face A, Y location found to be 15mm from Strut side.
- Material thickness is 50mm.
- The member is located in Tower Trial assembly(Lift2/Lift 3) area, Heavy Dock .

The Notice of Witness of Inspection is #006134. The indication is located within the area that has been previously tested and accepted by ZPMC Quality Control(QC)personnel.

Please refer to pictures below.

AWS D1.5-02 Section 6; Table 6.4 specifies welds >38mm through 60mm having a dbb rating of -1 & 0 being a class B indication. Any indication in this category having a length greater than 20 mm shall be rejected.

**Reference Resolution:** The NDT shows that the indication is no longer present and the weld is acceptable. Based on this ZPMC requests closure of this NCR.

This proposed resolution is accepted with action pending. This NCR will be considered closed once the proper NDT documentation is submitted and reviewed.

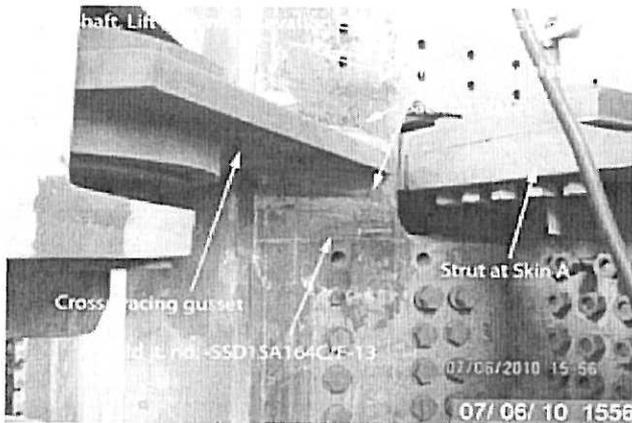
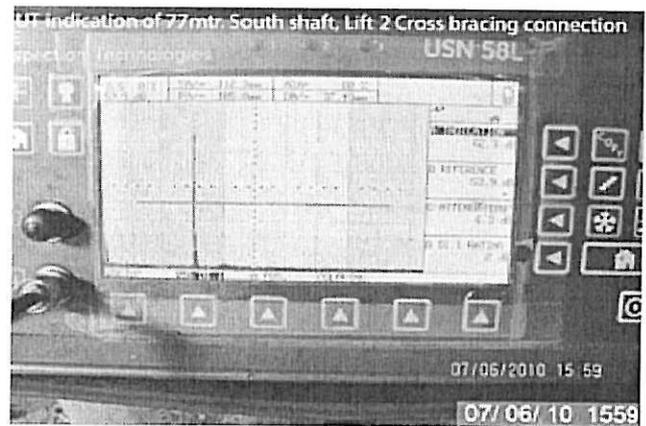
During random 10% verification of Ultrasonic Testing (UT) of Doubler Plate to Infill Plate, Quality Assurance Inspector (QA) discovered the following issues:

-One Class "B" non-conforming longitudinal indication measuring approximately 60 mm in length found in CJP weld between doubler plate and infill plate, at 77m level of South Shaft, Lift 2.

-The weld is identified as SSD1-SA164C/F-13.

-The discontinuity rating is Class "B" reject.

-Depth of the discontinuity is approximately 37mm from Face A, Y location found to be 15mm from Strut side.

- Material thickness is 50mm.

-The member is located in Tower Trial assembly(Lift2/Lift 3) area, Heavy Dock .

The Notice of Witness of Inspection is #006134. The indication is located within the area that has been previously tested and accepted by ZPMC Quality Control(QC)personnel.

Please refer to pictures below.

AWS D1.5-02 Section 6; Table 6.4 specifies welds >38mm through 60mm having a dbS rating of -1 & 0 being a class B indication. Any indication in this category having a length greater than 20 mm shall be rejected.

**Reference Resolution:** ZPMC is providing the NDT to show that the repair was successful and the indication removed. Based on this, ZPMC requests closure of this NCR.

This proposed resolution is acceptable. The documentation received is sufficient and the Department concurs that Non-Conformance ZPMC-0749 is closed.

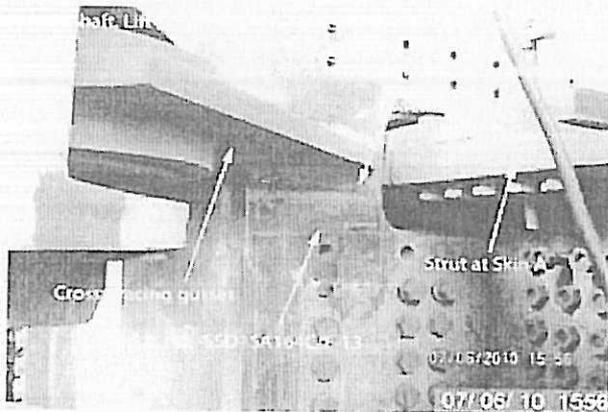
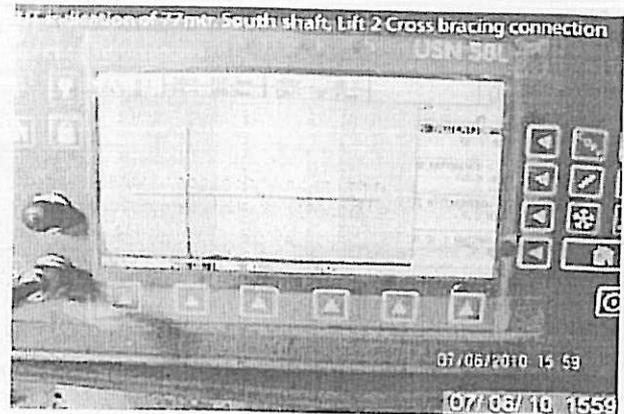
- One Class "B" non-conforming longitudinal indication measuring approximately 60 mm in length found in CJP weld between doubler plate and infill plate, at 77m level of South Shaft, Lift 2.
- The weld is identified as SSD1-SA164C/F-13.
- The discontinuity rating is Class "B" reject.
- Depth of the discontinuity is approximately 37mm from Face A, Y location found to be 15mm from Strut side.
- Material thickness is 50mm.
- The member is located in Tower Trial assembly(Lift2/Lift 3) area, Heavy Dock .

Contractor will repair the indication noted and provide NDT documentation showing weld meets contract requirements.

Contractor completed the weld repair, and submitted NDT documentation showing weld now in conformance with contract requirements.
