Contract #: 04-0120F4Cty: SF/ALA Rte: 80 PM: 13.2/13.9File #: 69.25B**QUALITY ASSURANCE -- NON-CONFORMANCE REPORT****Location:** Changxing Island, Shanghai, PR China**Report No:** NCR-000789**Prime Contractor:** American Bridge/Fluor Enterprises, a JV**Date:** 06-Jul-2010**Submitting Contractor:** Zhenhua Port Machinery Company, Ltd (ZPMC), Changxing Island**NCR #:** ZPMC-0751**Type of problem:**

Bridge No: 34-0006**Component:** Grillage Internal Stiffeners, Lift 5, East Tower**Reference Description:** Insufficient Preheat for Welding**Description of Non-Conformance:**

Reference Description: Insufficient Preheat for Welding/Tower/East/Lift 5 Internal Stiffeners

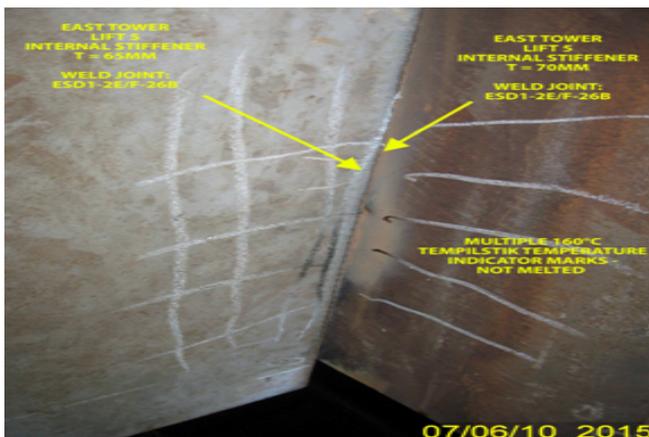
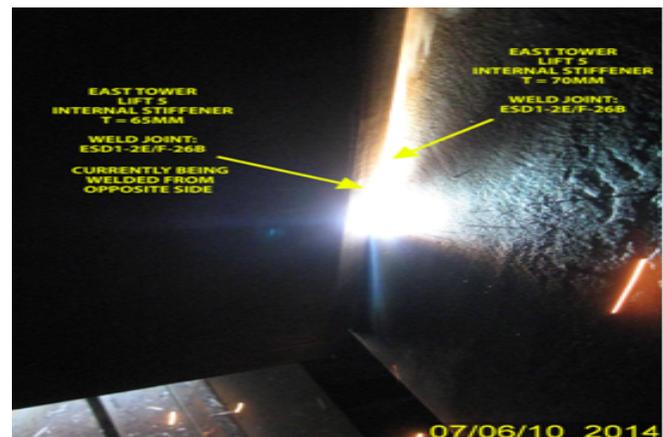
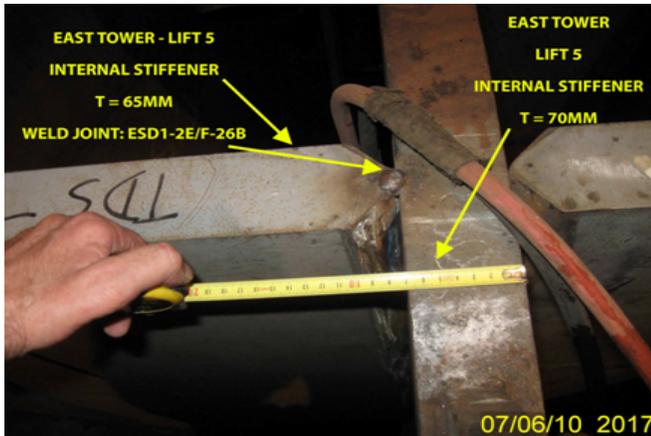
Caltrans Quality Assurance (QA) Inspector observed ZPMC personnel performing Shielded Metal Arc tack Welding (SMAW) of weld joint ESD1-TL5-2E/F-26B, 65mm to 70mm grillage internal stiffeners located inside East Tower, Lift 5, approximately 300mm from bottom of Lift 5, without sufficient base material preheat as follows:

- Multiple 160°C Tempilstik temperature indicator marks applied by this QA Inspector to the adjacent base material within approximately 40mm from the point of welding did not melt.
- East Tower, Lift 5, is designated as A709M, HPS 485W-T2. WPS-B-T-3213-TC-U5b requires the minimum preheat and interpass temperature to be 160°C for material thickness more than 60mm.

AWS D1.5 (2002), Section 4.2.7 requires the base metal material to be at or above the specified minimum temperature for a distance not less than 75mm in all directions from the point of welding.

Reference Resolution: ZPMC acknowledges that there was insufficient preheat during welding and will provide NDT documentation after NDT is complete to show that the weld is acceptable.

This proposed resolution is accepted with action pending. This NCR will be considered closed once the proper NDT documentation is submitted and reviewed.

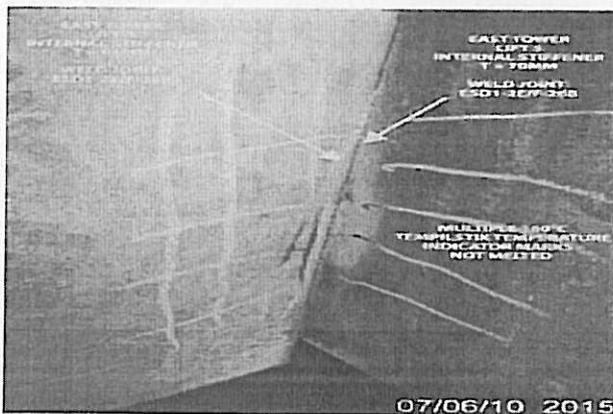
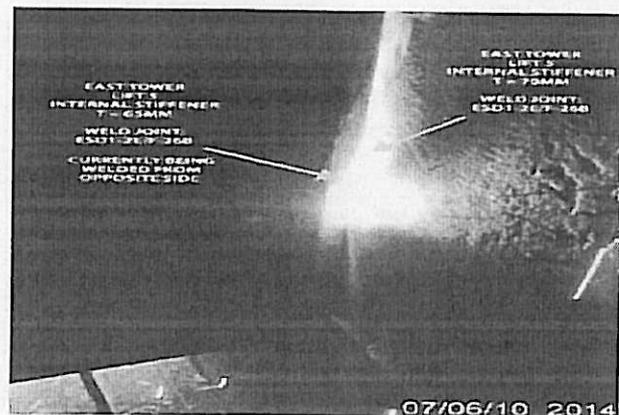
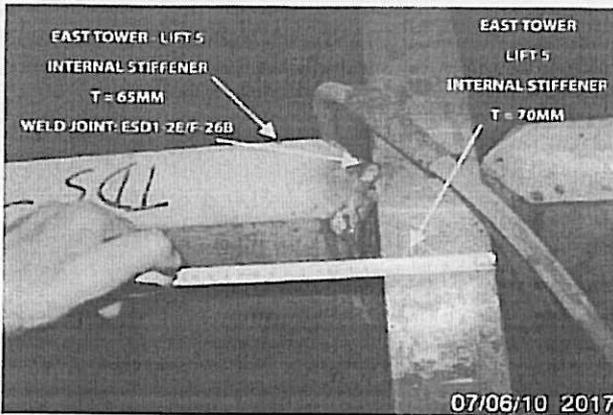
Caltrans Quality Assurance (QA) Inspector observed ZPMC personnel performing Shielded Metal Arc tack Welding (SMAW) of weld joint ESD1-TL5-2E/F-26B, 65mm to 70mm grillage internal stiffeners located inside East Tower, Lift 5, approximately 300mm from bottom of Lift 5, without sufficient base material preheat as follows:

- Multiple 160°C Tempilstik temperature indicator marks applied by this QA Inspector to the adjacent base material within approximately 40mm from the point of welding did not melt.

- East Tower, Lift 5, is designated as A709M, HPS 485W-T2. WPS-B-T-3213-TC-U5b requires the minimum preheat and interpass temperature to be 160°C for material thickness more than 60mm.

AWS D1.5 (2002), Section 4.2.7 requires the base metal material to be at or above the specified minimum temperature for a distance not less than 75mm in all directions from the point of welding.

Reference Resolution: ZPMC is providing NDT of the weld to show that despite the insufficient preheat the weld is still acceptable.

This proposed resolution is acceptable. The documentation received is sufficient and the Department concurs that Non-Conformance ZPMC-0751 is closed.

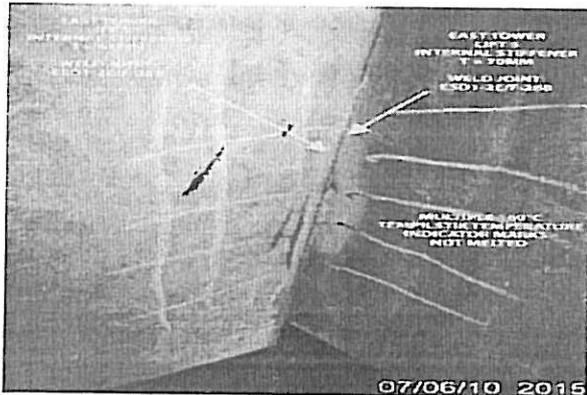
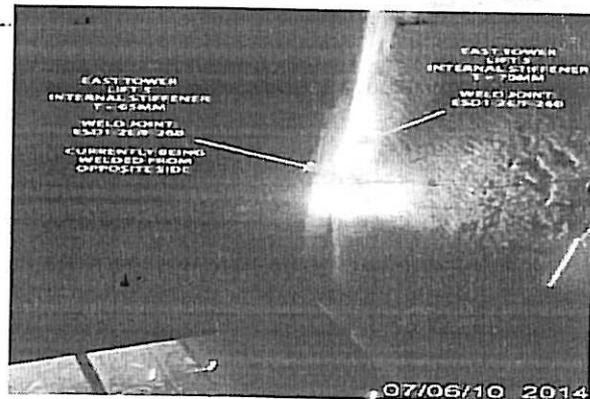
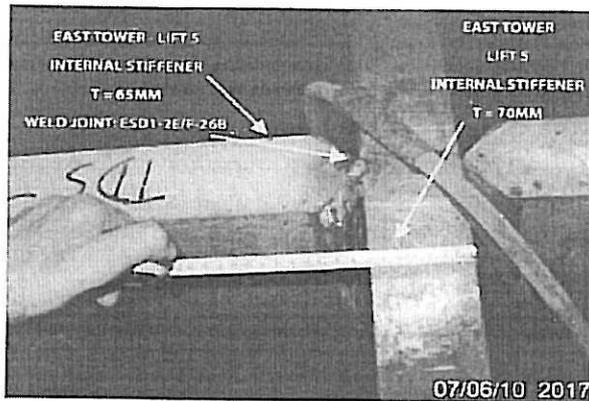
Caltrans Quality Assurance (QA) Inspector observed ZPMC personnel performing Shielded Metal Arc tack Welding (SMAW) of weld joint ESD1-TL5-2E/F-26B, 65mm to 70mm grillage internal stiffeners located inside East Tower, Lift 5, approximately 300mm from bottom of Lift 5, without sufficient base material preheat as follows:

- Multiple 160°C Tempilstik temperature indicator marks applied by this QA Inspector to the adjacent base material within approximately 40mm from the point of welding did not melt.
- East Tower, Lift 5, is designated as A709M, HPS 485W-T2. WPS-B-T-3213-TC-U5b requires the minimum preheat and interpass temperature to be 160°C for material thickness more than 60mm.

AWS D1.5 (2002), Section 4.2.7 requires the base metal material to be at or above the specified minimum temperature for a distance not less than 75mm in all directions from the point of welding.
