Contract #: 04-0120F4Cty: SF/ALA Rte: 80 PM: 13.2/13.9File #: 69.25B**QUALITY ASSURANCE -- NON-CONFORMANCE REPORT****Location:** Changxing Island, Shanghai, China**Report No:** NCR-000793**Prime Contractor:** American Bridge/Fluor Enterprises, a JV**Date:** 10-Jul-2010**Submitting Contractor:** Zhenhua Port Machinery Company, Ltd (ZPMC), Changxing Island**NCR #:** ZPMC-0755**Type of problem:**

Reference Description: Missed MT Indication**Description of Non-Conformance:**

Location: Changxing Island, Shanghai, China **Report No:** NCR-000793
Prime Contractor: American Bridge/Fluor Enterprises, a JV **Date:** 10-Jul-2010
Submitting Contractor: Zhenhua Port Machinery Company, Ltd (ZPMC), Changxing Island **NCR #:** ZPMC-0755

Contract #: 04-0120F4Cty: SF/ALA Rte: 80 PM: 13.2/13.9File #: xx.25A**QUALITY ASSURANCE -- NON-CONFORMANCE RESOLUTION****Location:** Changxing Island, Shanghai, China**Report No:** NCS-000719**Prime Contractor:** American Bridge/Fluor Enterprises, a JV**Date:** 17-Aug-2010**Submitting Contractor:** Zhenhua Port Machinery Company, Ltd (ZPMC), Changxing Island **NCR #:** ZPMC-0755**Type of problem:**

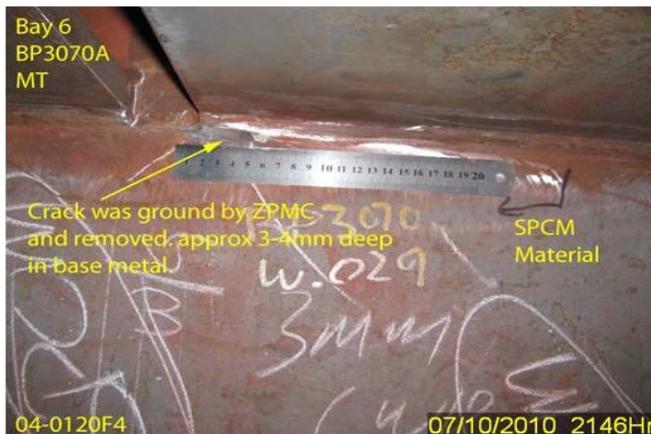
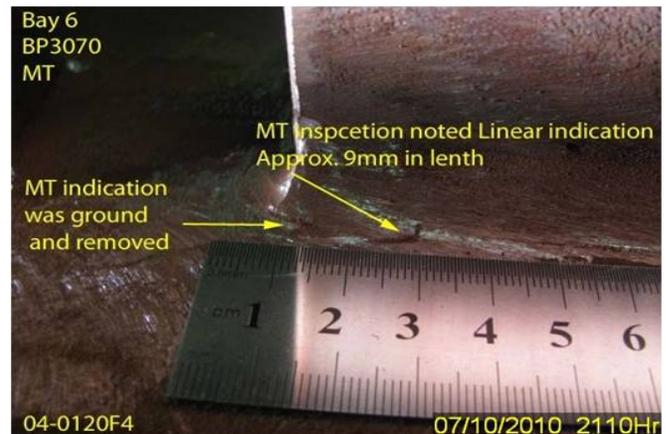
- Weld identified as: BP3070-029.
- One Longitudinal crack indication at the toe of the weld was missed by ZPMC.
- The "Y" location is approximately 10mm from the end of the stiffener.
- Length of Crack is 9mm.
- The fillet weld size as measured by QA is 8 mm.
- Bottom Plates are located in the OBG Sub assembly Bay#6.
- This component is SPCM material.

The Notice of Witness Inspection Number (NWIT) is 06168. The indication is located within the area that has been previously tested and accepted by ZPMC Quality Control (QC) personnel.

The attached photographs provide additional detail.

AWS D1.5 2002 Section 6 figure 6.8 – specifies for fillet weld size of 8mm the maximum discontinuity length is approximately 2.5mm.

ZPMC has performed the repair of this indication and attached the subsequent MT report denoting acceptance of this weld. ZPMC and ABFJV have held several meetings with the NDT department regarding missed indications. A disciplinary action procedure has been developed as well as an incentive procedure regarding this issue. We have stressed the point of being more thorough with inspections and to provide a cross checking for designated welds and or if questions arise regarding indications. ZPMC has also performed an internal training with the MT operators. ZPMC requests closure of this NCR.

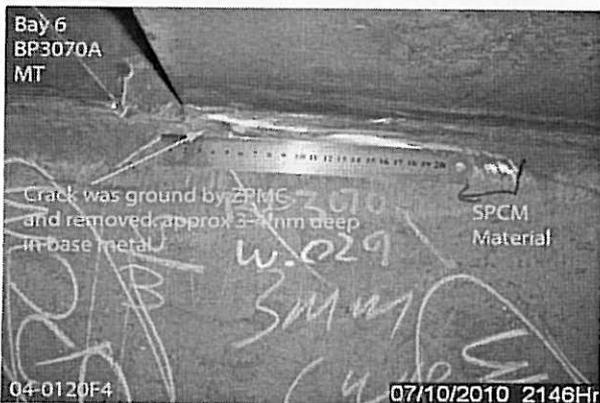
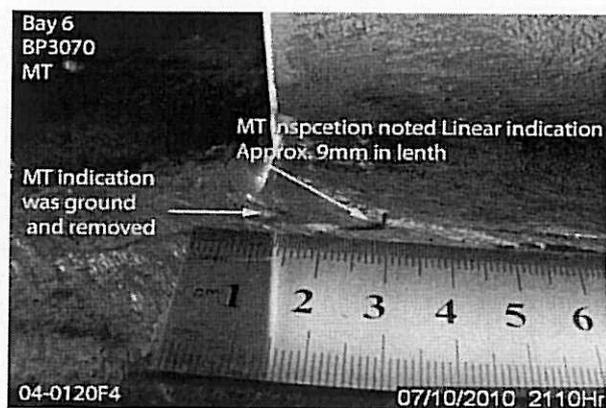
- Weld identified as: BP3070-029.
- One Longitudinal crack indication at the toe of the weld was missed by ZPMC.
- The "Y" location is approximately 10mm from the end of the stiffener.
- Length of Crack is 9mm.
- The fillet weld size as measured by QA is 8 mm.
- Bottom Plates are located in the OBG Sub assembly Bay#6.
- This component is SPCM material.

The Notice of Witness Inspection Number (NWIT) is 06168. The indication is located within the area that has been previously tested and accepted by ZPMC Quality Control (QC) personnel.

The attached photographs provide additional detail.

AWS D1.5 2002 Section 6 figure 6.8 – specifies for fillet weld size of 8mm the maximum discontinuity length is approximately 2.5mm.

Contractor supplied post repair NDT documentation verifying repair meets Contract weld quality requirements. ZPMC has instituted disciplinary actions as well as incentives to prompt inspectors to perform more thorough inspections. Supplemental training has also been provided to NDT technicians.
