QUALITY ASSURANCE -- NON-CONFORMANCE REPORT

Location: Changxing Island, Shanghai, P.R. China **Report No:** NCR-000795
Prime Contractor: American Bridge/Fluor Enterprises, a JV **Date:** 12-Jul-2010
Submitting Contractor: Zhenhua Port Machinery Company, Ltd (ZPMC), Changxing Island **NCR #:** ZPMC-0757

Reference Description: A Light Mounting Bracket on a 9DW Counterweight was damaged and bent

Job Name: SAS Superstructure

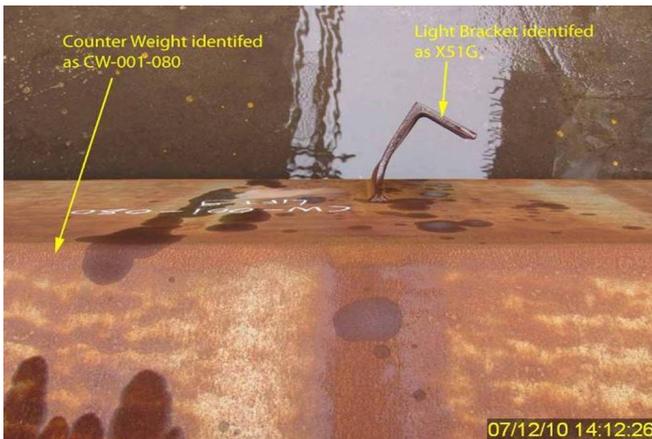
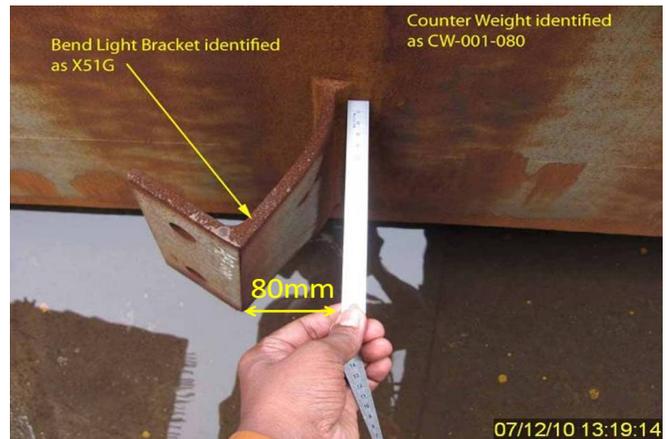
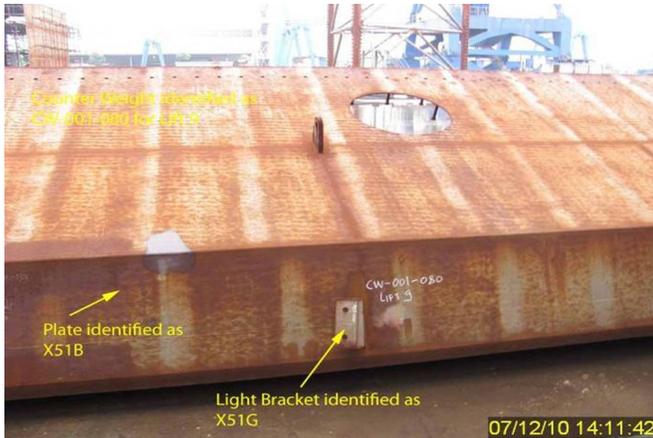
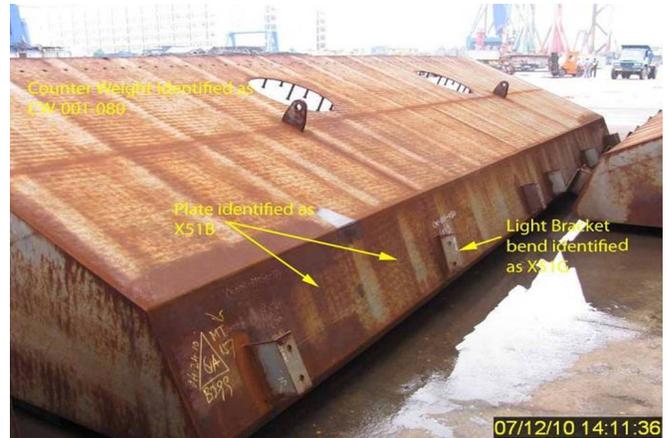
- The Counterweight Light Mounting Bracket was damaged and bent.
- The maximum displacement of the Light Mounting Bracket is 80mm.
- Counterweight of concern is CW-001-080 (Segment 9DW).
- Light Mounting Bracket identified as X51G.
- Counterweight Plate identified as X51B to which Light Mounting Bracket is welded.
- Counterweight CW-001-080 is located in the outside yard, behind bay 13.
- The area has previously tested and accepted by ZPMC prior to this damage.

Standard Specifications July, 1999 Section 55-1.04 Shipping, Handling and Storing Materials; "In handling and shipping of the steel work, every care shall be taken to avoid bending, scraping or overstressing the pieces. All pieces bent or otherwise injured will be rejected.

Reference Resolution: ZPMC is providing the heat straightening record used when they performed the work and the NDT done after to show the affected weld is acceptable.

ZPMC acknowledges that this heat straightening requires Engineer approval before being performed. In the future, work requiring heat straightening will be approved prior to commencing. ZPMC is providing the heat straightening record used when they performed the work and the NDT done after to show the affected weld is acceptable. Based on this ZPMC requests closure of this NCR.

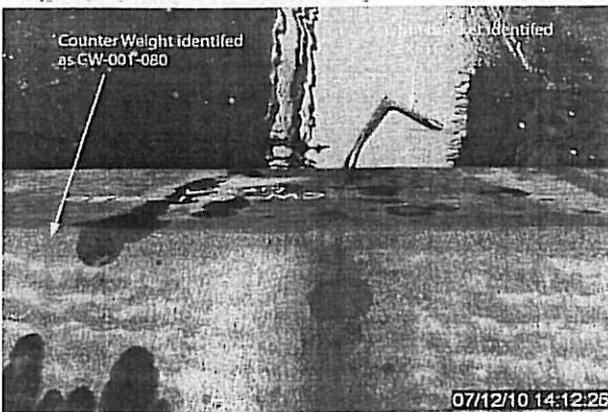
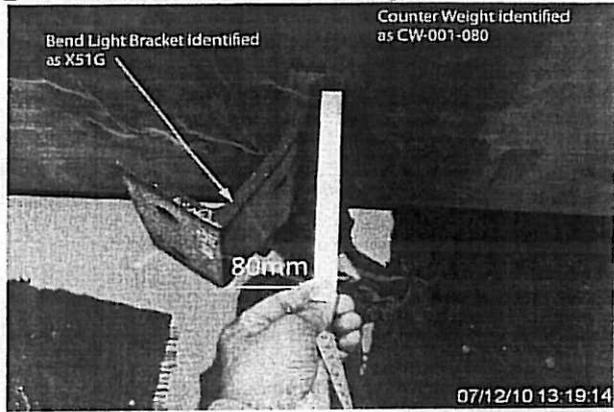
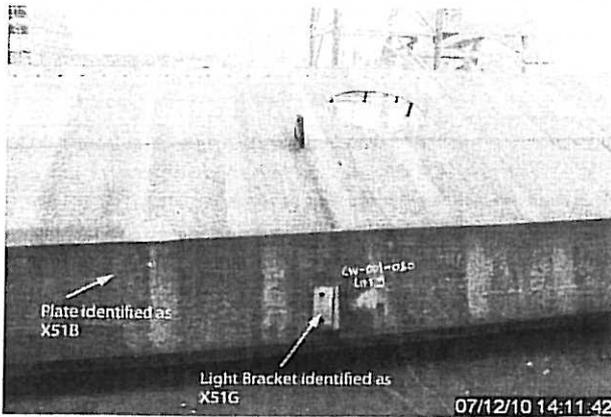
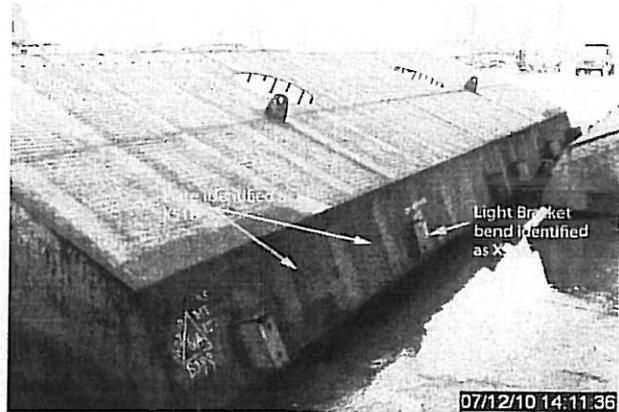
- The Counterweight Light Mounting Bracket was damaged and bent.
- The maximum displacement of the Light Mounting Bracket is 80mm.
- Counterweight of concern is CW-001-080 (Segment 9DW).
- Light Mounting Bracket identified as X51G.
- Counterweight Plate identified as X51B to which Light Mounting Bracket is welded.
- Counterweight CW-001-080 is located in the outside yard, behind bay 13.
- The area has previously tested and accepted by ZPMC prior to this damage.

Standard Specifications July, 1999 Section 55-1.04 Shipping, Handling and Storing Materials; "In handling and shipping of the steel work, every care shall be taken to avoid bending, scraping or overstressing the pieces. All pieces bent or otherwise injured will be rejected.

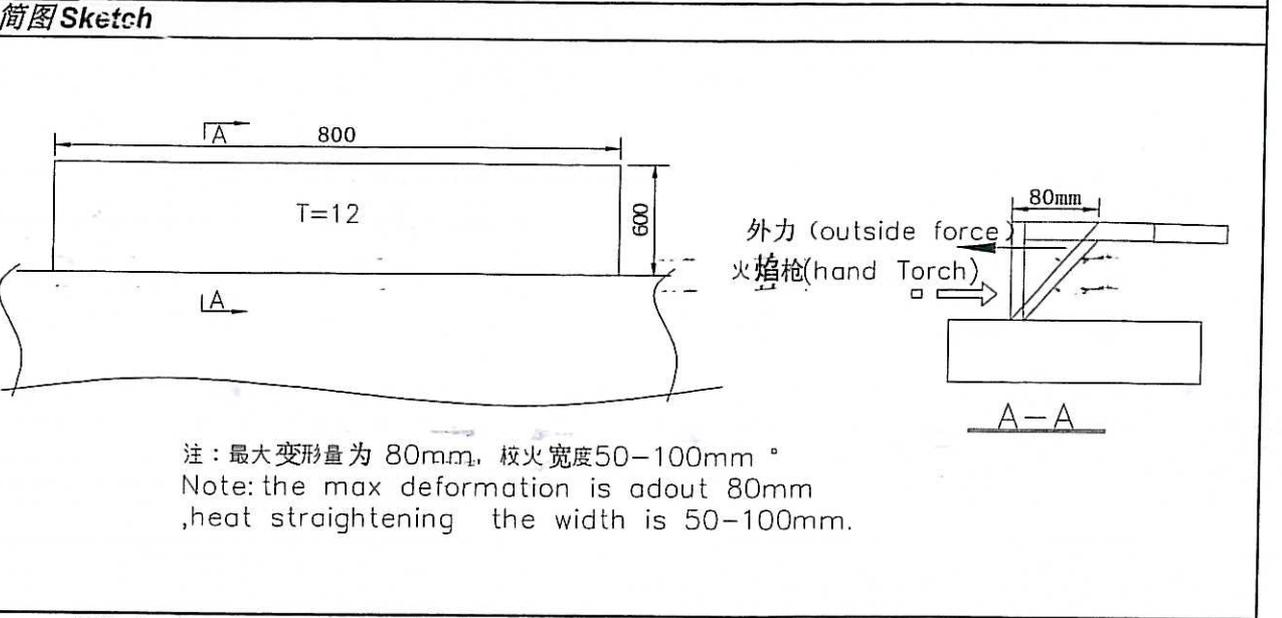
<h2 style="margin: 0;">火工校正记录</h2> <h3 style="margin: 0;">Heat Straightening Record (HSR1)</h3>	报告号 Record #	HSR1(B)-8655 -
	版本号 Revision #	0
日期 Date		2010.08.17

情况描述 Description of Condition	
Cause 原因	Welding distortion 焊接变形
Type of Defect 缺陷类型	Welding distortion 焊接变形
Inspection Method 检查方法	Visual 目检

缺陷去除方法(Defect Removal Method): 1、Flame Straightening by oxygen acetylene 运用氧乙炔进行校火 2、QC is responsible for monitoring temperature during heat straightening. QC必须持有校火报告批准件, 全程监控, 并控制好校火温度。

后续NDE(Post-Removal NDE): Jack shall be used in a manner such that all forces are applied passively. After finishing heat straightening, the weld of the heated area shall perform NDT according to approved shop drawing. 正确使用千斤顶, 避免因千斤顶使用不当造成构件塑性变形; 校火后, 根据图纸要求对校火区和热影响区域进行100%VT, 100%MT, 检测。

纠正措施(Corrective Action(s)): Fasten subcomponent to transportation trailer securely prior to transport. 转运之前将构件安全地紧固在转运拖车上。

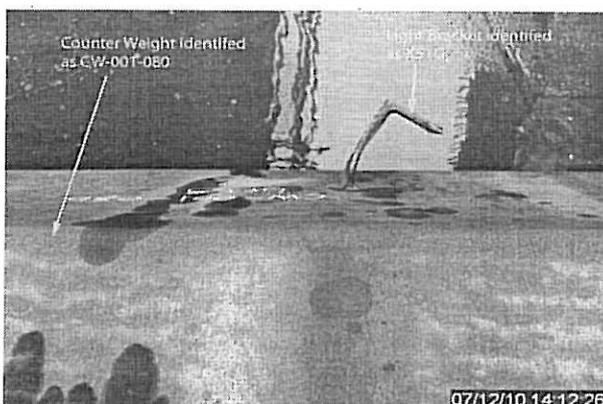
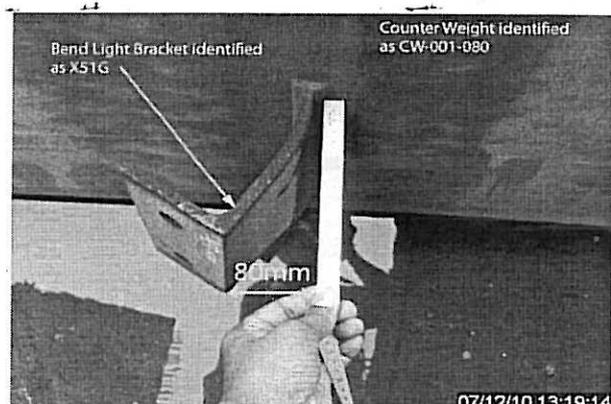
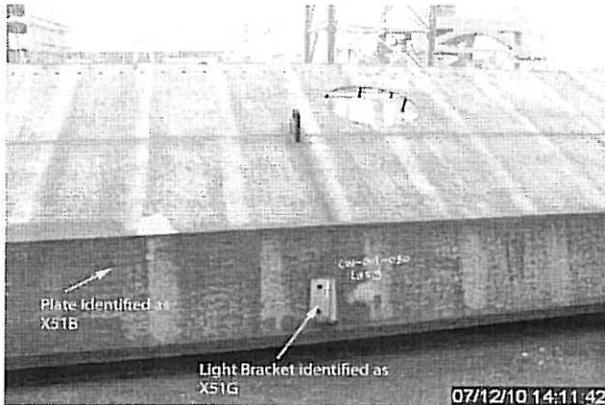
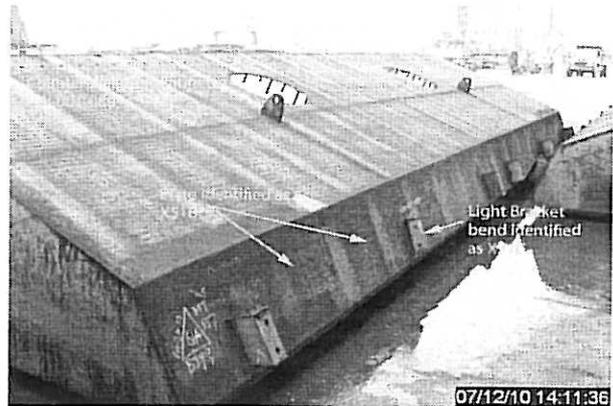
- The Counterweight Light Mounting Bracket was damaged and bent.
- The maximum displacement of the Light Mounting Bracket is 80mm.
- Counterweight of concern is CW-001-080 (Segment 9DW).
- Light Mounting Bracket identified as X51G.
- Counterweight Plate identified as X51B to which Light Mounting Bracket is welded.
- Counterweight CW-001-080 is located in the outside yard, behind bay 13.
- The area has previously tested and accepted by ZPMC prior to this damage.

Standard Specifications July, 1999 Section 55-1.04 Shipping, Handling and Storing Materials; "In handling and shipping of the steel work, every care shall be taken to avoid bending, scraping or overstressing the pieces. All pieces bent or otherwise injured will be rejected.
