Contract #: 04-0120F4
 Cty: SF/ALA Rte: 80 PM: 13.2/13.9
 File #: 69.25B

QUALITY ASSURANCE -- NON-CONFORMANCE REPORT

Report No: NCR-000802

Reference Description: ZPMC performed welding on wet surfaces (Segment 9BW/9CW Side Panels)

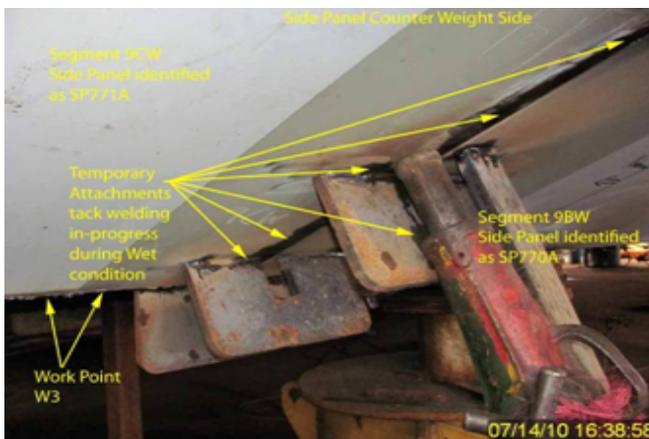
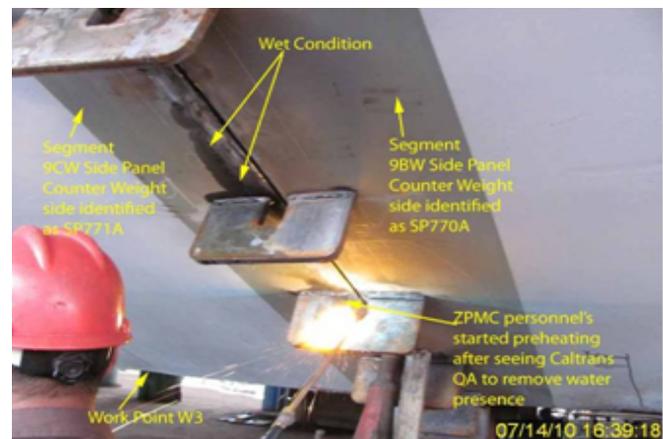
- During the fit up of segment splice 9BW to 9CW, ZPMC personnel performed tack welding of temporary attachments on wet surfaces.
- The tacks are on Side Panel SP770A (9BW) and Side Panel SP771A (9CW) at the counterweight side.
- No ZPMC QC personnel were aware of this issue.
- Segment's 9BW and 9CW are located at the OBG Trial Assembly Yard.

AWS D1.5 2002 Section 3.1.3: "Welding shall not be done when the ambient temperature is lower than -20°C [0°F](see 4.2), when surfaces are wet or exposed to rain, snow, or high wind velocities, nor when welders are exposed to inclement conditions."

ZPMC acknowledges this tack welding on wet surfaces is not acceptable and has issued a internal NCR to document this occurrence. ZPMC QC's are aware that this is not acceptable, the absence of the QC prevented ZPMC from halting this non conformance. In the future, ABFJV and ZPMC are ensuring that areas across the project are staffed to prevent this type of non conformance from occurring, as the instances of non conformances related to welding over wet material have been infrequent ZPMC and ABF are confident that this action will be sufficient in addressing this issue. Based on these actions and attached NDT documentation which shows the base metal is acceptable where the temporary attachments were welded, ZPMC requests closure of this NCR.

ZPMC acknowledged this problem and has issued an internal NCR. ZPMC production department will pay more attention on the removal of water around weld area prior to start welding. ZPMC is providing the MT record show the affected area were tested to be acceptable after the removal of temp-attachment. Based on this, ZPMC is requesting closure of this NCR.

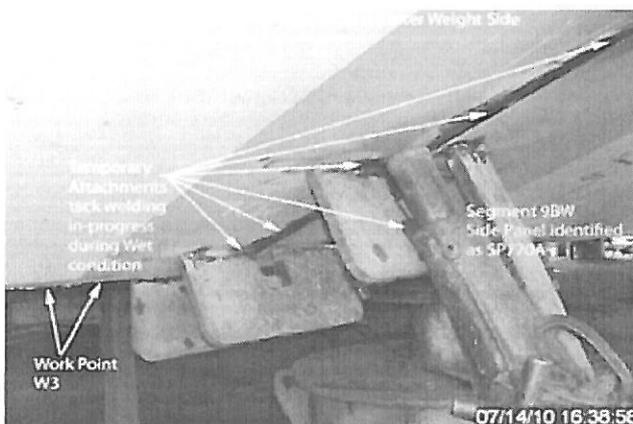
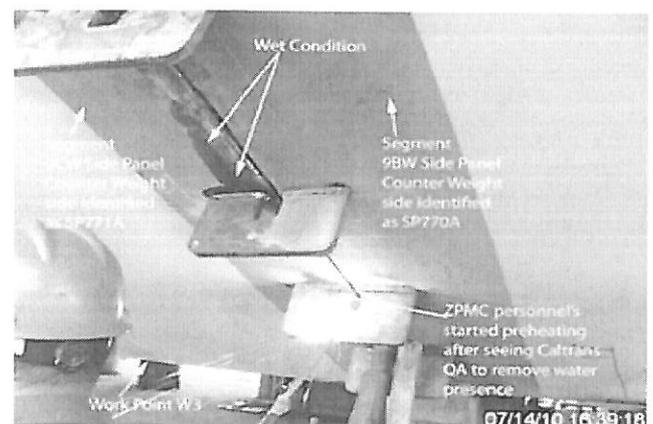
- During the fit up of segment splice 9BW to 9CW, ZPMC personnel performed tack welding of temporary attachments on wet surfaces.
- The tacks are on Side Panel SP770A (9BW) and Side Panel SP771A (9CW) at the counterweight side.
- No ZPMC QC personnel were aware of this issue.
- Segment's 9BW and 9CW are located at the OBG Trial Assembly Yard.

AWS D1.5 2002 Section 3.1.3: "Welding shall not be done when the ambient temperature is lower than -20°C [0°F](see 4.2), when surfaces are wet or exposed to rain, snow, or high wind velocities, nor when welders are exposed to inclement conditions."

Perform NDT required to verify base metal was not damaged after removal of temporary attachments.

The Contractor has issued an internal NCR in regards to this issue along with the applicable NDT to verify the base metal was not damaged after removal of the temporary attachments.
