Contract #: 04-0120F4Cty: SF/ALA Rte: 80 PM: 13.2/13.9File #: 69.25B**QUALITY ASSURANCE -- NON-CONFORMANCE REPORT****Location:** Changxing Island, Shanghai, P.R. China**Report No:** NCR-000804**Prime Contractor:** American Bridge/Fluor Enterprises, a JV**Date:** 15-Jul-2010**Submitting Contractor:** Zhenhua Port Machinery Company, Ltd (ZPMC), Changxing Island**NCR #:** ZPMC-0766**Type of problem:**

Welding	Concrete	Other	
Welding	Curing	Procedural	Bridge No: 34-0006
Joint fit-up	Coating	Other	Component: OBG Traveler Rail
Procedural	Procedural	Description: Missed MT crack by QC

Reference Description: QA found a 60mm long MT crack after the contractor's had tested and accepted a weld on a Traveler Rail

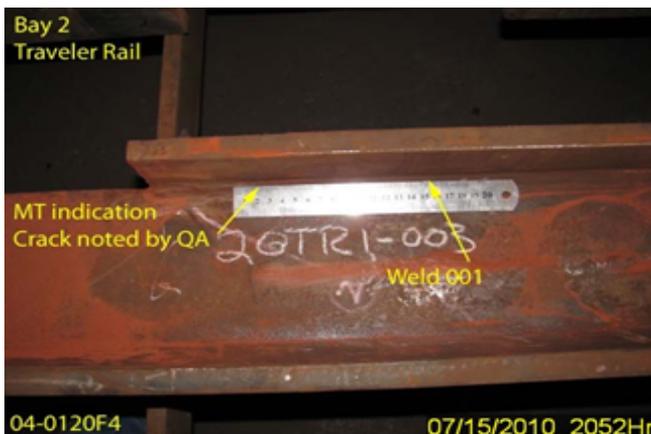
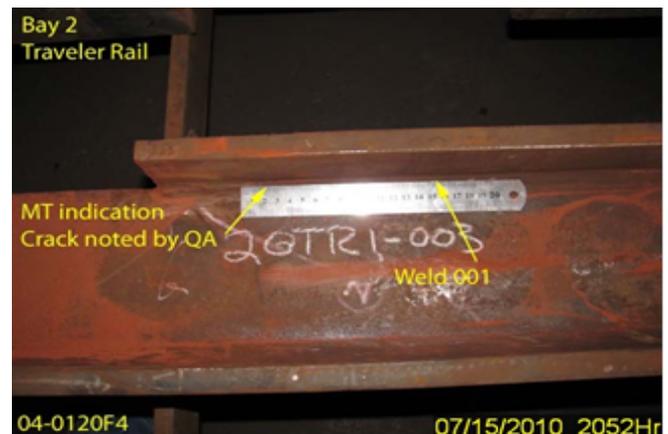
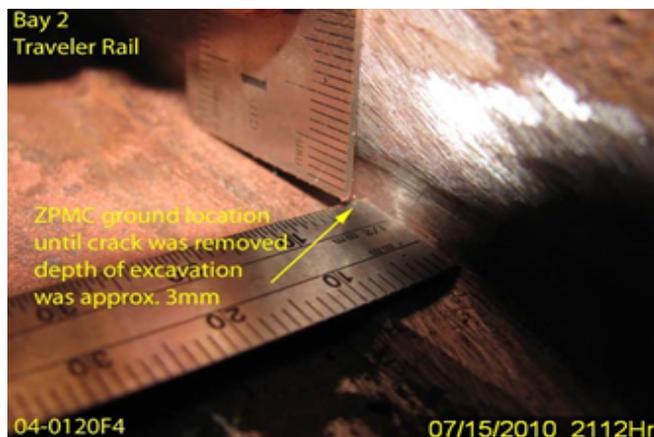
During Quality Assurance (QA) Magnetic Particle Testing (MT) review of welds located on Orthotropic Box Girder (OBG) Bottom Plate, this QA Inspector discovered the following issue:

- Weld identified as: 20TR1-003-001.
- One (1) longitudinal linear crack at the toe of the weld was found by QA.
- The "Y" location is approximately 60mm from the end of the stiffener.
- Length of Crack is 70mm.
- The weld is a CJP.
- This Traveler Rail is located in the OBG Sub assembly Bay #2.
- ZPMC QC agreed that this is a MT crack and will require a Critical Weld Repair (CWR)
- The Notice of Witness Inspection Number (NWIT) is 06206 item #4. The crack is located within the area that has been previously tested and accepted by ZPMC Quality Control (QC) personnel.

AWS D1.5 2002 Section 6 par.6.26.2 – Welds that are subject to RT or MT in addition to visual inspection shall have no cracks and shall be unacceptable if the RT or MT shows any of the types of discontinuities described in 6.26.2.1, 6.26.2.2, 6.26.2.3 or 6.26.2.4.

ZPMC has performed the repair of this indication and attached the subsequent MT report denoting acceptance of this weld. ZPMC and ABFJV have held several meetings with the NDT department regarding missed indications. A disciplinary action procedure has been developed as well as an incentive procedure regarding this issue. We have stressed the point of being more thorough with inspections and to provide a cross checking for designated welds and or if questions arise regarding indications. ZPMC has also performed an internal training with the MT operators. ZPMC requests closure of this NCR.

Contractor supplied post repair NDT documentation verifying weld is in conformance with Contract weld quality requirements. Contractor has also taken action directly with NDT Technicians to avoid similar issues in the future.

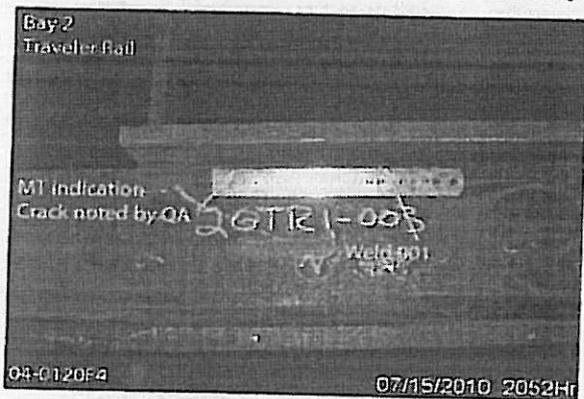
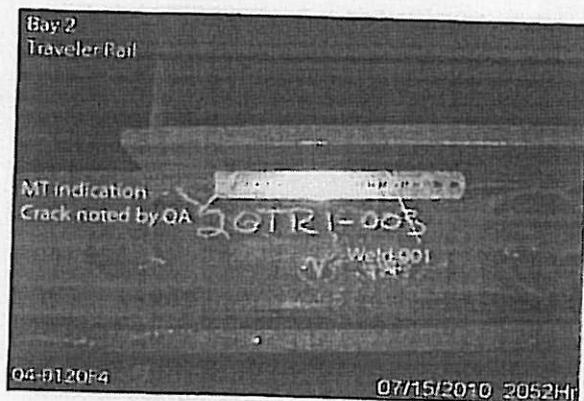
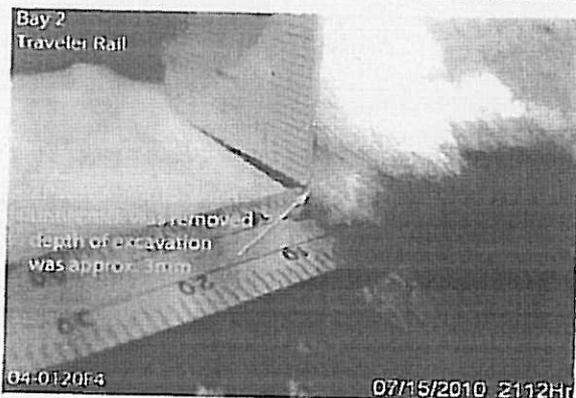
During Quality Assurance (QA) Magnetic Particle Testing (MT) review of welds located on Orthotropic Box Girder (OBG) Bottom Plate, this QA Inspector discovered the following issue:

- Weld identified as: 20TR1-003-001.
- One (1) longitudinal linear crack at the toe of the weld was found by QA.
- The "Y" location is approximately 60mm from the end of the stiffener.
- Length of Crack is 70mm.
- The weld is a CJP.
- This Traveler Rail is located in the OBG Sub assembly Bay #2.
- ZPMC QC agreed that this is a MT crack and will require a Critical Weld Repair (CWR)
- The Notice of Witness Inspection Number (NWIT) is 06206 item #4. The crack is located within the area that has been previously tested and accepted by ZPMC Quality Control (QC) personnel.

AWS D1.5 2002 Section 6 par.6.26.2 – Welds that are subject to RT or MT in addition to visual inspection shall have no cracks and shall be unacceptable if the RT or MT shows any of the types of discontinuities described in 6.26.2.1, 6.26.2.2, 6.26.2.3 or 6.26.2.4.

Repair said indication and perform NDT required to verify weld quality.
