## QUALITY ASSURANCE -- NON-CONFORMANCE REPORT

**Report No:** NCR-000805

<b>Welding</b>	<b>Concrete</b>	<b>Other</b>	
<b>Welding</b>	<b>Curing</b>	<b>Procedural</b>	<b>Bridge No:</b> 34-0006
<b>Joint fit-up</b>	<b>Coating</b>	<b>Other</b>	<b>Component:</b> Segment 7BW Floorbeam & Bottom Panel
<b>Procedural</b>	<b>Procedural</b>	<b>Description:</b>

**Reference Description:** Segment 7BW Floorbeam & Bottom Panel at the FL3 area was damaged during its loading onto the ship

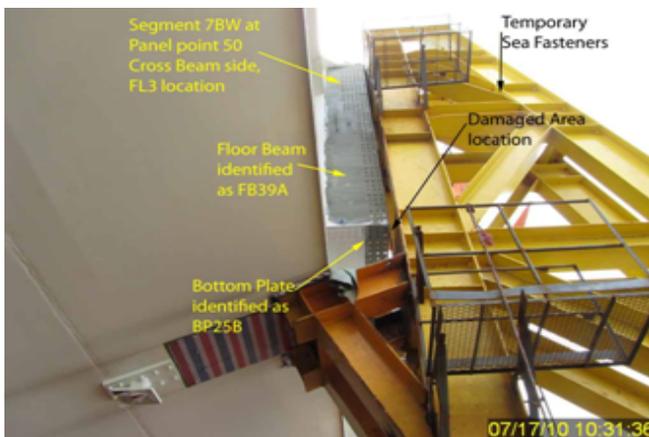
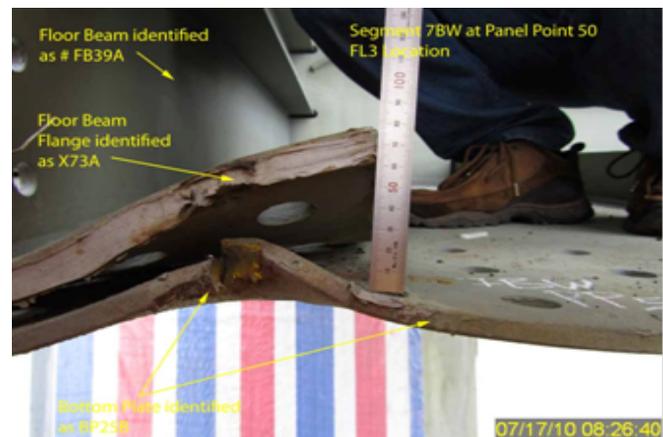
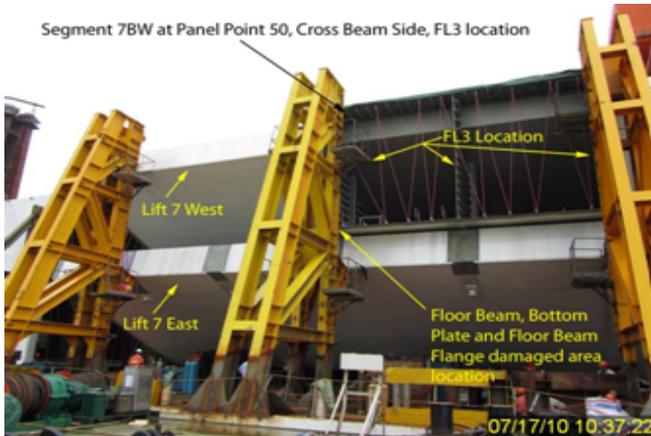
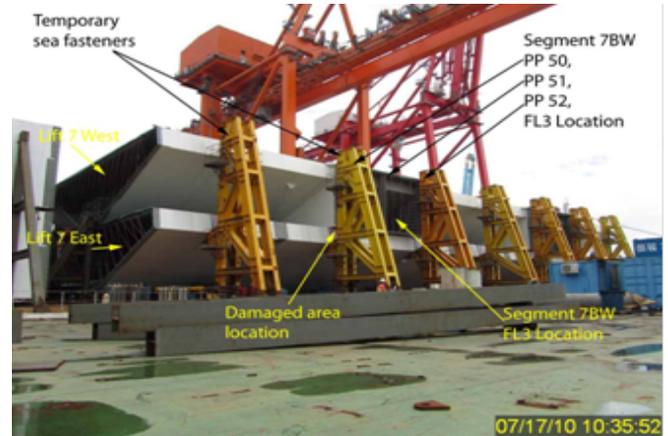
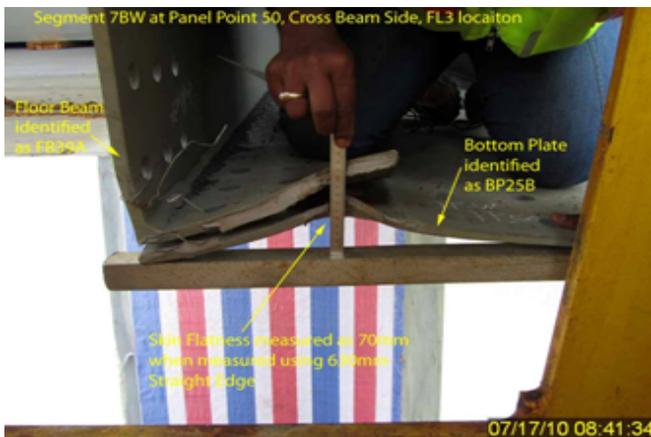
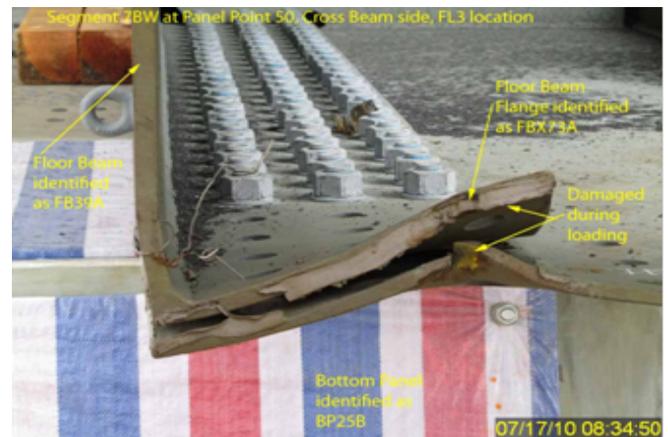
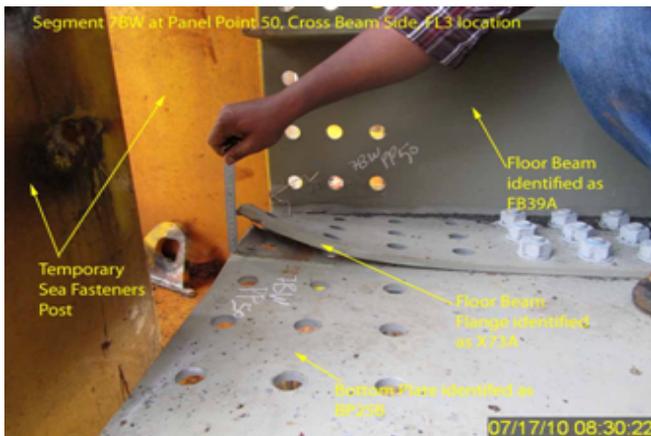
- Segment 7BW was damaged during its loading onto the ship. The damage areas were at the lower portion of the Floor Beam, the adjacent Floor Beam Bottom Flange, and the adjacent Bottom Panel at the FL3 Location. The measured maximum bent is at the Bottom Panel near the Crossbeam connection at Panel Point 50. The skin is out of flatness with a maximum deflection of 70mm when measured with 630mm Straight Edge.
- The FL3 location Floor Beam identified as FB39A.
- The Floor Beam Web identified as X90A.
- The Floor Beam Flange identified as X73A.
- The Bottom Plate identified as BP25B.
- Segment 7BW is located on Ship Zhenhua #19.

Damaged areas were removed and replaced. Contractor has submitted post repair NDT documentation verifying newly added welds conform with Contract weld quality requirements. Weld maps and as-built plans will be updated to show new welds.

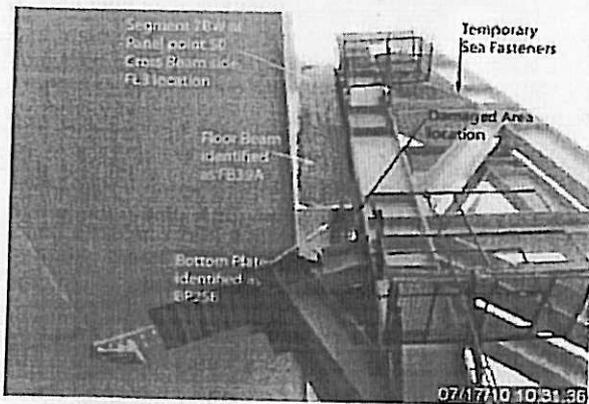
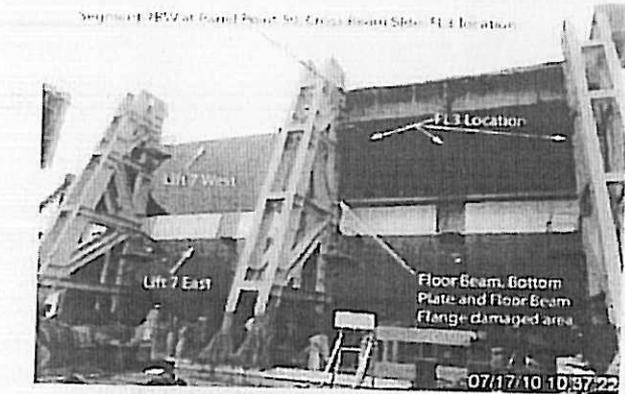
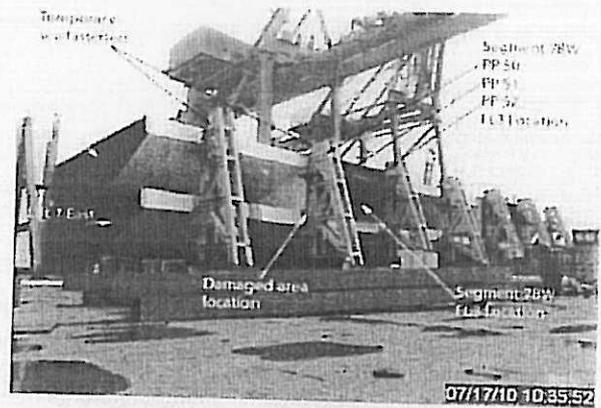
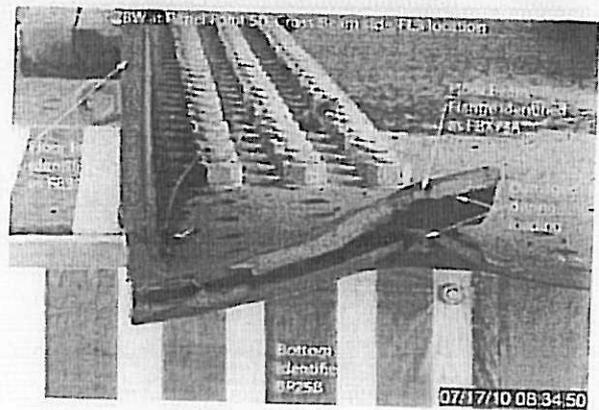
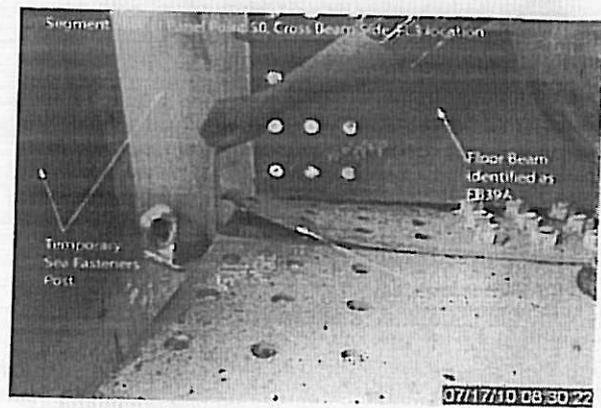
- Segment 7BW was damaged during its loading onto the ship. The damage areas were at the lower portion of the Floor Beam, the adjacent Floor Beam Bottom Flange, and the adjacent Bottom Panel at the FL3 Location. The measured maximum bent is at the Bottom Panel near the Crossbeam connection at Panel Point 50. The skin is out of flatness with a maximum deflection of 70mm when measured with 630mm Straight Edge.
- The FL3 location Floor Beam identified as FB39A.
- The Floor Beam Web identified as X90A.
- The Floor Beam Flange identified as X73A.
- The Bottom Plate identified as BP25B.
- Segment 7BW is located on Ship Zhenhua #19.
