Contract #: 04-0120F4Cty: SF/ALA Rte: 80 PM: 13.2/13.9File #: 69.25B**QUALITY ASSURANCE -- NON-CONFORMANCE REPORT****Location:** Changxing Island, Shanghai, China**Report No:** NCR-000806**Prime Contractor:** American Bridge/Fluor Enterprises, a JV**Date:** 17-Jul-2010**Submitting Contractor:** Zhenhua Port Machinery Company, Ltd (ZPMC), Changxing Island**NCR #:** ZPMC-0768**Type of problem:**

Reference Description: Critical Weld Repair (SPCM) without Prior Approval from Engineer**Description of Non-Conformance:**

To: AMERICAN BRIDGE/FLUOR, A JV **Date:** 19-Jul-2010
 375 BURMA ROAD
 OAKLAND CA 95607 **Contract No:** 04-0120F4
 04-SF-80-13.2 / 13.9
Dear: Mr. Charles Kanapicki **Job Name:** SAS Superstructure
Attention: Mr. Thomas Nilsson Project/Fabrication Manager **Document No:** 05.03.06-000762
Subject: NCR No. ZPMC-0768

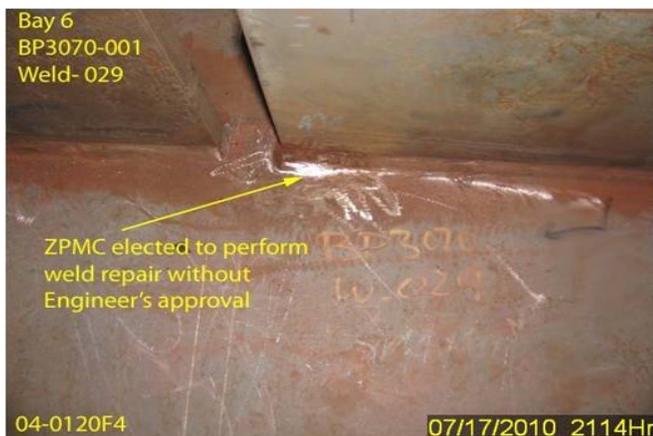
During Quality Assurance (QA) random in-process observations of the fabrication of Orthotropic Box Girder (OBG) Bottom Panel BP3070-001 discovered the following issue:

- Weld metal / base metal crack repair performed on Seismic Performance Critical Member (SPCM) without prior Engineer's approval.
 - The repair was performed on fillet weld identified as BP3070-001-029.
 - This weld was previously tested and rejected by Caltrans (CT) QA.
 - The indication was confirmed as a crack using the Magnetic particle Testing (MT) method.
 - ZPMC workers removed a portion of the weld and ground approximately 4mm into the SPCM bottom plate to remove the crack entirely.
 - The weld is a fillet weld T-joint, joining stiffener identified as RS3415M to SPCM bottom plate identified as PL3380A.
 - The repair area is approximately 10mm from the east end of the stiffener (nearest to PP124).
- For further information, please see the attached picture below.

AWS D1.5 2002, Section 12.17.4: Except as provided in 12.17.2, all welded repairs shall be considered critical.

AWS D1.5 Sec 12 par. 12.17.4: All critical weld repairs to base metal and welds shall be approved by the Engineer prior to beginning the repair and shall be documented giving details of the type of discontinuity and extent of repair.

Reference Resolution: ZPMC has repaired the base metal indication in accordance with the approved CWR and is providing NDT after repair to show it is acceptable.

ZPMC has repaired the base metal indication in accordance with the approved CWR and is providing NDT after repair to show it is acceptable. ZPMC's QA engineers have written an internal NCR and brought this to the Production department's attention. ZPMC has identified the personnel involved and will monitor the specific individual's performance in the future. Based on this ZPMC requests closure of this NCR.

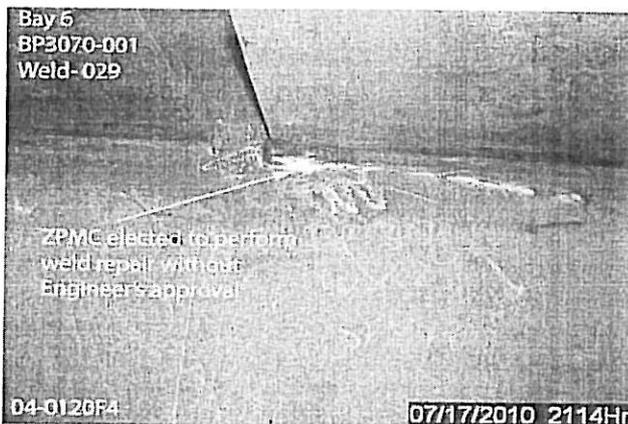
During Quality Assurance (QA) random in-process observations of the fabrication of Orthotropic Box Girder (OBG) Bottom Panel BP3070-001 discovered the following issue:

- Weld metal / base metal crack repair performed on Seismic Performance Critical Member (SPCM) without prior Engineer's approval.
 - The repair was performed on fillet weld identified as BP3070-001-029.
 - This weld was previously tested and rejected by Caltrans (CT) QA.
 - The indication was confirmed as a crack using the Magnetic particle Testing (MT) method.
 - ZPMC workers removed a portion of the weld and ground approximately 4mm into the SPCM bottom plate to remove the crack entirely.
 - The weld is a fillet weld T-joint, joining stiffener identified as RS3415M to SPCM bottom plate identified as PL3380A.
 - The repair area is approximately 10mm from the east end of the stiffener (nearest to PP124).
- For further information, please see the attached picture below.

AWS D1.5 2002, Section 12.17.4: Except as provided in 12.17.2, all welded repairs shall be considered critical. They include, but are not limited to the following:

AWS D1.5 Sec 12 par. 12.17.4: All critical weld repairs to base metal and welds shall be approved by the Engineer prior to beginning the repair and shall be documented giving details of the type of discontinuity and extent of repair.

Contractor repaired the base metal indications with approved CWR, and NDT report is provided. The NDT report showed the weld is acceptable. Contractor issued an internal NCR, and brought the Production department's attention. Contractor identified and monitored the inspector.
