Contract #: 04-0120F4Cty: SF/ALA Rte: 80 PM: 13.2/13.9File #: 69.25B**QUALITY ASSURANCE -- NON-CONFORMANCE REPORT****Location:** Changxing Island, Shanghai, P.R. China**Report No:** NCR-000809**Prime Contractor:** American Bridge/Fluor Enterprises, a JV**Date:** 20-Jul-2010**Submitting Contractor:** Zhenhua Port Machinery Company, Ltd (ZPMC), Changxing Island**NCR #:** ZPMC-0771**Type of problem:**

Welding	Concrete	Other	
Welding	Curing	Procedural	Bridge No: 34-0006
Joint fit-up	Coating	Other	Component: Segment 11BE Deck Panel Diaphragm
Procedural	Procedural	Description: Missed MT Transverse Crack by QC

Reference Description: QA found a MT crack after the contractor's had tested and accepted a weld joint on Segment 11BE U-Rib to Deck Diaphragm

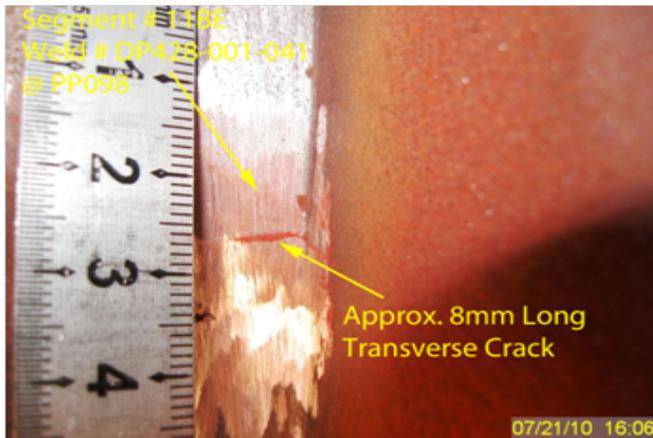
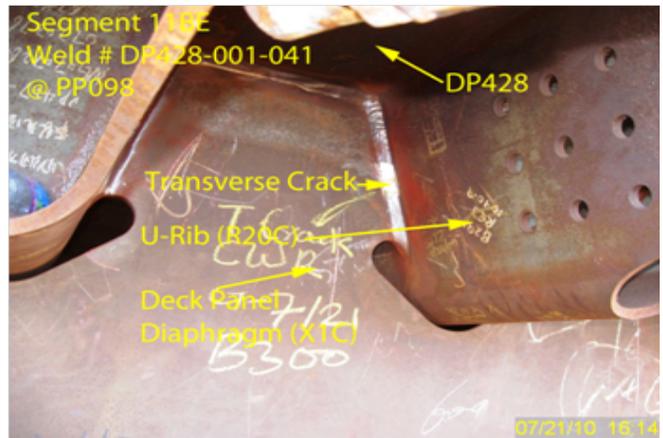
During random Quality Assurance (QA) Magnetic Particle Testing (MT) review of welds located on segment 11BE, this Caltrans QA Inspector discovered one Transverse Crack on the following weld:

- One (1) Transverse Crack measuring approximately 8 mm in length.
- The weld is identified as DP428-001-041 @ panel point (PP) 98.
- Weld is a Fillet Weld joining the Deck Panel Diaphragm to U-Rib.
- The weld is designated as Non-Seismic Performance Critical Member (Non-SPCM).
- Deck Panel Diaphragm identified as X1C (Non-SPCM).
- Closed U-Rib identified as R20C (Non-SPCM).
- The indication is clearly marked on the material near the weld.
- OBG segment 11BE is located in outside yard, west of OBG Bay 13.

The Notice of Witness Inspection (NWIT) No. is 006235. The indication is located within an area previously tested and accepted by ZPMC Quality Control (QC) personnel. As per the contract documents, ZPMC's QC personnel are required to perform 100% MT inspection of this weld.

Reference Resolution: ZPMC has repaired this crack and is providing the NDT performed after to show that the repair was successful.

ZPMC has repaired this crack and is providing the NDT performed after to show that the repair was successful. In order to decrease missed indications, ZPMC QA will conduct refresher training with its inspectors and continue to monitor inspector performance. Based on this ZPMC requests closure of this NCR.

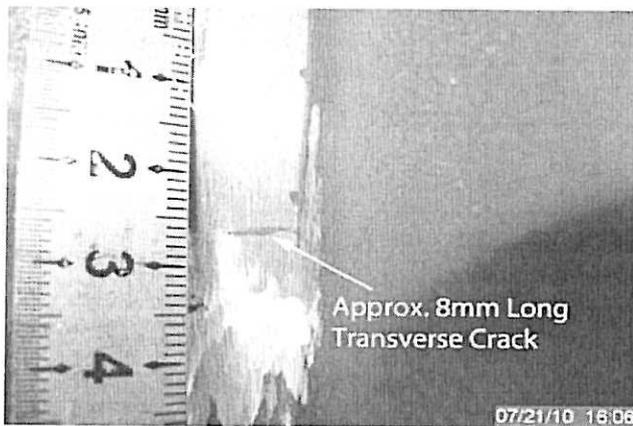
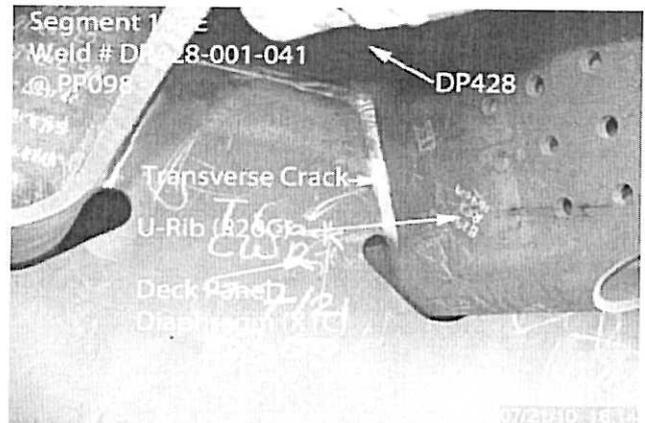
During random Quality Assurance (QA) Magnetic Particle Testing (MT) review of welds located on segment 11BE, this Caltrans QA Inspector discovered one Transverse Crack on the following weld:

- One (1) Transverse Crack measuring approximately 8 mm in length.
- The weld is identified as DP428-001-041 @ panel point (PP) 98.
- Weld is a Fillet Weld joining the Deck Panel Diaphragm to U-Rib.
- The weld is designated as Non-Seismic Performance Critical Member (Non-SPCM).
- Deck Panel Diaphragm identified as X1C (Non-SPCM).
- Closed U-Rib identified as R20C (Non-SPCM).
- The indication is clearly marked on the material near the weld.
- OBG segment 11BE is located in outside yard, west of OBG Bay 13.

The Notice of Witness Inspection (NWIT) No. is 006235. The indication is located within an area previously tested and accepted by ZPMC Quality Control (QC) personnel. As per the contract documents, ZPMC's QC personnel are required to perform 100% MT inspection of this weld.

Repair said indication and perform NDT required to verify weld quality.

Contractor supplied post repair NDT documentation verifying weld conforms with Contract weld quality requirements. An internal NCR was also issued by ZPMC in regards to this issue, and refresher training was provided to NDT technicians.
