Contract #: 04-0120F4Cty: SF/ALA Rte: 80 PM: 13.2/13.9File #: 69.25B**QUALITY ASSURANCE -- NON-CONFORMANCE REPORT****Location:** Changxing Island, Shanghai, P.R. China**Report No:** NCR-000812**Prime Contractor:** American Bridge/Fluor Enterprises, a JV**Date:** 26-Jul-2010**Submitting Contractor:** Zhenhua Port Machinery Company, Ltd (ZPMC), Changxing Island**NCR #:** ZPMC-0774**Type of problem:**

Reference Description: Weld Repair performed on SPCM Material without Engineer's approval**Description of Non-Conformance:**

To:	AMERICAN BRIDGE/FLUOR, A JV 375 BURMA ROAD OAKLAND CA 95607	Date:	28-Jul-2010
Dear:	Mr. Charles Kanapicki	Contract No:	04-0120F4 04-SF-80-13.2 / 13.9
Attention:	Mr. Thomas Nilsson Project/Fabrication Manager	Job Name:	SAS Superstructure
Subject:	NCR No. ZPMC-0774	Document No:	05.03.06-000770

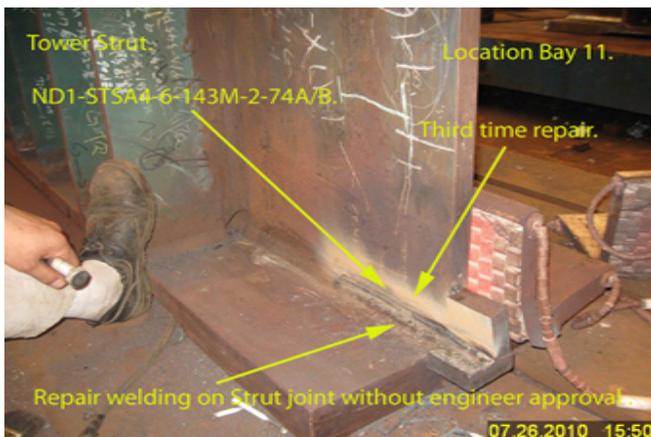
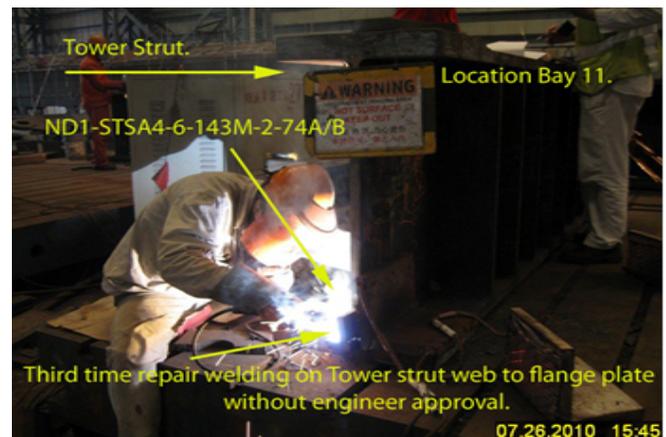
- ZPMC welder personnel is performing Shielded Metal Arc Welding (SMAW) repair on Seismic Performance Critical Material (SPCM) without the Engineer approval.

- The effected Tower Strut identified as ND1-STSA4-6-143M-2, Joint No identified as ND1-STSA4-6-143M-2-74A/B.

- The Material thickness is 32 mm.

- This Tower Strut is located in Sub assembly Bay#11.

AWS D1.1 (2002) Section 12.17.4: "All critical repairs to base metal and welds shall be approved by the Engineer prior to beginning the repair and shall be documented giving details of the type of discontinuity and extent of repair."

Propose a resolution for the non-conformance item and document that the deficiencies have been brought into compliance with contract requirements. Also propose a resolution that addresses the apparent failure of Quality Control to identify the non-conformance with the appropriate Welding Procedure Specification (WPS). Provide documentation of the steps taken by the Quality Control Manager to prevent future occurrences.

Contractor stopped the repair works immediately. Repair resumed until CWR is approved by Engineer. NDT report submitted subsequently showed that the weld is acceptable. Contractor reprimanded the inspector involved and made him aware of the consequence of repairing with no Engineer's approval.

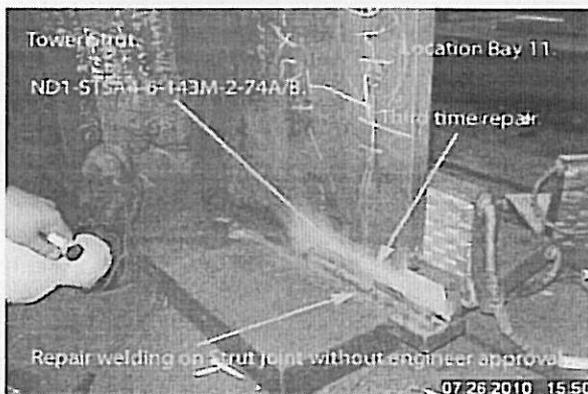
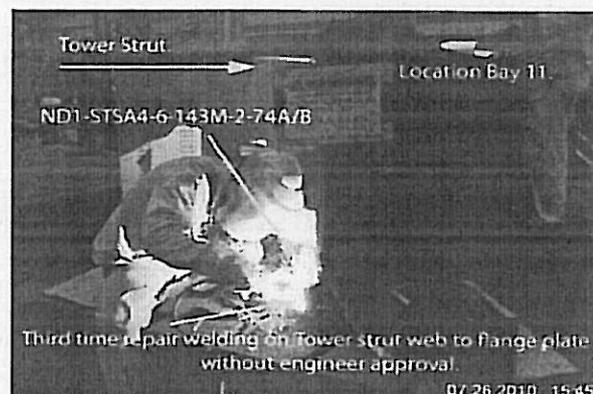
-ZPMC welder personnel is performing Shielded Metal Arc Welding (SMAW) repair on Seismic Performance Critical Material (SPCM) without the Engineer approval.

-The effected Tower Strut identified as ND1-STSA4-6-143M-2, Joint No identified as ND1-STSA4-6-143M-2-74A/B.

-The Material thickness is 32 mm.

-This Tower Strut is located in Sub assembly Bay#11.

AWS D1.1 (2002) Section 12.17.4: "All critical repairs to base metal and welds shall be approved by the Engineer prior to beginning the repair and shall be documented giving details of the type of discontinuity and extent of repair."

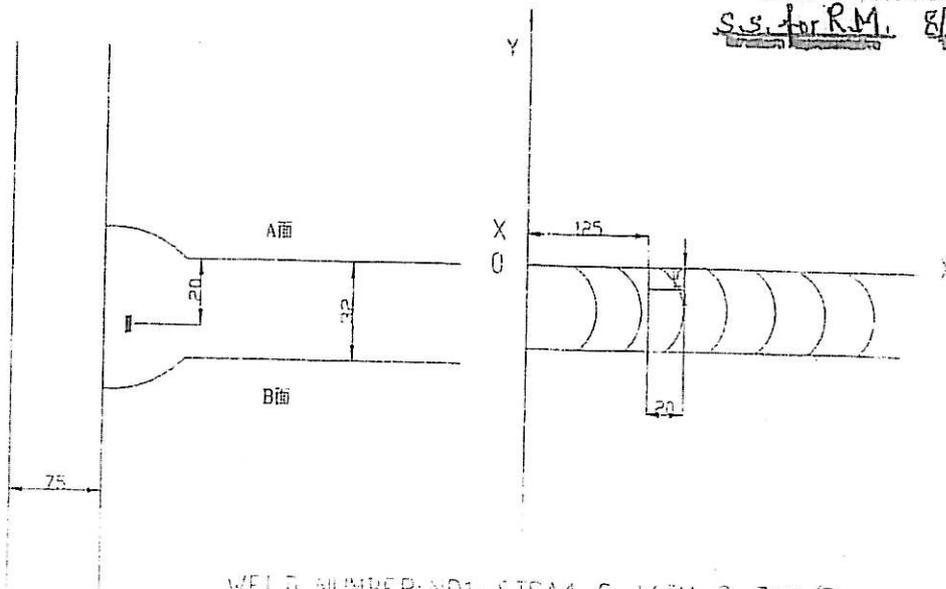
WELD NUMBER: ND1-STSA4-6-143M-2-74A/B

Rejected indication found by ultrasonic inspection at second time.

(UT探伤返修第二次, 并且该板为A709SL-GE485。) ND1-STSA4-6-143M-2-74A/B

1 The weld defect location may not have been properly identified prior to grinding. i.e. the X and Y location was incorrect or the excavation was not centered on the defect, therefore the excavation did not encompass the whole defect

1. QC shall monitor and direct the welder and the grinder doing the repair operation.
2. Preheat before gouging; the temperature shall be at least 65°C.
3. Gouge the weld to remove identified defects.
4. Joint details shall refer to the approved WPS repair.
5. Grind the gouged areas to a smooth and shiny surface.
6. Verify with VT and MT to ensure no defects remain in the weld joint prior to welding.
7. QC shall monitor all welding passes being deposited.
8. QC shall ensure all slag has been removed prior the deposition of next pass.
9. Preheat and maintain interpass temperature control in accordance with the WPS.
10. Blend the weld repaired areas into the adjacent weld or base metal by grinding.
11. Perform VT, MT and UT NDT inspection to the repaired areas.

- QC and production to properly lay out the UT defect, mark the X, Y, D on the base metal and the location on the surface of weld by use of rectangle or circle, by doing this, UT operator will verify the exact location of the defect prior to excavation.
 - The UT operator and or CWI will take the responsibility to verify the excavation has completely removed the defect
- QC和生产部门应该正确的标出缺陷的位置, 在母材上标出缺陷X, Y, D的值, 在焊缝上, 用长方形和圆圈标出缺陷的位置, 这样, 在碳刨前, 能够准确的确认缺陷的位置;
 - UT检验员和CWI必须确认缺陷已经完全刨除.
