QUALITY ASSURANCE -- NON-CONFORMANCE REPORT

Location: Changxing Island, Shanghai, China**Report No:** NCR-000815**Prime Contractor:** American Bridge/Fluor Enterprises, a JV**Date:** 26-Jul-2010**Submitting Contractor:** Zhenhua Port Machinery Company, Ltd (ZPMC), Changxing Island**NCR #:** ZPMC-0777**Type of problem:**

Welding	Concrete	Other	
Welding	Curing	Procedural	Bridge No: 34-0006
Joint fit-up	Coating	Other	Component: OBG Suspender Bracket SB78E
Procedural	Procedural	Description: Missed MT transverse cracks by QC

Reference Description: 15 Transverse Cracks discovered with MT testing after ZPMC had tested and accepted these welds

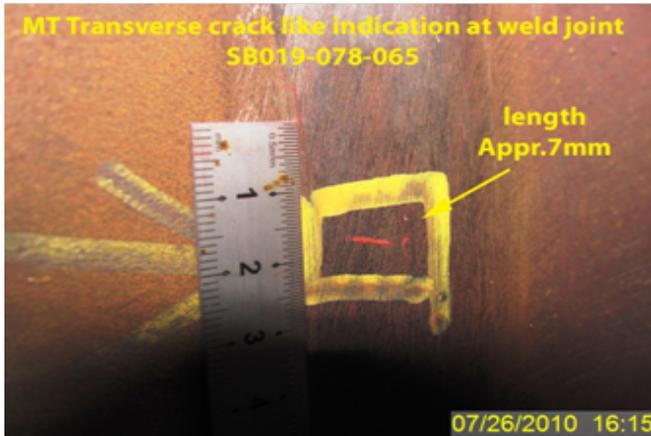
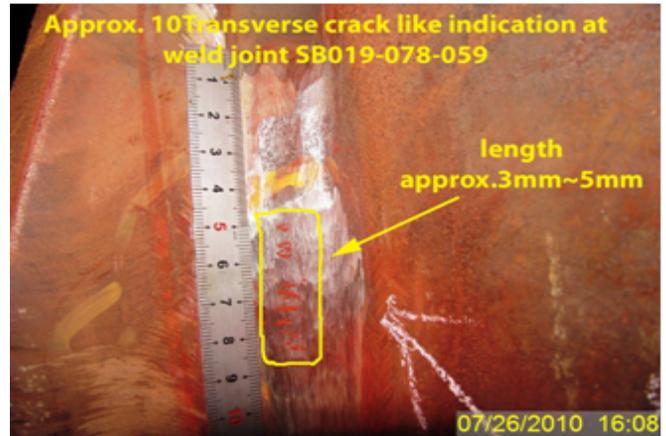
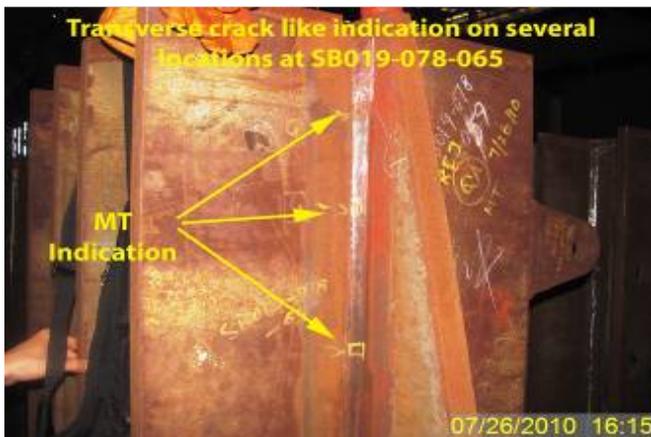
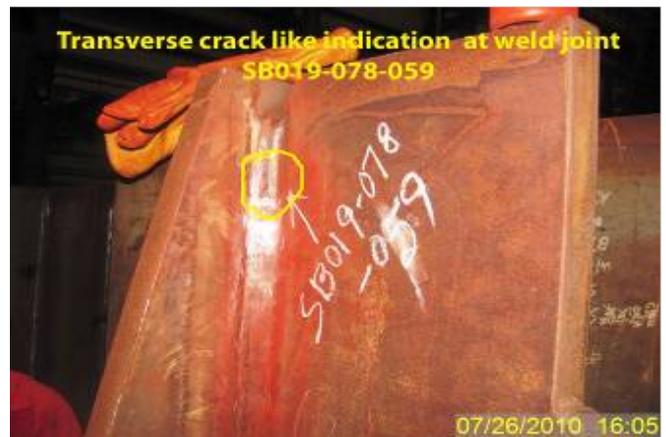
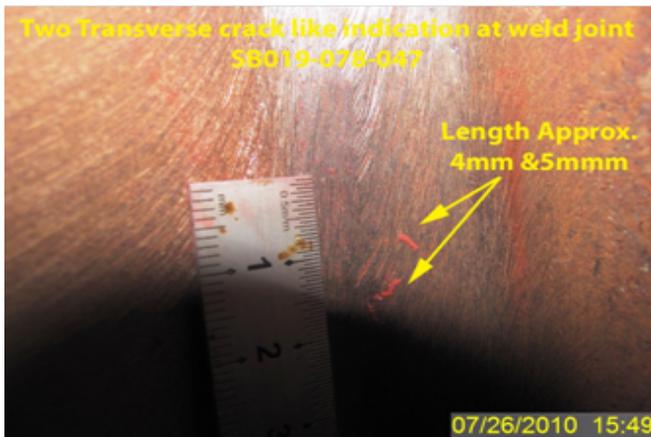
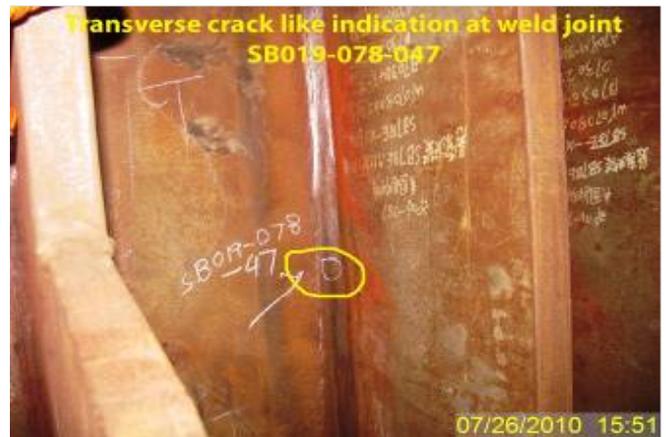
During the Quality Assurance (QA) Magnetic Particle Testing (MT) review of welds located on Suspender Bracket SB78E for Segment 9CE, this QA Inspector discovered fifteen (15) Transverse linear cracks on the following welds:

- Weld # SB019-078-047: Two (2) Transverse linear cracks measuring approximately 4mm to 5mm in length.
- Weld # SB019-078-059: Ten (10) Transverse linear cracks measuring approximately 3mm to 5mm in length.
- Weld # SB019-078-065: Three (3) Transverse linear cracks measuring approximately 3mm to 7mm in length.
- All indications are clearly marked on the material near the weld.
- All welds are designated as Non-Seismic Performance Critical Members (Non-SPCM).
- All welds are fillet welds that join the Middle Web plate (X56CC) to Stiffeners (X55).
- OBG Suspender Bracket SB78E is located in Bay # 19.

The Notice of Witness Inspection Number (NWIT) is 06286. The indications are located inside an area that has been previously tested by ZPMC Quality Control (QC) personnel. As per the contract documents, ZPMC's QC personnel are required to perform 100% MT inspection of this weld.

Reference Resolution: ZPMC has repaired the areas noted in the NCR and is submitting the MT documents to show that the repair was successful.

These indications have been removed, repaired and retested to be acceptable. ZPMC is providing both the NDT records to show the soundness of these welds. The indications were repaired prior to the related templete CWR be confirmed by department's representative, due to the misunderstanding from ZPMC site personnel. ZPMC QA personnel have instruct the site personnel to follow the procedure of templete CWR which requirs all the templete CWR shall be confirmed by department's representative prior to using. And the unverified CWR has been submitted to department's engineer to review. Based on this, ZPMC is request closure of this NCR.

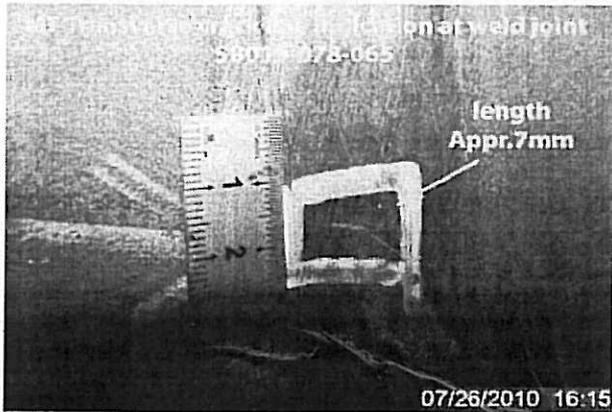
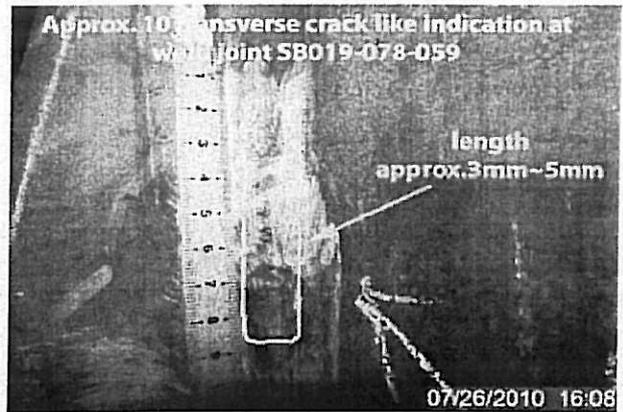
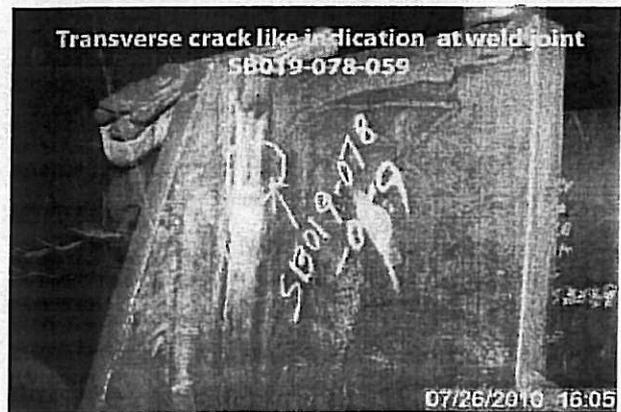
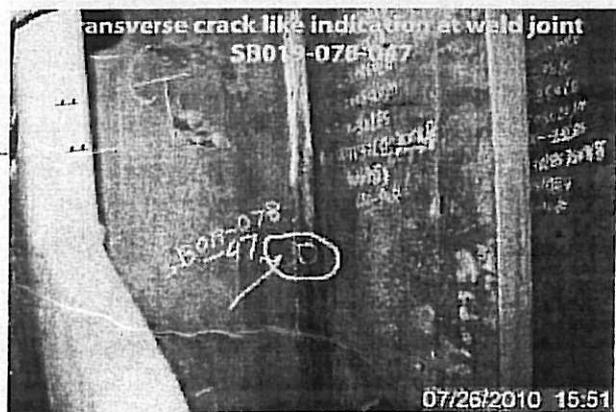
During the Quality Assurance (QA) Magnetic Particle Testing (MT) review of welds located on Suspender Bracket SB78E for Segment 9CE, this QA Inspector discovered fifteen (15) Transverse linear cracks on the following welds:

-Weld # SB019-078-047: Two (2) Transverse linear cracks measuring approximately 4mm to 5mm in length.

-Weld # SB019-078-059: Ten (10) Transverse linear cracks measuring approximately 3mm to 5mm in length.

-Weld # SB019-078-065: Three (3) Transverse linear cracks measuring approximately 3mm to 7mm in length.

-All indications are clearly marked on the material near the weld.

Contractor proposes to repair the areas noted in NCR, and submits the MT report to show the repair work is acceptable. Contractor will discuss with inspectors at the work site to ensure that inspectors are aware of the procedure of critical welding repair prior to the repairing work. Contractor will identify and educate the inspector who accepts these welds. Contractor will monitor his working performance.

Contractor repaired the weld areas that were noted in NCR, and provided the MT report. The MT report shows the weld area is acceptable. Contractor discussed with inspectors at the work site to ensure that inspectors are aware of the procedure of critical welding repair prior to the repairing work. Contractor identified and educated the inspector who accepted these welds. Contractor is monitoring his performance.
