**DEPARTMENT OF TRANSPORTATION**

**Reference Description:** Transverse Crack discovered with MT after ZPMC had tested and accepted this weld in Segment 11CE

# QUALITY ASSURANCE -- NON-CONFORMANCE REPORT

**Subject:** NCR No. ZPMC-0778

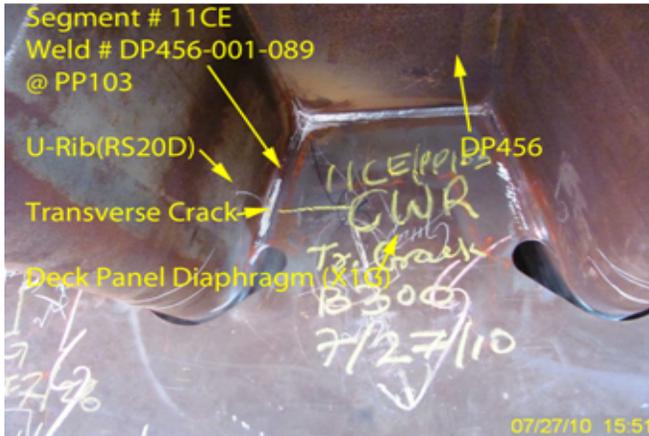
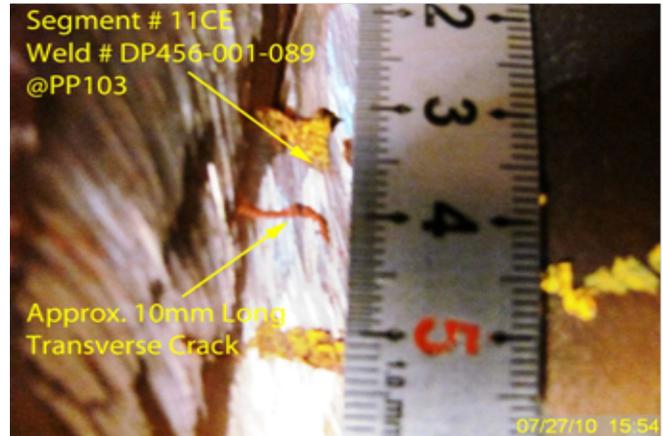
During random Quality Assurance (QA) of Magnetic Particle Testing (MT) review of welds located on segment 11CE, this Caltrans (CT) QA Inspector discovered One Transverse Crack on the following weld:

- One (1) Transverse crack measuring approximately 10mm in length.
- The weld is identified as DP456-001-089 at panel point (PP) 103.
- Weld is a Fillet Weld joining the Deck Panel Diaphragm to the U-Rib.
- The weld is designated as Non-Seismic Performance Critical Member (Non-SPCM).
- The Deck Panel Diaphragm is identified as X1G (Non-SPCM)
- The Closed U-Rib is identified as RS20D (Non-SPCM).
- OBG Segment 11CE is located in the outside yard, west of OBG Blast Shop 1.
- The indication is clearly marked on the material near the weld.

The Notice of Witness Inspection (NWIT) No. is 006285. The indication is located within an area previously tested and accepted by ZPMC Quality Control (QC) personnel. As per the contract documents, ZPMC's QC personnel are required to perform 100% MT inspection of this weld.

ZPMC has repaired this crack and is providing the NDT performed after to show that the repair was successful. In order to decrease missed indications, ZPMC QA will conduct refresher training with its inspectors and continue to monitor inspector performance. Based on this ZPMC requests closure of this NCR.

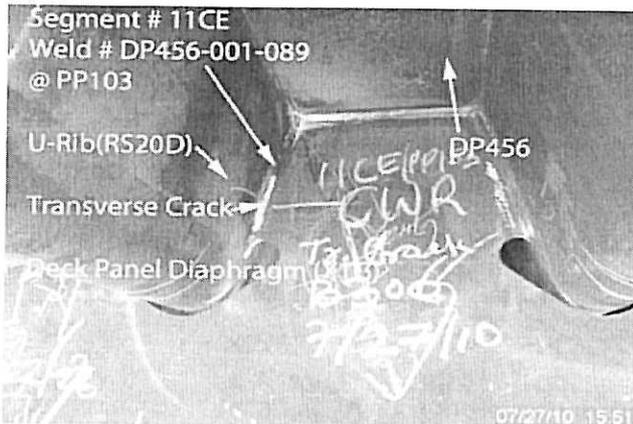
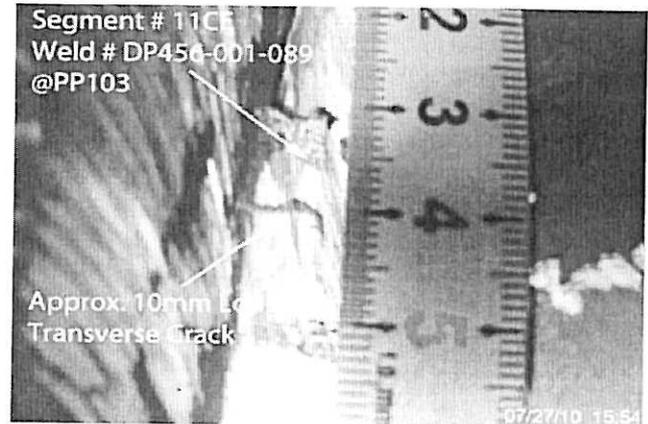
During random Quality Assurance (QA) of Magnetic Particle Testing (MT) review of welds located on segment 11CE, this Caltrans (CT) QA Inspector discovered One Transverse Crack on the following weld:

- One (1) Transverse crack measuring approximately 10mm in length.
- The weld is identified as DP456-001-089 at panel point (PP) 103.
- Weld is a Fillet Weld joining the Deck Panel Diaphragm to the U-Rib.
- The weld is designated as Non-Seismic Performance Critical Member (Non-SPCM).
- The Deck Panel Diaphragm is identified as X1G (Non-SPCM)
- The Closed U-Rib is identified as RS20D (Non-SPCM).
- OBG Segment 11CE is located in the outside yard, west of OBG Blast Shop 1.
- The indication is clearly marked on the material near the weld.

The Notice of Witness Inspection (NWIT) No. is 006285. The indication is located within an area previously tested and accepted by ZPMC Quality Control (QC) personnel. As per the contract documents, ZPMC's QC personnel are required to perform 100% MT inspection of this weld.

Contractor supplied post repair NDT documentation verifying weld conforms with Contract weld quality requirements. An internal NCR was also issued by ZPMC in regards to this issue, and refresher training was provided to NDT technicians.
