QUALITY ASSURANCE -- NON-CONFORMANCE REPORT

Location: Changxing Island, Shanghai, China**Report No:** NCR-000817**Prime Contractor:** American Bridge/Fluor Enterprises, a JV**Date:** 28-Jul-2010**Submitting Contractor:** Zhenhua Port Machinery Company, Ltd (ZPMC), Changxing Island**NCR #:** ZPMC-0779**Type of problem:**

Welding	Concrete	Other	
Welding	Curing	Procedural	Bridge No: 34-0006
Joint fit-up	Coating	Other	Component: Suspender Bracket SB88W
Procedural	Procedural	Description: Missed MT cracks were repaired without CWR

Reference Description: Fifteen (15) Transverse Cracks were discovered by MT testing after ZPMC had accepted and tested this weld; Subsequent repairs made without Engineer's approval

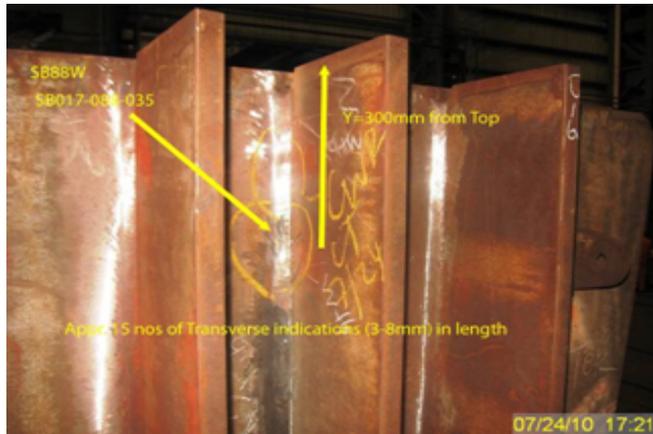
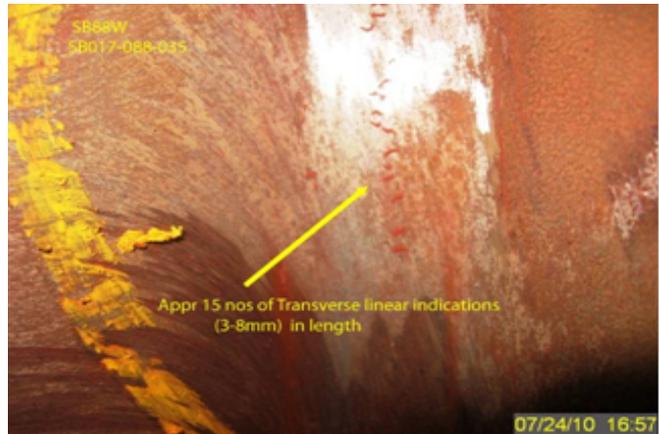
- Fifteen (15) transverse cracks that measured approximately 3mm to 8mm in length.
- The weld is identified as SB017-088-035.
- The weld is a fillet weld connecting the Centre web plate to the Stiffener.
- These cracks are located Y=300mm from top of the centre web plate.
- The OBG Suspender Bracket is located in BAY#19.
- These cracks are clearly marked on the material on/near the weld.
- This weld joint is designated as Non-Seismic performance critical (Non-SPCM) weld member.
- The Notice of Witness Inspection Number (NWIT) is 006272.
- These cracks are located within the area that has been previously tested and accepted by ZPMC Quality Control (QC) personnel.

Subsequently, on July 28, 2010, QA observed that the repairs were made without prior Engineer's approval or an approved Critical Weld Repair (CWR).

AWS D1.5 (02) Section 6.26.2 – “Welds that are subject to MT in addition to visual inspection shall have no cracks.

AWS D1.5 2002 section 3.7.4 specifies “Prior approval of the Engineer shall be obtained for repairs to base metal (other than those required by 3.2), repair of major or delayed cracks, repairs to ESW and EGW welds with internal defects, or for a revised design to compensate for deficiencies.”

Reference Resolution: ZPMC has repaired these cracks and is providing the NDT performed after to show that the repair was successful. ZPMC has repaired these cracks and is providing the NDT performed after to show that the repair was successful. In order to decrease missed indications, ZPMC QA will conduct refresher training with its inspectors and continue to monitor inspector performance. Based on this ZPMC requests closure of this NCR.

Contractor supplied post repair NDT documentation verifying weld conforms with Contract weld quality requirements. An internal NCR was also issued by ZPMC in regards to this issue, and refresher training was provided to NDT technicians.

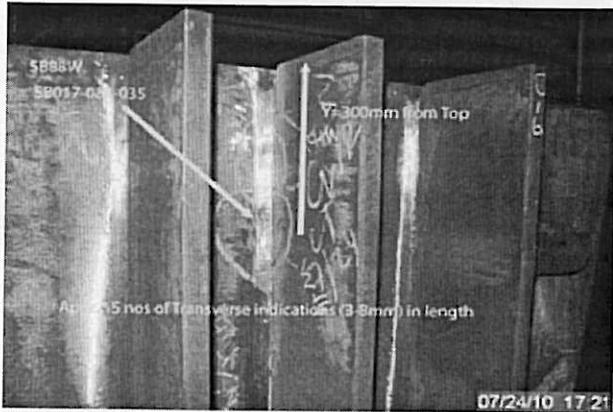
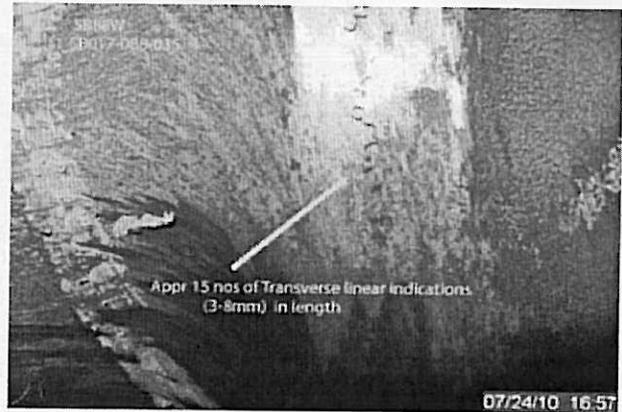
- Fifteen (15) transverse cracks that measured approximately 3mm to 8mm in length.
- The weld is identified as SB017-088-035.
- The weld is a fillet weld connecting the Centre web plate to the Stiffener.
- These cracks are located Y=300mm from top of the centre web plate.
- The OBG Suspender Bracket is located in BAY#19.
- These cracks are clearly marked on the material on/near the weld.
- This weld joint is designated as Non-Seismic performance critical (Non-SPCM) weld member.
- The Notice of Witness Inspection Number (NWIT) is 006272.
- These cracks are located within the area that has been previously tested and accepted by ZPMC Quality Control (QC) personnel.

Subsequently, on July 28, 2010, QA observed that the repairs were made without prior Engineer's approval or an approved Critical Weld Repair (CWR).

AWS D1.5 (02) Section 6.26.2 – “Welds that are subject to MT in addition to visual inspection shall have no cracks.

AWS D1.5 2002 section 3.7.4 specifies “Prior approval of the Engineer shall be obtained for repairs to base metal (other than those required by 3.2), repair of major or delayed cracks, repairs to ESW and EGW welds with internal defects, or for a revised design to compensate for deficiencies.”

Repair said cracks and perform NDT required to verify weld quality.
