Contract #: 04-0120F4
 Cty: SF/ALA Rte: 80 PM: 13.2/13.9
 File #: 69.25B

QUALITY ASSURANCE -- NON-CONFORMANCE REPORT

Report No: NCR-000818

Reference Description: Missed MT Transverse Crack Discovered

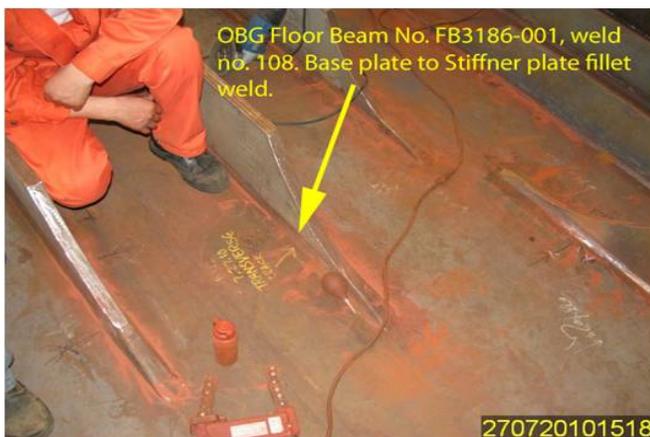
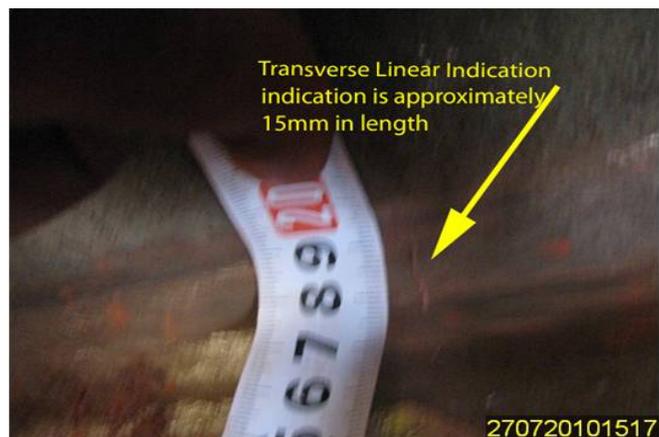
- One transverse linear crack indication measuring approximately 15mm in length.
- The weld is identified as FB3186-001-108.
- The weld is a fillet weld T-joint, joining the stiffener plate to floorbeam web.
- This floor beam is located in OBG subassembly Bay 2.

The NDT Inspection Notification Sheet is Document No. 06290. The indication is located within an area that has been previously tested and accepted by ZPMC Quality Control (QC) personnel. ZPMC's QC personnel are required to perform 25% MT inspection of this weld.

AWS D1.5 (02) Section 6.26.2 – “Welds that are subject to MT in addition to visual inspection shall have no cracks.

Reference Resolution: This indications has been repaired and ZPMC is providing the NDT to show it is acceptable.

This indications has been repaired and ZPMC is providing the NDT to show it is acceptable. ZPMC has reprimanded the inspector involved and provided him clear understanding of what was done incorrectly to prevent future occurrences. Based on this ZPMC requests closure of this NCR.

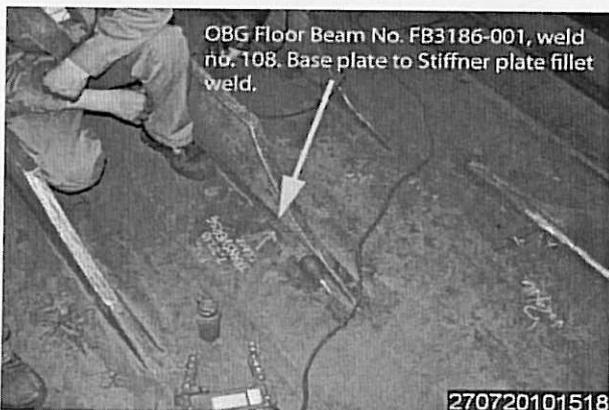
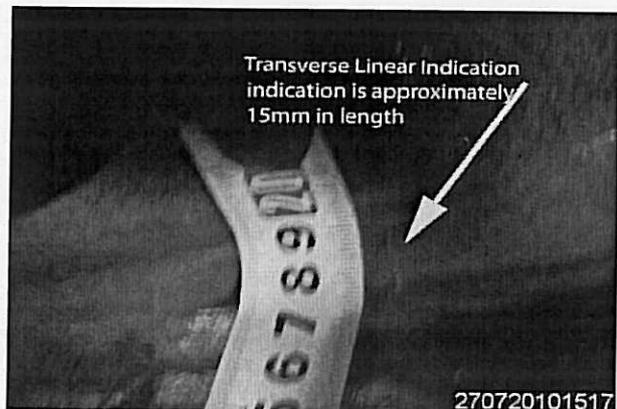
- One transverse linear crack indication measuring approximately 15mm in length.
- The weld is identified as FB3186-001-108.
- The weld is a fillet weld T-joint, joining the stiffener plate to floorbeam web.
- This floor beam is located in OBG subassembly Bay 2.

The NDT Inspection Notification Sheet is Document No. 06290. The indication is located within an area that has been previously tested and accepted by ZPMC Quality Control (QC) personnel. ZPMC's QC personnel are required to perform 25% MT inspection of this weld.

AWS D1.5 (02) Section 6.26.2 – “Welds that are subject to MT in addition to visual inspection shall have no cracks.

Repair said indication and perform NDT required to verify weld quality.

Contractor supplied post repair NDT documentation verifying weld conforms with Contract weld quality requirements. QC Inspector responsible for area in question was reprimanded and provided with a clear understanding of what was done incorrectly to prevent future occurrences.
