Contract #: 04-0120F4Cty: SF/ALA Rte: 80 PM: 13.2/13.9File #: 69.25B**QUALITY ASSURANCE -- NON-CONFORMANCE REPORT****Location:** Changxing Island, Shanghai, China**Report No:** NCR-000819**Prime Contractor:** American Bridge/Fluor Enterprises, a JV**Date:** 29-Jul-2010**Submitting Contractor:** Zhenhua Port Machinery Company, Ltd (ZPMC), Changxing Island**NCR #:** ZPMC-0781**Type of problem:**

Reference Description: Mishandling Side Plates on Lift 13 resulting in Distortion of Members**Description of Non-Conformance:**

Job Name: SAS Superstructure

Report No: NCR-000819

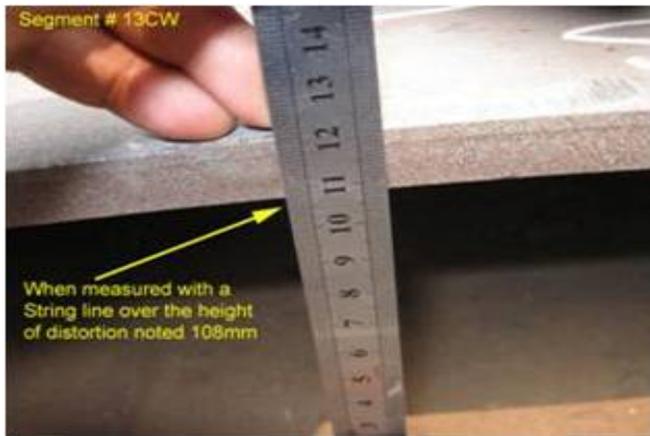
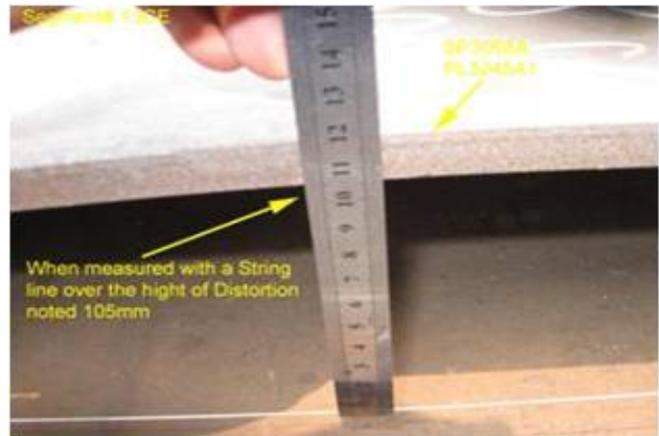
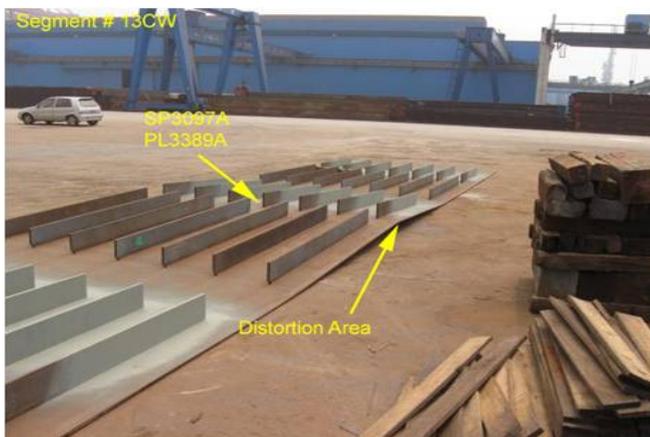
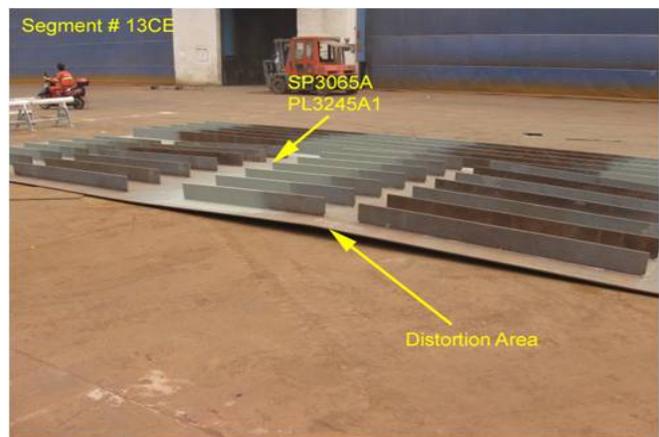
During random in process observations of the Blast Shop (1) of Side plate 13CE & 13CW, this Quality Assurance discovered the following issue:

- Side plates were observed being moved with lift truck (forks) using a center pick point and no additional support on either end of the Side Panel. The unsupported ends sagged significantly, causing the members to become distorted. Pieces were on ground without support and the following distortion was measured in this condition.
- The distortion measuring approximately 107mm from the Side plate 13CW.
- The distortion measuring approximately 105mm from the Side plate 13CE.
- The Side Plate is identified as 13CW: SP3097A-PL3389A (Non SPCM)
- The Side Plate is identified as 13CE: SP3065A-PL3245A1 (Non SPCM)
- The distortion was measured using a string Line and straight edge.
- Plate is located in the north side of Blast Shop (1).

Standard Specifications July 1999, Section 55-1.04; "In handling of the steel work, every care shall be taken to avoid bending, scraping or overstressing the pieces. All pieces bent or otherwise injured will be rejected."

Standard Specifications July 1999, Section 55-3.09; "Finished members shall be true to line and free from twists, bends and open joints."

ZPMC has repaired the distortion using mechanical means and is providing the NDT done after to show that distortion caused during mishandling and the subsequent repair did not damage the welds. ZPMC has documented this internally with a NCR to make the department responsible for moving is aware that parts need to be supported while in transit to prevent future occurrences. If this becomes a systematic problem, ZPMC QA will conduct training and meet to discuss this with the department responsible. Based on this ZPMC requests closure of this NCR.

The NDT records of the mechanically straightened area and its adjacent area shall receive 100% MT rather than 10%.

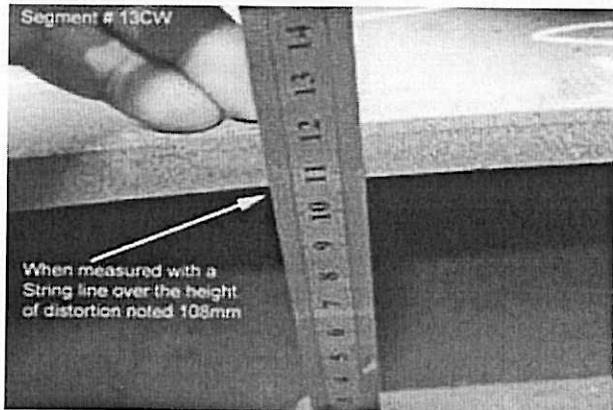
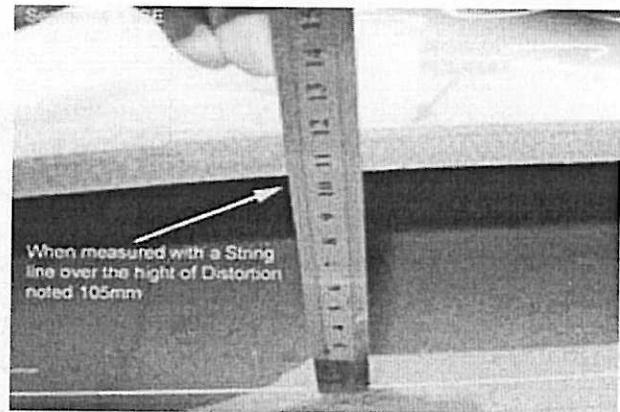
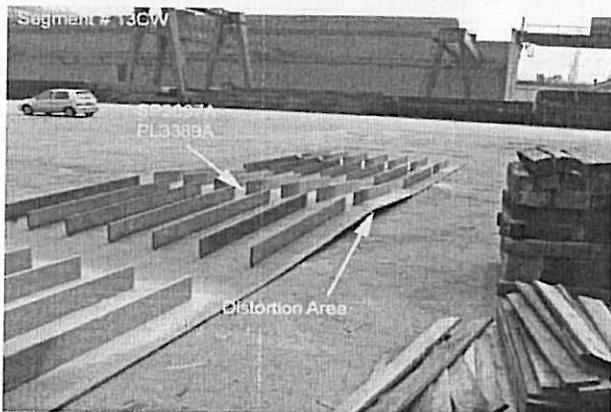
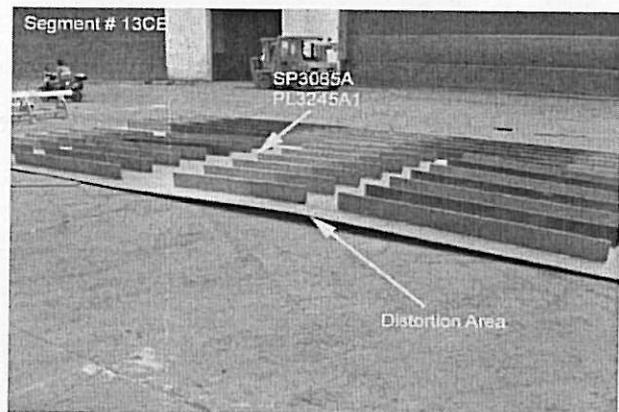
During random in process observations of the Blast Shop (1) of Side plate 13CE & 13CW, this Quality Assurance discovered the following issue:

-Side plates were observed being moved with lift truck (forks) using a center pick point and no additional support on either end of the Side Panel. The unsupported ends sagged significantly, causing the members to become distorted. Pieces were on ground without support and the following distortion was measured in this condition.

-The distortion measuring approximately 107mm from the Side plate 13CW.

-The distortion measuring approximately 105mm from the Side plate 13CE.

-The Side Plate is identified as 13CW: SP3097A-PL3389A (Non SPCM)

-The Side Plate is identified as 13CE: SP3065A-PL3245A1 (Non SPCM)

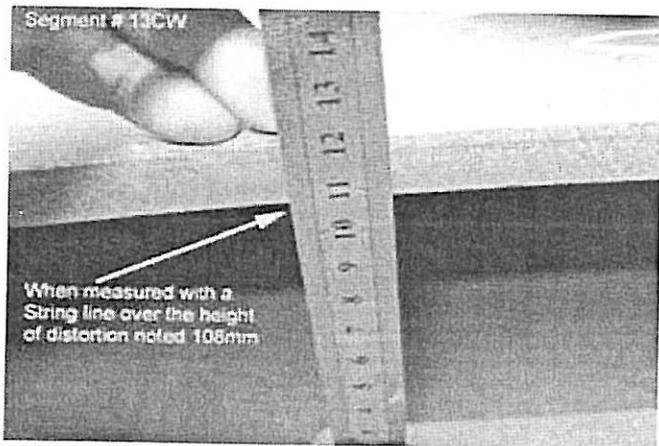
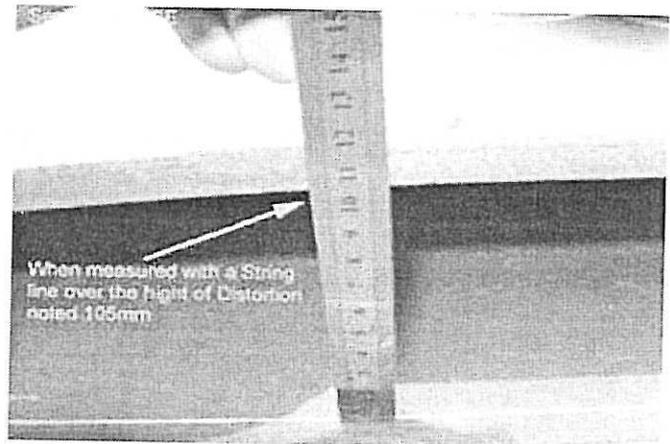
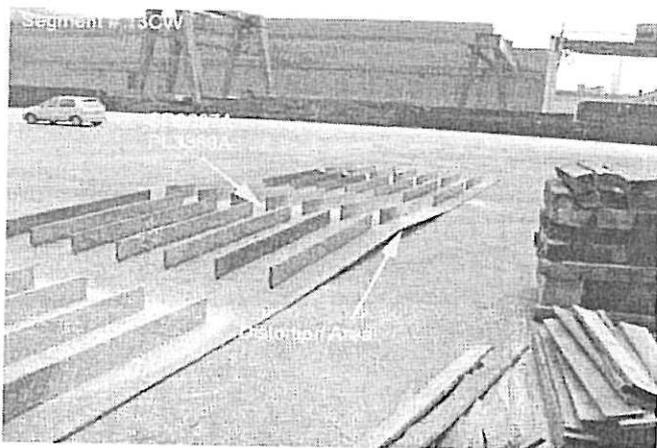
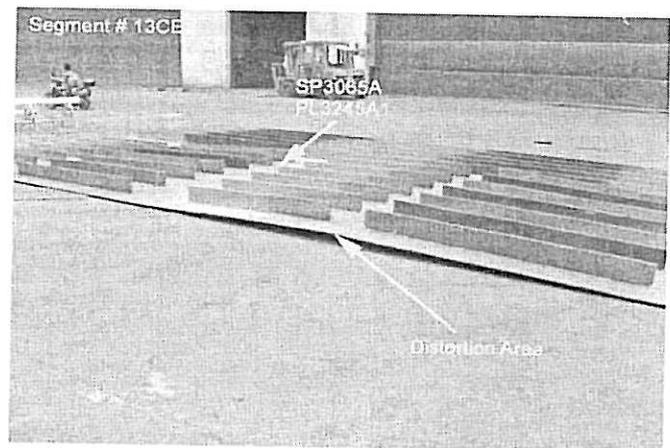
During random in process observations of the Blast Shop (1) of Side plate 13CE & 13CW, this Quality Assurance discovered the following issue:

- Side plates were observed being moved with lift truck (forks) using a center pick point and no additional support on either end of the Side Panel. The unsupported ends sagged significantly, causing the members to become distorted. Pieces were on ground without support and the following distortion was measured in this condition.
- The distortion measuring approximately 107mm from the Side plate 13CW.
- The distortion measuring approximately 105mm from the Side plate 13CE.
- The Side Plate is identified as 13CW: SP3097A-PL3389A (Non SPCM)
- The Side Plate is identified as 13CE: SP3065A-PL3245A1 (Non SPCM)
- The distortion was measured using a string Line and straight edge.
- Plate is located in the north side of Blast Shop (1).

ZPMC performed mechanical straightening and provided NDT verification records to the affected area.
