Contract #: 04-0120F4Cty: SF/ALA Rte: 80 PM: 13.2/13.9File #: 69.25B**QUALITY ASSURANCE -- NON-CONFORMANCE REPORT****Location:** Changxing Island, Shanghai, P.R. China**Report No:** NCR-000820**Prime Contractor:** American Bridge/Fluor Enterprises, a JV**Date:** 29-Jul-2010**Submitting Contractor:** Zhenhua Port Machinery Company, Ltd (ZPMC), Changxing Island**NCR #:** ZPMC-0782**Type of problem:**

**Reference Description:** Bent/Damage was noted on the Segment 10BE DP425 U-Rib Skin**Description of Non-Conformance:**

**Job Name:** SAS Superstructure

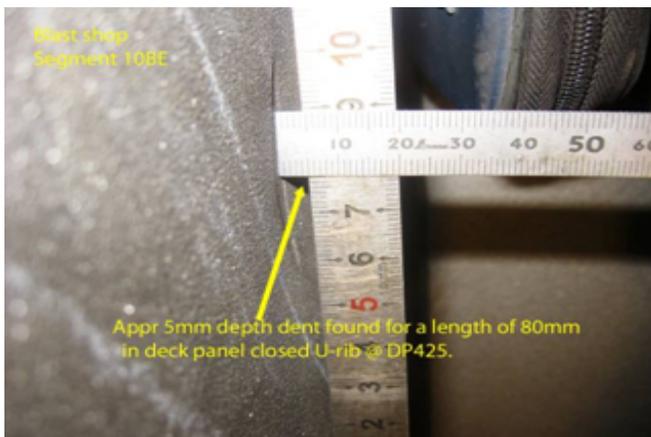
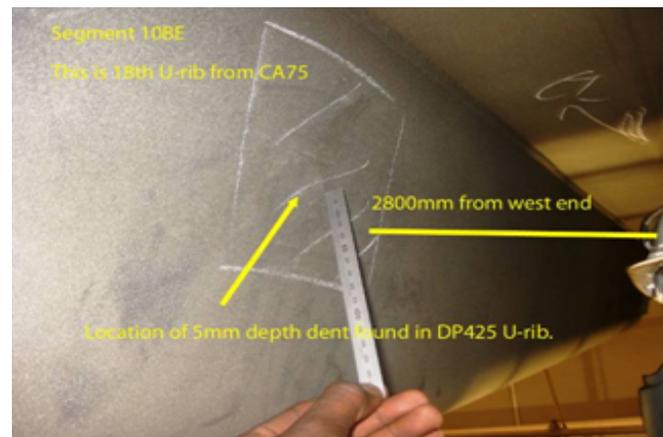
During random in-process Visual inspection of OBG Segment 10BE after Abrasive Blasting this Caltrans Quality Assurance Inspector discovered the following issue:

- Damage was observed on the U-Rib Skin.
- A bent mark of approximately 5mm in depth was measured with a 150mm ruler.
- The length of the bent mark is approximately 80mm.
- This deck panel is identified as DP425 (PL445B) and the U-rib is identified as (RS23C).
- This is 18th U-rib from the CA75.
- The location of the distortion is 2800mm away from the west end of the Segment 10BE.
- Prior to this damage, this DP was previously inspected and accepted as documented by green tag #7850.
- The OBG Segment 10BE is located inside the Paint shop#1.

Caltrans Standard Specifications Section 55-1.04: In handling of the steel work, every care shall be taken to avoid bending, scraping or overstressing the pieces. All pieces bent or otherwise injured will be rejected.

ZPMC has repaired the damaged area in accordance with the TC RFI and is providing the NDT after to show the repair is acceptable. In the future great caution will be exercised to prevent this kind of damage. Based on this ZPMC requests closure of this NCR.

Contractor repaired the area according to TC RFI. NDT report is provided, and prove the repaired area is acceptable.

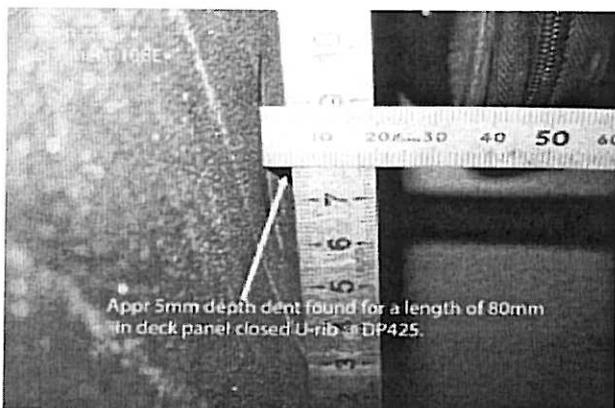
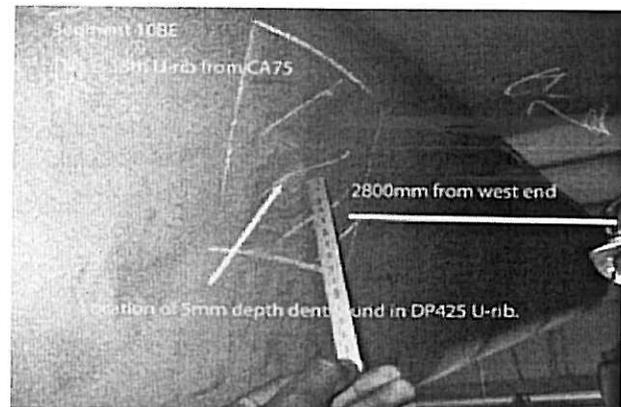
During random in-process Visual inspection of OBG Segment 10BE after Abrasive Blasting this Caltrans Quality Assurance Inspector discovered the following issue:

- Damage was observed on the U-Rib Skin.
- A bent mark of approximately 5mm in depth was measured with a 150mm ruler.
- The length of the bent mark is approximately 80mm.
- This deck panel is identified as DP425 (PL445B) and the U-rib is identified as (RS23C).
- This is 18th U-rib from the CA75.
- The location of the distortion is 2800mm away from the west end of the Segment 10BE.
- Prior to this damage, this DP was previously inspected and accepted as documented by green tag #7850.
- The OBG Segment 10BE is located inside the Paint shop#1.

Caltrans Standard Specifications Section 55-1.04: In handling of the steel work, every care shall be taken to avoid bending, scraping or overstressing the pieces. All pieces bent or otherwise injured will be rejected.

Contractor will repair the damaged area according to TC RFI. Contractor will submit the NDT report to show the repair is acceptable. Contractor will perform the repair work carefully to prevent this kind of damage.
