Contract #: 04-0120F4
 Cty: SF/ALA Rte: 80 PM: 13.2/13.9
 File #: 69.25B

QUALITY ASSURANCE -- NON-CONFORMANCE REPORT

Report No: NCR-000822

Reference Description: Missed MT Transverse Crack Discovered by QA

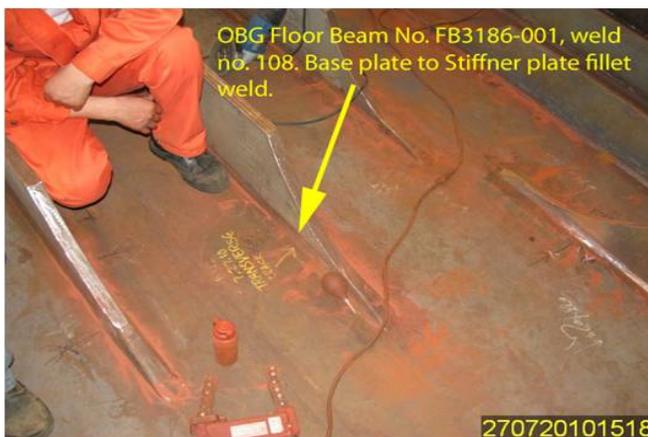
During the Quality Assurance Magnetic Particle Testing (MT) review of welds located on OBG Floor Beam FB3186-001 this Quality Assurance Inspector (QA) discovered the following issues:

- One transverse linear crack indication measuring approximately 15mm in length.
- The weld is identified as FB3186-001-108.
- The weld is a fillet weld T-joint, joining the stiffener plate (X4327) to the floor beam web (X243A).
- This floor beam is located in OBG subassembly Bay 2.

The NDT Inspection Notification Sheet is Document No. 06290. The indication is located within an area that has been previously tested and accepted by ZPMC Quality Control (QC) personnel. ZPMC's QC personnel are required to perform 25% MT inspection of this weld.

Remove crack and perform weld repair with NDT verification.

Weld repair was performed. NDT reports were provided verifying that the weld is now in conformance with the contract requirements.

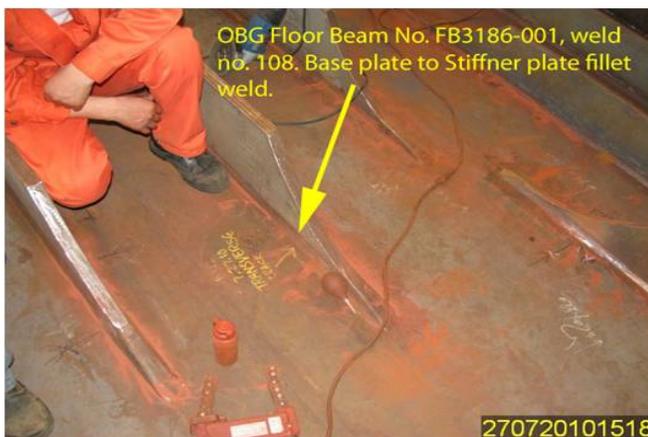
During the Quality Assurance Magnetic Particle Testing (MT) review of welds located on OBG Floorbeam FB3186-001 this Quality Assurance Inspector (QA) discovered the following issues:

- One transverse linear crack indication measuring approximately 15mm in length.
- The weld is identified as FB3186-001-108.
- The weld is a fillet weld T-joint, joining the stiffener plate to floorbeam web.
- This floor beam is located in OBG subassembly Bay 2.

The NDT Inspection Notification Sheet is Document No. 06290. The indication is located within an area that has been previously tested and accepted by ZPMC Quality Control (QC) personnel. ZPMC's QC personnel are required to perform 25% MT inspection of this weld.

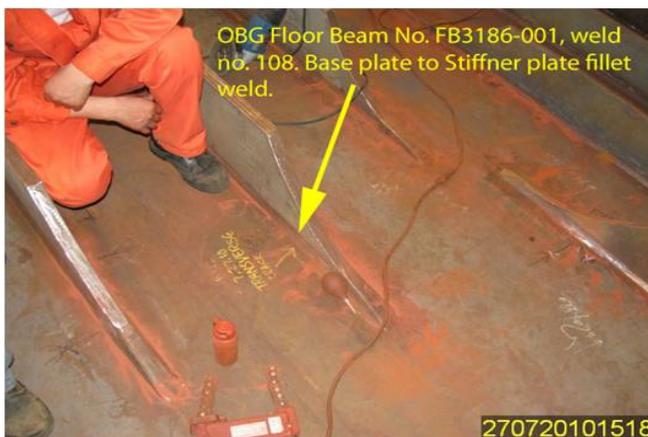
During the Quality Assurance Magnetic Particle Testing (MT) review of welds located on OBG Floor Beam FB3186-001 this Quality Assurance Inspector (QA) discovered the following issues:

- One transverse linear crack indication measuring approximately 15mm in length.
- The weld is identified as FB3186-001-108.
- The weld is a fillet weld T-joint, joining the stiffener plate (X4327) to the floor beam web (X243A).
- This floor beam is located in OBG subassembly Bay 2.

The NDT Inspection Notification Sheet is Document No. 06290. The indication is located within an area that has been previously tested and accepted by ZPMC Quality Control (QC) personnel. ZPMC's QC personnel are required to perform 25% MT inspection of this weld.
