Contract #: 04-0120F4  
 Cty: SF/ALA Rte: 80 PM: 13.2/13.9  
 File #: 69.25B

**QUALITY ASSURANCE -- NON-CONFORMANCE REPORT**

**Location:** Changxing Island, Shanghai, China **Report No:** NCR-000824  
**Prime Contractor:** American Bridge/Fluor Enterprises, a JV **Date:** 09-Aug-2010  
**Submitting Contractor:** Zhenhua Port Machinery Company, Ltd (ZPMC), Changxing Island **NCR #:** ZPMC-0786

**Reference Description:** Missed MT Indication discovered by QA

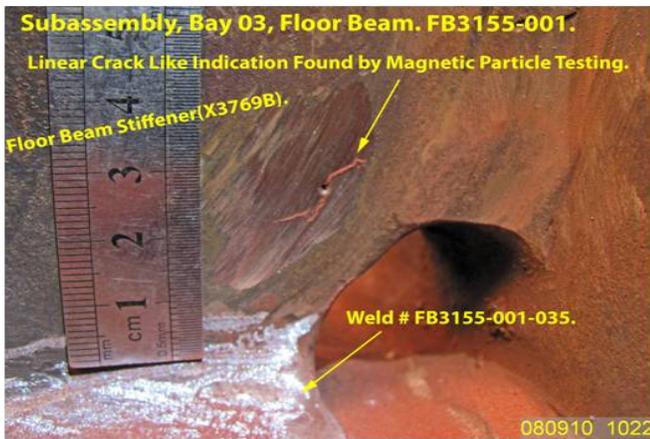
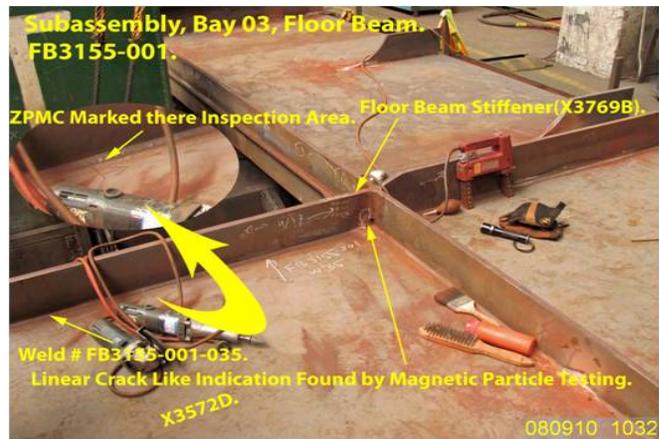
- One linear crack indication measuring approximately 16mm in length near Floor Beam to stiffener weld joint on the Stiffener (base metal).
- Weld is identified as FB3155-001-035.
- The weld is a T-joint fillet weld joining Floor beam Plate (X3572D) to Floor beam Stiffener (X3769B).
- The crack is located adjacent to the cope hole on the stiffener
- The indication is clearly marked on the material.

The Notice of Witness Inspection Number (NWIT) is 06364. The indication is located within an area that has been previously tested and accepted by ZPMC Quality Control (QC) personnel. Per the contract documents ZPMC's QC personnel are required to perform 25% MT inspection of this weld.

**Reference Resolution:** ZPMC has repaired the indication in the base metal and is providing the NDT documentation after repair to show the base metal is acceptable.

Contractor supplied post repair NDT documentation verifying repair was made and is in conformance with Contract weld quality requirements. A discrepancy was noted between the piecemark listed in the NCR and the piecemark listed in the MT report. After review of the pictures supplied and the approved drawings, it should be noted that the correct piecemark is listed in the MT report.

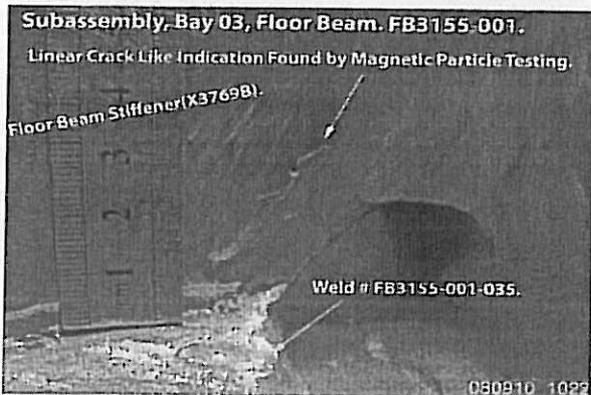
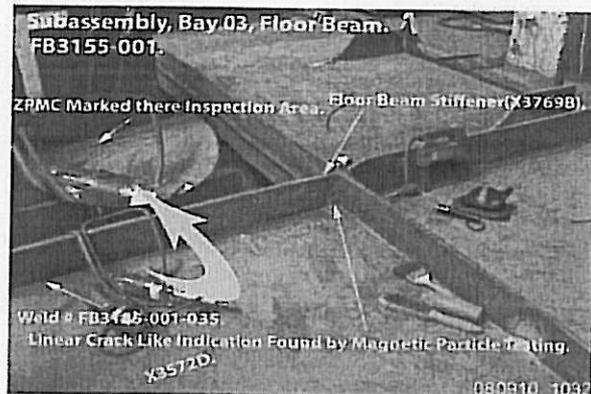
- One linear crack indication measuring approximately 16mm in length near Floor Beam to stiffener weld joint on the Stiffener (base metal).
- Weld is identified as FB3155-001-035.
- The weld is a T-joint fillet weld joining Floor beam Plate (X3572D) to Floor beam Stiffener (X3769B).
- The crack is located adjacent to the cope hole on the stiffener
- The indication is clearly marked on the material.

The Notice of Witness Inspection Number (NWIT) is 06364. The indication is located within an area that has been previously tested and accepted by ZPMC Quality Control (QC) personnel. Per the contract documents ZPMC's QC personnel are required to perform 25% MT inspection of this weld.

Repair said indication and perform NDT required to verify complete defect removal.
