Contract #: 04-0120F4
 Cty: SF/ALA Rte: 80 PM: 13.2/13.9
 File #: 69.25B

QUALITY ASSURANCE -- NON-CONFORMANCE REPORT

Location: Changxing Island, Shanghai, China **Report No:** NCR-000825
Prime Contractor: American Bridge/Fluor Enterprises, a JV **Date:** 15-Aug-2010
Submitting Contractor: Zhenhua Port Machinery Company, Ltd (ZPMC), Changxing Island **NCR #:** ZPMC-0787

Reference Description: Missed MT Crack Discovered by QA on Lift 13 Side Plate - SP3113A

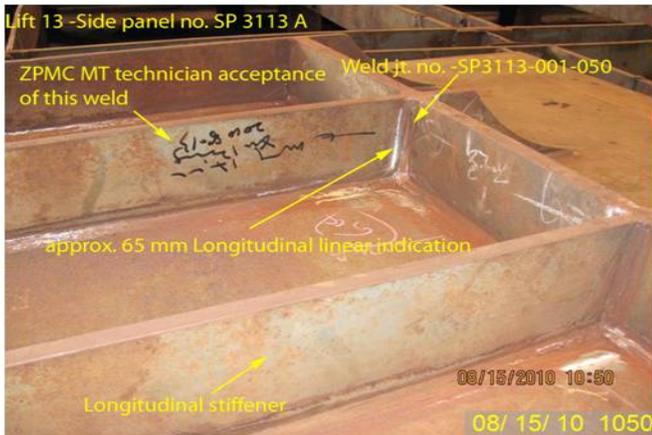
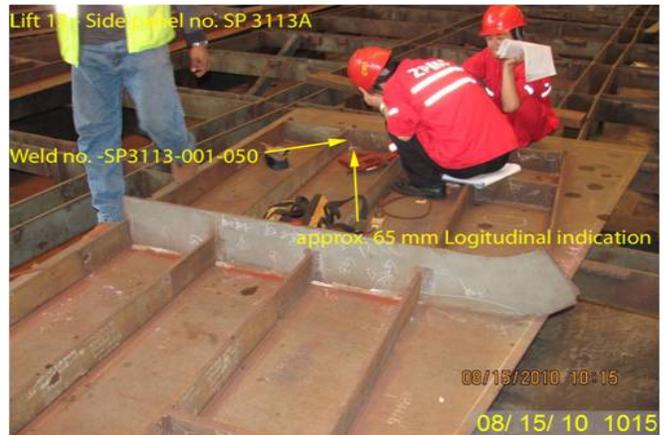
During the Quality Assurance Magnetic Particle Testing (MT) review of welds located on Orthotropic Box Girder (OBG) Side panel, SP3113A, this Quality Assurance Inspector (QA) discovered the following issue:

- One Longitudinal crack indication measuring approximately 65mm in length.
- The weld is identified as SP3113-001-050.
- The weld is a fillet weld T-joint, joining the Longitudinal stiffener identified as RS3446C to the Transverse diaphragm identified as X4174A.
- Y location of this indication is approximately 30 mm from the Bottom plate.
- The indication is clearly marked on the material.
- This side panel is located in Bay# 10.
- The Notice of Witness Inspection Number (NWIT) is 06404.
- This weld is within an area previously tested and accepted by ZPMC Quality Control (QC) personnel.

According to the contract documents, ZPMC QC personnel are required to perform 100% MT inspection of this weld.

Reference Resolution: The missed indication has been removed and ZPMC has retested the area. The attached NDT records show that the repair was successful and the weld is acceptable.

Repair said indication and perform NDT required to verify weld quality.

Contractor has submitted post repair NDT data and ABF has agreed to perform MT alongside ZPMC in order to prevent technicians from missing indications.

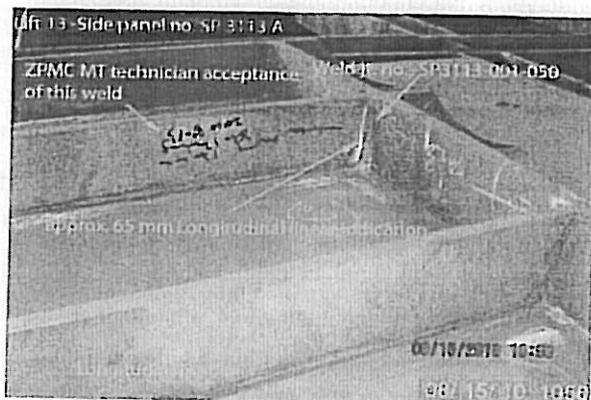
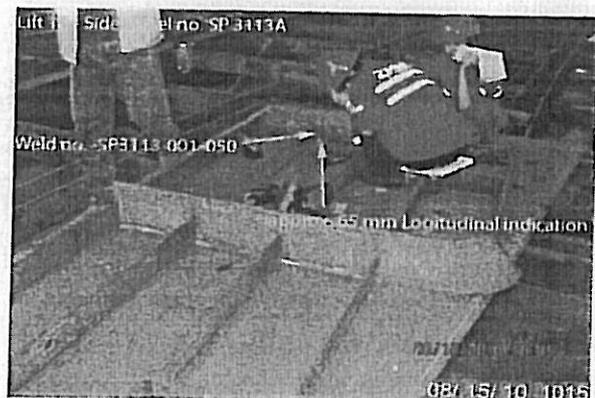
During the Quality Assurance Magnetic Particle Testing (MT) review of welds located on Orthotropic Box Girder (OBG) Side panel, SP3113A, this Quality Assurance Inspector (QA) discovered the following issue:

-One Longitudinal crack indication measuring approximately 65mm in length.

-The weld is identified as SP3113-001-050.

-The weld is a fillet weld T-joint, joining the Longitudinal stiffener identified as RS3446C to the Transverse diaphragm identified as X4174A.

-Y location of this indication is approximately 30 mm from the Bottom plate.

-The indication is clearly marked on the material.

-This weld is within an area previously tested and accepted by ZPMC Quality Control (QC) personnel.

AWS D1.5 (02) Section 6.26.2 – “Welds that are subject to MT in addition to visual inspection shall have no cracks.
