Contract #: 04-0120F4  
 Cty: SF/ALA Rte: 80 PM: 13.2/13.9  
 File #: 69.25B

## QUALITY ASSURANCE -- NON-CONFORMANCE REPORT

**Report No:** NCR-000827

**Reference Description:** Longitudinal Crack on Cross Bracing Gusset Plate

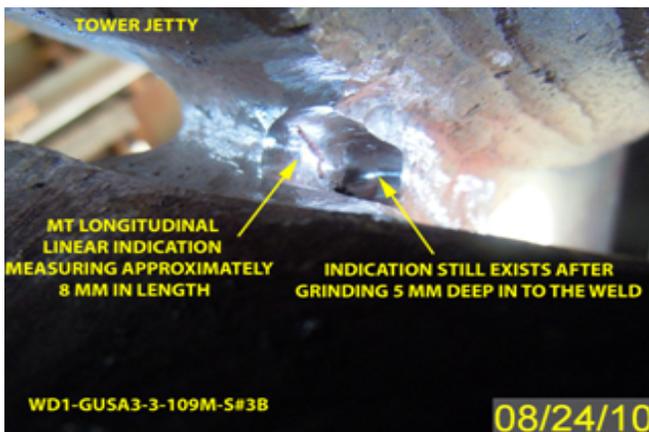
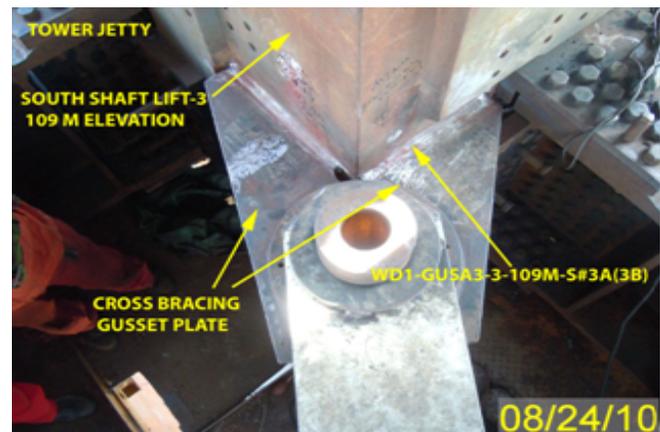
During Magnetic Particle Testing (MT) review of welds on Cross Bracing Gusset Plate, 109 M elevation South Tower Lift-3, this Quality Assurance Inspector (QA) discovered the following issue:

- One (1) longitudinal crack measuring approximately 8 mm in length.
- The member is identified as Cross Bracing Gusset Plate.
- The weld is identified as WD1 – GUSA3 – 3 – 109M – S # 3B.
- The weld is a Complete Joint Penetration (CJP) T-joint joining the Cross Bracing Gusset Plate to South Tower Lift-3 at 109 M elevation.
- The member is Seismic Performance critical Member (SPCM).
- The member is located in Tower Trial Assembly, Heavy Dock.

The Notice of Witness Inspection Number (NWIT) is 006469. The indication is located inside the area that has been previously tested and accepted by ZPMC Quality Control (QC) personnel. As per the contract documents, ZPMC's QC personnel are required to perform 100% MT inspection of these welds.

For further information, please see the attached photos and applicable reference below.

AWS D1.5 (02) Section 6.2.6.2 – “Welds that are subject to MT in addition to visual inspection shall have no cracks”.

**Reference Resolution:** ZPMC has repaired this missed indication and is providing NDT to show that the repair was successful.

ZPMC has repaired this missed indication and is providing NDT to show that the repair was successful. The inspector involved with this missed indication has been reprimanded and is fully aware of the consequences of future missed indications. Based on these actions ZPMC requests closure of this NCR.

Contractor repaired the weld and NDT report provided which showed the weld is acceptable. Contractor reprimanded the inspector involved.

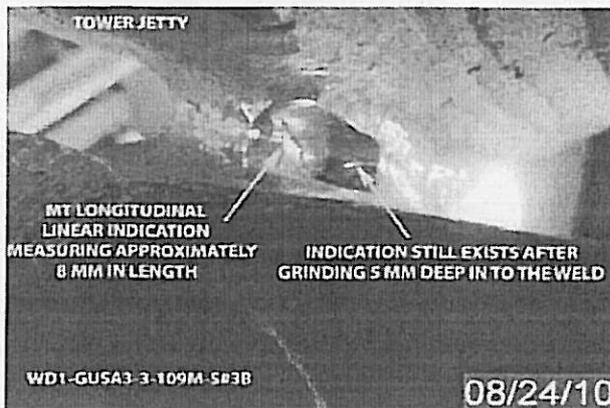
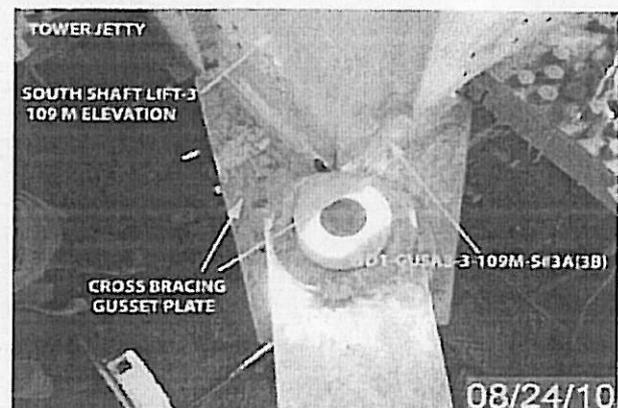
During Magnetic Particle Testing (MT) review of welds on Cross Bracing Gusset Plate, 109 M elevation South Tower Lift-3, this Quality Assurance Inspector (QA) discovered the following issue:

- One (1) longitudinal crack measuring approximately 8 mm in length.
- The member is identified as Cross Bracing Gusset Plate.
- The weld is identified as WD1 - GUSA3 - 3 - 109M - S # 3B.
- The weld is a Complete Joint Penetration (CJP) T-joint joining the Cross Bracing Gusset Plate to South Tower Lift-3 at 109 M elevation.
- The member is Seismic Performance critical Member (SPCM).
- The member is located in Tower Trial Assembly, Heavy Dock.

The Notice of Witness Inspection Number (NWIT) is 006469. The indication is located inside the area that has been previously tested and accepted by ZPMC Quality Control (QC) personnel. As per the contract documents, ZPMC's QC personnel are required to perform 100% MT inspection of these welds.

For further information, please see the attached photos and applicable reference below.

AWS D1.5 (02) Section 6.26.2 - "Welds that are subject to MT in addition to visual inspection shall have no cracks".
