Contract #: 04-0120F4Cty: SF/ALA Rte: 80 PM: 13.2/13.9File #: 69.25B**QUALITY ASSURANCE -- NON-CONFORMANCE REPORT****Location:** Changxing Island, Shanghai, China**Report No:** NCR-000830**Prime Contractor:** American Bridge/Fluor Enterprises, a JV**Date:** 31-Aug-2010**Submitting Contractor:** Zhenhua Port Machinery Company, Ltd (ZPMC), Changxing Island**NCR #:** ZPMC-0792**Type of problem:**

Reference Description: Missed UT Indication discovered by QA on FB3329A (Lift 14W)**Description of Non-Conformance:**

Job Name: SAS Superstructure

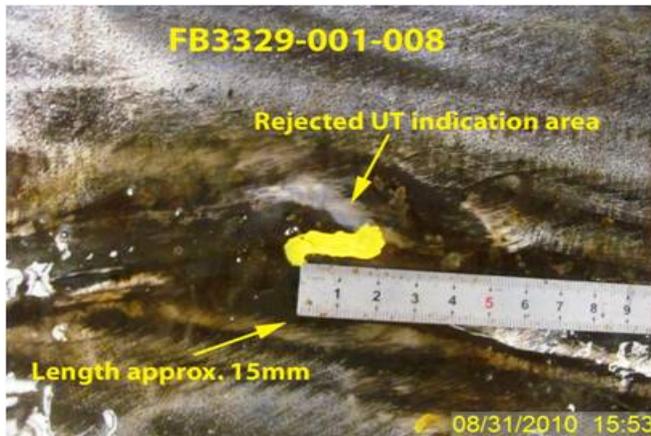
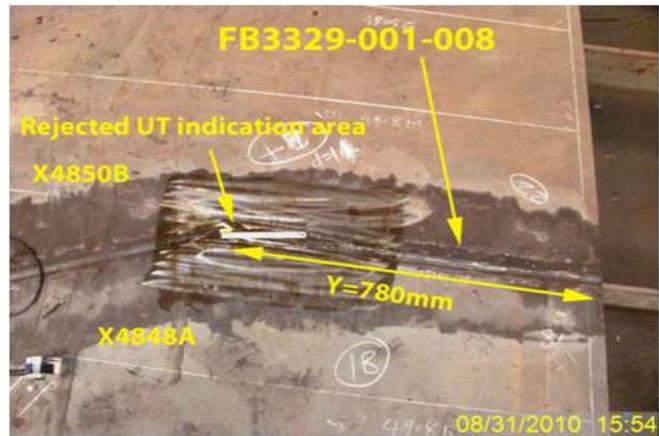
- One longitudinal linear Class "A" rejectable indication measuring approximately 15mm in length.
- The indication dbS rating is a +7.
- Material thickness is 18/22mm.
- The depth of the indication is approximately 11.2mm.
- The weld is identified as FB3329-001-008.
- The weld is Complete Joint Penetration (CJP) butt joint, joining floor beam web X4850B to floor beam web X4848A.
- The weld is designated as Seismic Performance Critical Material (SPCM).
- The indication is clearly marked on or near the weld.
- The Y distance for this indication is 780 mm from edge of the joint.
- Floor Beam FB3329A is located at bay 2.

The Notice of Witness Inspection (NWIT) No. is 006542. The indication is located within an area previously tested and accepted by ZPMC Quality Control (QC) personnel. As per the contract documents, ZPMC's QC personnel are required to perform 100% UT inspection of this weld.

AWS D1.5-02 Section 6; Table 6.3 specifies a class "A" indication as having a rating of 10dbs and under for material thicknesses 8mm through 20mm.

ZPMC has repaired the indication and is providing NDT after to show it is acceptable. ZPMC QA has written an internal NCR to identify and reprimand the inspector for missing the indication and make him aware to prevent future occurrences. Based on this ZPMC is requesting closure of this NCR.

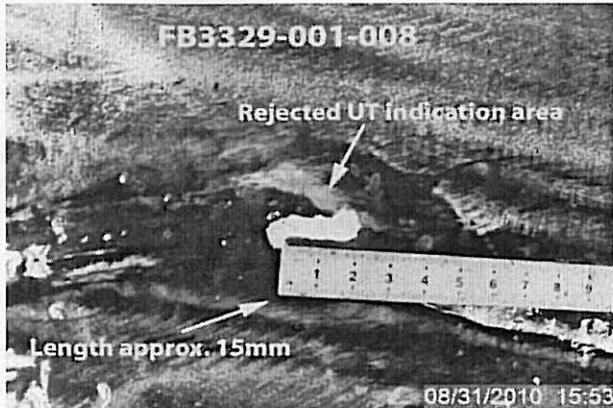
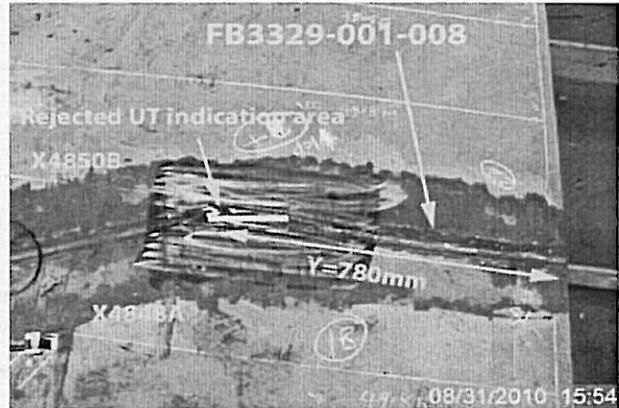
- One longitudinal linear Class "A" rejectable indication measuring approximately 15mm in length.
- The indication dbS rating is a +7.
- Material thickness is 18/22mm.
- The depth of the indication is approximately 11.2mm.
- The weld is identified as FB3329-001-008.
- The weld is Complete Joint Penetration (CJP) butt joint, joining floor beam web X4850B to floor beam web X4848A.
- The weld is designated as Seismic Performance Critical Material (SPCM).
- The indication is clearly marked on or near the weld.
- The Y distance for this indication is 780 mm from edge of the joint.
- Floor Beam FB3329A is located at bay 2.

The Notice of Witness Inspection (NWIT) No. is 006542. The indication is located within an area previously tested and accepted by ZPMC Quality Control (QC) personnel. As per the contract documents, ZPMC's QC personnel are required to perform 100% UT inspection of this weld.

AWS D1.5-02 Section 6; Table 6.3 specifies a class "A" indication as having a rating of 10dbs and under for material thicknesses 8mm through 20mm.

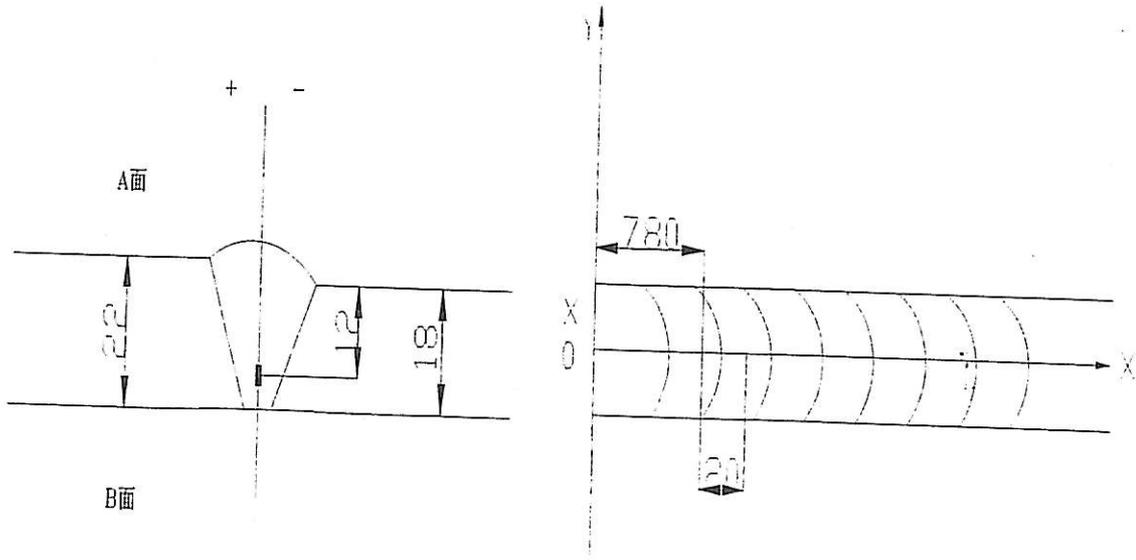
Draft of welding discontinuity:

焊缝缺陷描述：(普通UT探伤发现的缺陷长度小于最大允许长度)
 (Description of welding discontinuity): Rejected indication found by ultrasonic inspection is less than the maximum allowance aggregate length.

焊缝编号为: FB3329-001-008

- 1、焊道未及时处理干净。
1. Did not clear the weld pass completely in time.

1. 从缺陷距离端面较近一侧 ($D \leq 0.65T$, D为缺陷深度, T为板厚) 采用碳刨或打磨的方法去除焊缝缺陷;
 2. 参照返修焊接工艺规程 (WPS) 准备正确的接头型式, 预热和焊接;
 3. 将修补区域打磨到与母材或邻近焊缝平齐;
 4. 根据批准的车间图纸检查焊缝.
-
1. Gouge or grind from nearer side from metal edge ($D \leq 0.65T$, "D" is depth of defects, "T" is thickness of metal) to remove all defects;
 2. Follow repair WPS for joint preparation, preheat, and weld deposit;
 3. Grind the repaired area flush with base metal or the adjacent weld;
 4. Check the welds according to the working drawings.
