Contract #: 04-0120F4Cty: SF/ALA Rte: 80 PM: 13.2/13.9File #: 69.25B**QUALITY ASSURANCE -- NON-CONFORMANCE REPORT****Location:** Changxing Island, Shanghai, P.R. China**Report No:** NCR-000831**Prime Contractor:** American Bridge/Fluor Enterprises, a JV**Date:** 02-Sep-2010**Submitting Contractor:** Zhenhua Port Machinery Company, Ltd (ZPMC), Changxing Island**NCR #:** ZPMC-0793**Type of problem:**

Welding	Concrete	Other	
Welding	Curing	Procedural	Bridge No: 34-0006
Joint fit-up	Coating	Other	Component: Segment 9DW Bottom Panel
Procedural	Procedural	Description: Missed MT crack by QC

Reference Description: QA found a crack in the bottom panel base metal at Segment 9DW by MT after ZPMC had tested and accepted base metal repair

To:	AMERICAN BRIDGE/FLUOR, A JV 375 BURMA ROAD OAKLAND CA 95607	Date:	03-Sep-2010
Dear:	Mr. Charles Kanapicki	Contract No:	04-0120F4 04-SF-80-13.2 / 13.9
Attention:	Mr. Thomas Nilsson Project/Fabrication Manager	Job Name:	SAS Superstructure
Subject:	NCR No. ZPMC-0793	Document No:	05.03.06-000788

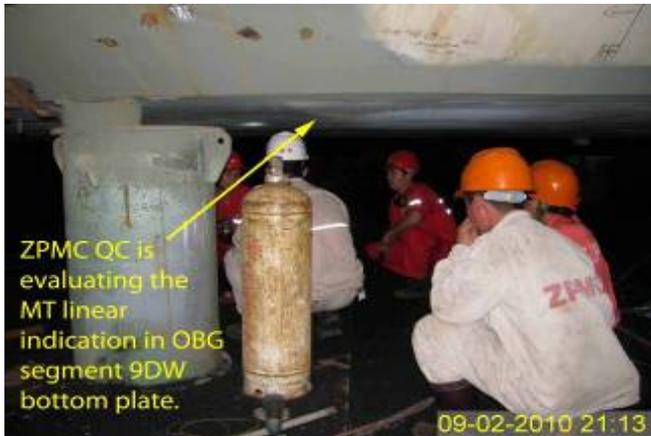
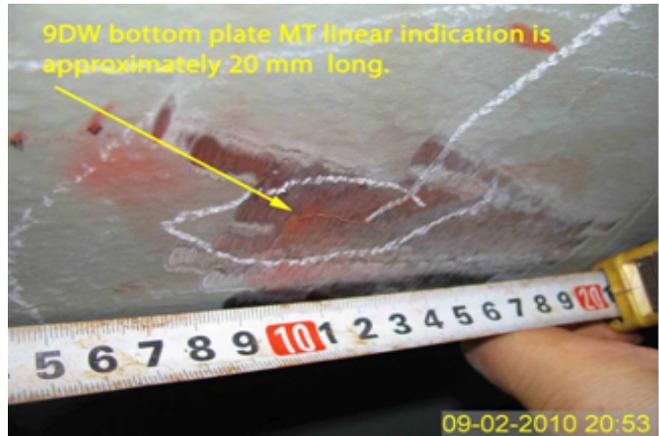
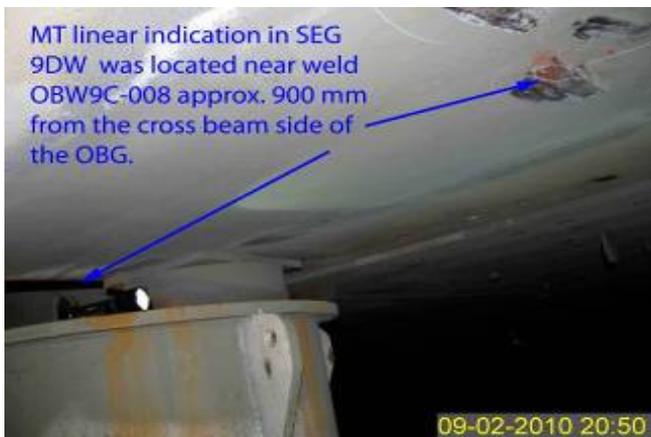
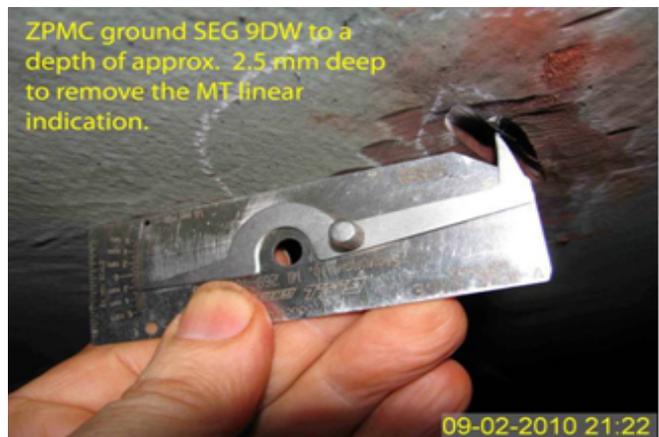
During Quality Assurance (QA) Magnetic Particle Testing (MT) inspections of temporary alignment plate weld removal areas on OBG segment 9DW Bottom Plate (BP), this QA Inspector discovered the following issue:

- One (1) linear crack was observed during a QA MT verification of BP154A base metal repair. The crack on the base metal is adjacent to transverse splice weld OBW9C-008.
- The "Y" location was approximately 900mm from the Cross Beam side near weld OBW9C-008.
- The "X" location was approximately 100mm from weld OBW9C-008.
- Length of the linear crack is approximately 20mm in length.
- The crack on the base metal was at the temporary attachment removal area.
- Weld OBW9C-008 is a transverse splice CJP weld that joins OBG segments 9DW and 9EW Bottom plates.
- Bottom Plate BP154A is classified as Seismic Performance Critical Member (SPCM).
- OBG segment 9DW is located in the Trial Assembly yard.

-The Notice of Witness Inspection Number (NWIT) is 006565 item #3. This MT crack is located inside the area that has been previously tested and accepted by ZPMC Quality Control (QC) personnel. ZPMC's QC personnel performed 100% MT inspection of this temporary attachment base metal repair area.

AWS D1.5 2002 Section 6.26.2 – “Welds that are subject to RT or MT in addition to visual inspection shall have no cracks and shall be unacceptable if the RT or MT shows any of the types of discontinuities described in 6.26.2.1, 6.26.2.2, 6.26.2.3 or 6.26.2.4”.

ZPMC has repaired the indication in accordance with the attached CWR and is providing NDT done after to show that the weld is acceptable. For future work to decrease incidents of missed indications, inspectors who miss indications are being tracked to ensure that they are accountable for their work if there is a systematic issue they will be reprimanded. Based on this ZPMC requests closure of this NCR.

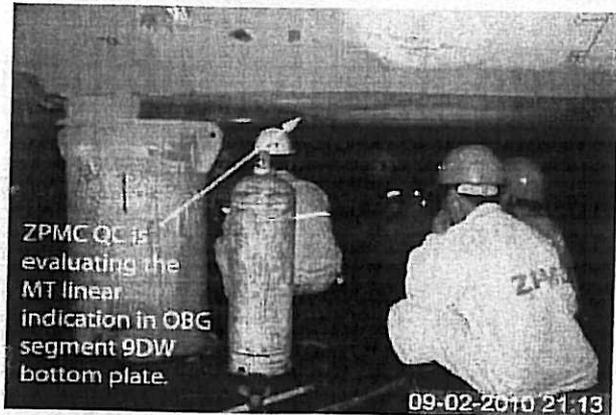
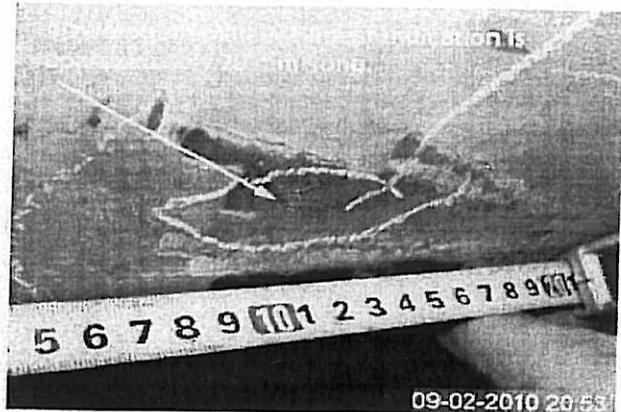
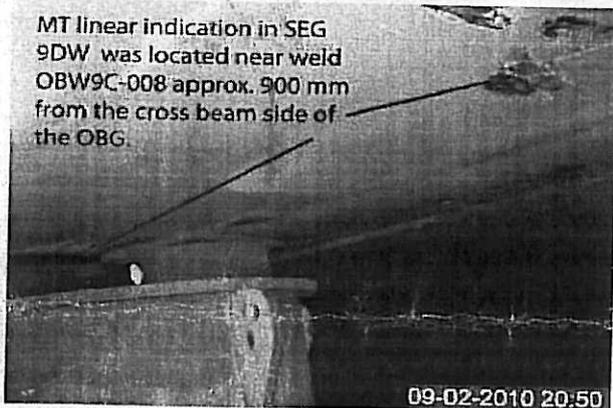
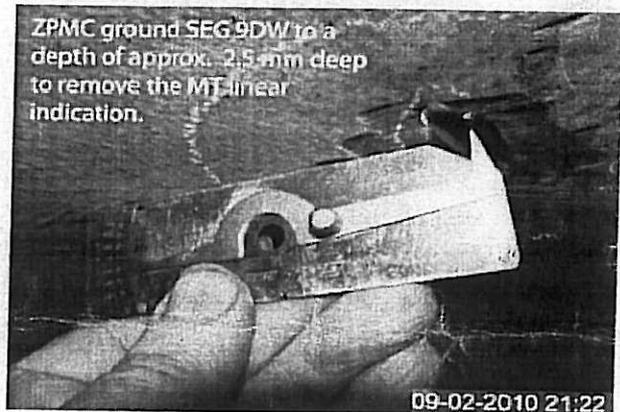
During Quality Assurance (QA) Magnetic Particle Testing (MT) inspections of temporary alignment plate weld removal areas on OBG segment 9DW Bottom Plate (BP), this QA Inspector discovered the following issue:

- One (1) linear crack was observed during a QA MT verification of BP154A base metal repair. The crack on the base metal is adjacent to transverse splice weld OBW9C-008.
- The "Y" location was approximately 900mm from the Cross Beam side near weld OBW9C-008.
- The "X" location was approximately 100mm from weld OBW9C-008.
- Length of the linear crack is approximately 20mm in length.
- The crack on the base metal was at the temporary attachment removal area.
- Weld OBW9C-008 is a transverse splice CJP weld that joins OBG segments 9DW and 9EW Bottom plates.
- Bottom Plate BP154A is classified as Seismic Performance Critical Member (SPCM).
- OBG segment 9DW is located in the Trial Assembly yard.

-The Notice of Witness Inspection Number (NWIT) is 006565 item #3. This MT crack is located inside the area that has been previously tested and accepted by ZPMC Quality Control (QC) personnel. ZPMC's QC personnel performed 100% MT inspection of this temporary attachment base metal repair area.

AWS D1.5 2002 Section 6.26.2 – “Welds that are subject to RT or MT in addition to visual inspection shall have no cracks and shall be unacceptable if the RT or MT shows any of the types of discontinuities described in 6.26.2.1, 6.26.2.2, 6.26.2.3 or 6.26.2.4”.

The NDT reports have been revised to show the plate IDs where the base metal repair occurred. Based on these revised reports and previously submitted documentation ZPMC requests closure of this NCR.

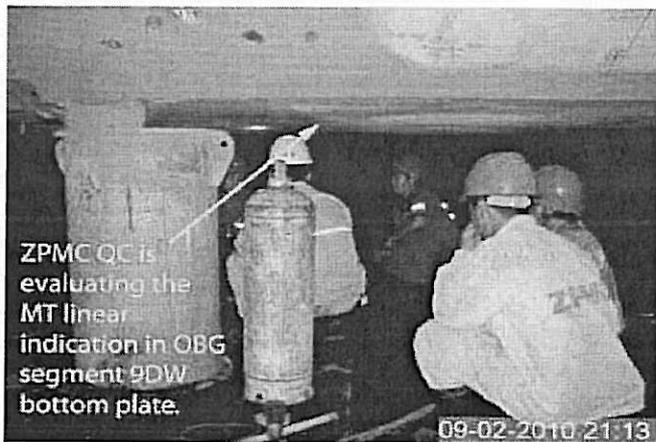
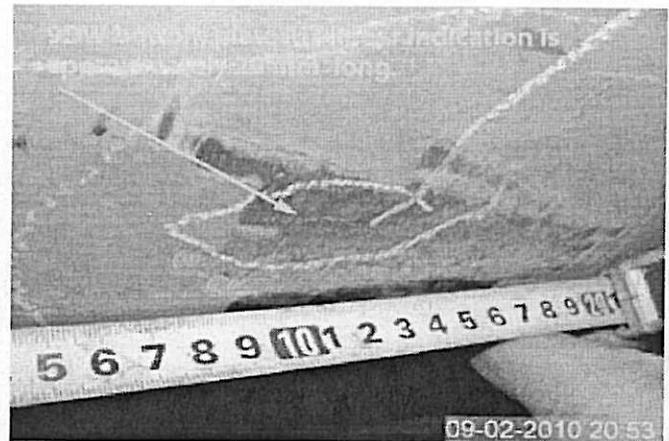
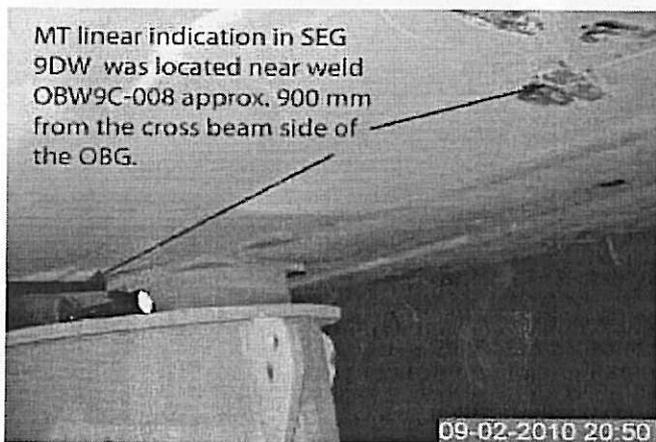
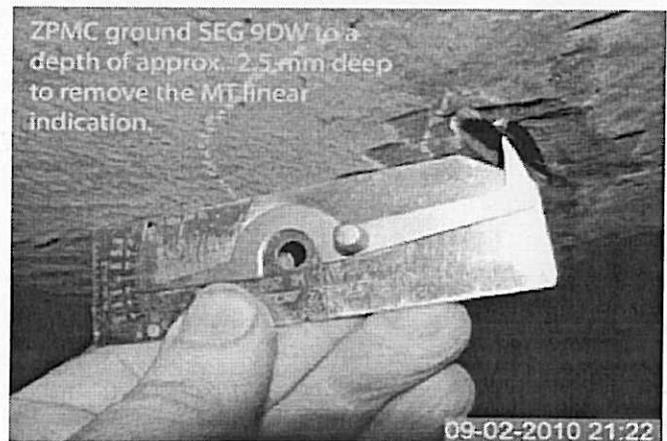
- One (1) linear crack was observed during a QA MT verification of BP154A base metal repair. The crack on the base metal is adjacent to transverse splice weld OBW9C-008.
- The "Y" location was approximately 900mm from the Cross Beam side near weld OBW9C-008.
- The "X" location was approximately 100mm from weld OBW9C-008.
- Length of the linear crack is approximately 20mm in length.
- The crack on the base metal was at the temporary attachment removal area.
- Weld OBW9C-008 is a transverse splice CJP weld that joins OBG segments 9DW and 9EW Bottom plates.
- Bottom Plate BP154A is classified as Seismic Performance Critical Member (SPCM).
- OBG segment 9DW is located in the Trial Assembly yard.

-The Notice of Witness Inspection Number (NWIT) is 006565 item #3. This MT crack is located inside the area that has been previously tested and accepted by ZPMC Quality Control (QC) personnel. ZPMC's QC personnel performed 100% MT inspection of this temporary attachment base metal repair area.

AWS D1.5 2002 Section 6.26.2 – “Welds that are subject to RT or MT in addition to visual inspection shall have no cracks and shall be unacceptable if the RT or MT shows any of the types of discontinuities described in 6.26.2.1, 6.26.2.2, 6.26.2.3 or 6.26.2.4”.

Contractor revised the NDT reports to prove the plate IDs where the base metal repair occurred.
