Contract #: 04-0120F4  
 Cty: SF/ALA Rte: 80 PM: 13.2/13.9  
 File #: 69.25B

**QUALITY ASSURANCE -- NON-CONFORMANCE REPORT**

**Location:** Changxing Island, Shanghai, China **Report No:** NCR-000834  
**Prime Contractor:** American Bridge/Fluor Enterprises, a JV **Date:** 07-Sep-2010  
**Submitting Contractor:** Zhenhua Port Machinery Company, Ltd (ZPMC), Changxing Island **NCR #:** ZPMC-0796

**Reference Description:** Base Metal Repair without Prior Approval from Engineer

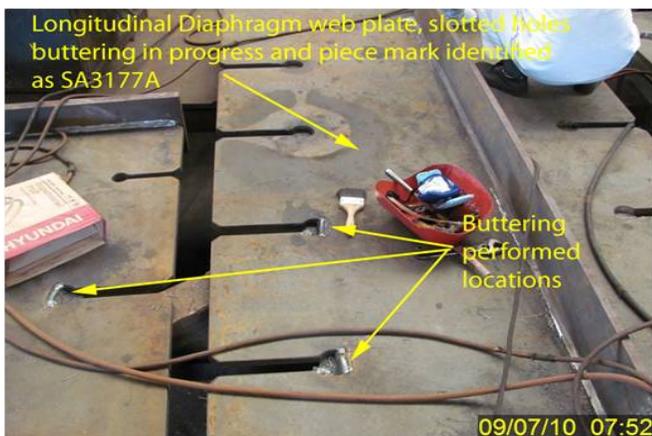
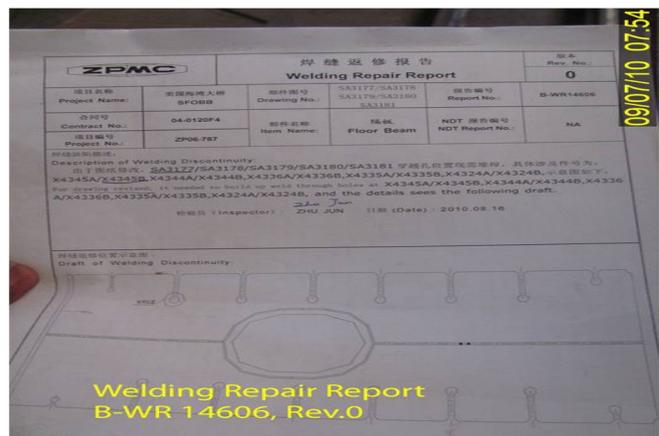
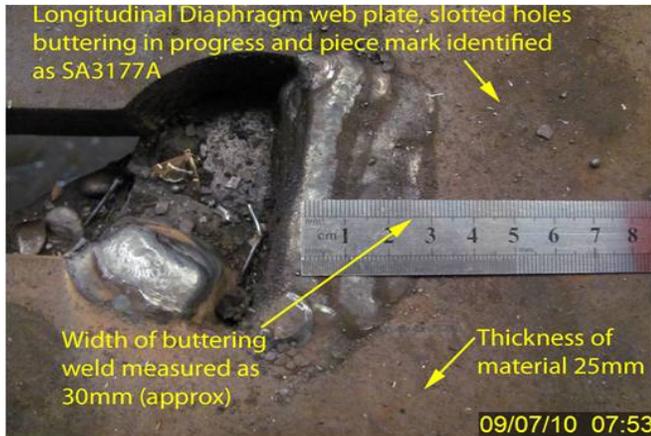
- During Quality Assurance Inspection of fabrication in Bay#2 QA discovered the following issue:
- Base metal repair being performed by ZPMC personnel without Engineers approval.
  - The base metal repairs were being performed in the area of the cope holes at the top of the stiffener pass through slots in the web plates.
  - ZPMC is building up the inside of all the cope areas to accommodate a drawing revision.
  - Additionally ZPMC did not appear to prepare the edge of the material in a manner suitable for building up the edges as specified in ABF submittal 200.
  - The members are identified as SA3177A, SA3177B, SA3179A, SA3179B, SA3178A, SA3178B, SA3158A and SA3177B.
  - ZPMC personnel were performing the weld repairs per Weld Repair Report (WRR) B-WR14606.
  - The Longitudinal Diaphragm components are located in Bay 2.

Reference attached pictures.

AWS D1.5 2002, Section 3.7.4 "Prior approval of the Engineer shall be obtained for repairs to base metal...or for a revised design to compensate for deficiencies."

ZPMC acknowledges that base metal repairs require Engineer approval. In this case, the floor QC thought that since this repair was the result of drawings revisions a WRR was sufficient. This point has been clarified to prevent future occurrences. Subsequently ZPMC has submitted and received an approved CWR for this work. ZPMC is providing NDT after the repair to show that work done is acceptable. Based on this ZPMC requests closure of this NCR.

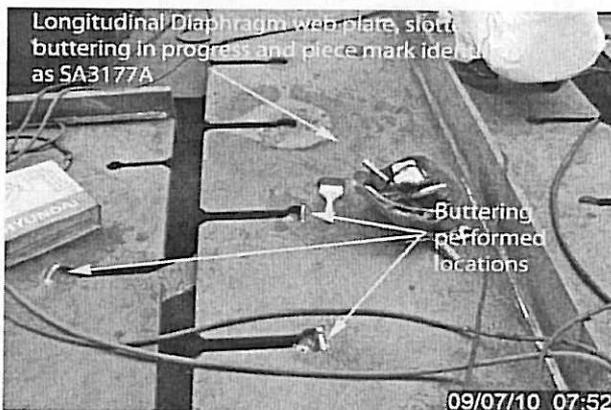
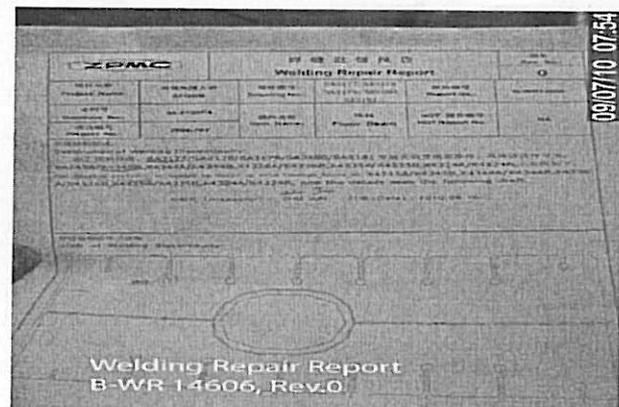
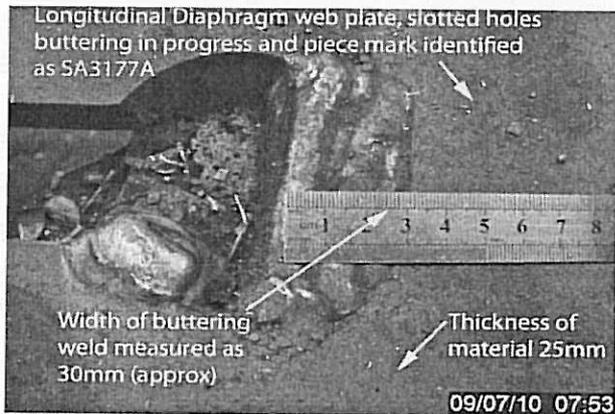
- Base metal repair being performed by ZPMC personnel without Engineers approval.
- The base metal repairs were being performed in the area of the cope holes at the top of the stiffener pass through slots in the web plates.
- ZPMC is building up the inside of all the cope areas to accommodate a drawing revision.
- Additionally ZPMC did not appear to prepare the edge of the material in a manner suitable for building up the edges as specified in ABF submittal 200.
- The members are identified as SA3177A, SA3177B, SA3179A, SA3179B, SA3178A, SA3178B, SA3158A and SA3177B.
- ZPMC personnel were performing the weld repairs per Weld Repair Report (WRR) B-WR14606.
- The Longitudinal Diaphragm components are located in Bay 2.

Reference attached pictures.

AWS D1.5 2002, Section 3.7.4 "Prior approval of the Engineer shall be obtained for repairs to base metal...or for a revised design to compensate for deficiencies."

- ZPMC QA personnel talked with on-site QC to address the requirement of "prior approval of the engineer".
- Submit Critical Weld Repair (CWR) for the job record.
- Repair and inspect accordingly to the CWR.

- Discussed the issue with onsite QC staff.
- Performed repair and inspection according to the approved critical weld repair.
