QUALITY ASSURANCE -- NON-CONFORMANCE REPORT

Location: Changxing Island, Shanghai, P.R. China**Report No:** NCR-000836**Prime Contractor:** American Bridge/Fluor Enterprises, a JV**Date:** 09-Sep-2010**Submitting Contractor:** Zhenhua Port Machinery Company, Ltd (ZPMC), Changxing Island**NCR #:** ZPMC-0798**Type of problem:**

Reference Description: QA found a missed UT indication after ZPMC had tested and accepted a side panel weld in Segment 11EE

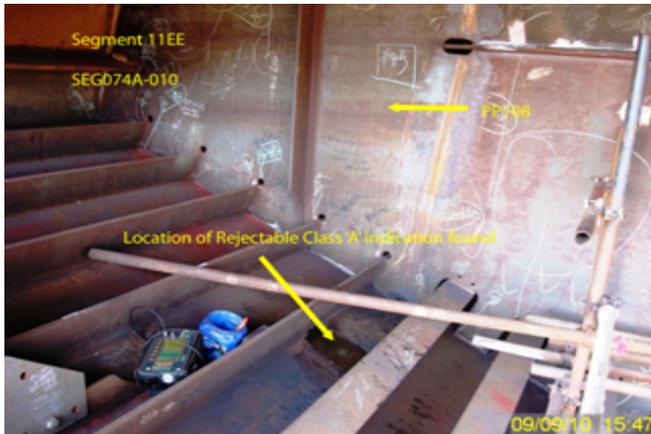
- One (1) Class "A" indication measuring approximately 20 mm in length.
- The dB rating is +9.
- The weld is identified as SEG074A-010.
- The weld is a Complete Joint Penetration (CJP) butt weld joining Side plate SP330A (PL985A) to Side plate SP718A (PL1432 SPCM).
- The Thickness of the Side plate is 18mm.
- The "Y" location is approximately 800mm away from Panel Point 108 towards East side.
- The indication is clearly marked by QA on/near the weld.
- OBG Segment 11EE is located in Repair yard (West side of Bay 14).
- This weld joint is designated as Seismic performance critical weld member (SPCM).

The Notice of Witness Inspection Number (NWIT) is 006616. The indication is located inside the area that has been previously tested and accepted by ZPMC Quality Control (QC) personnel. As per the contract documents, ZPMC's QC personnel are required to perform 100% UT inspection of this weld.

AWS D1.5-2002, Section 6, Table 6.3. Specifies a class A indication as having a db's rating of +10 and lower for weld thicknesses 8mm through 20mm.

ZPMC has repaired the missed indications and is providing the WWR used at the time to repair the weld and the UT report performed after to show that the weld is acceptable. To prevent future occurrences ZPCM has written an internal NCR and the inspector who missed the indications has been identified and his performance will be monitored to ensure that he does not continue a pattern of missed indications. Based on this ZPMC requests closure of this NCR.

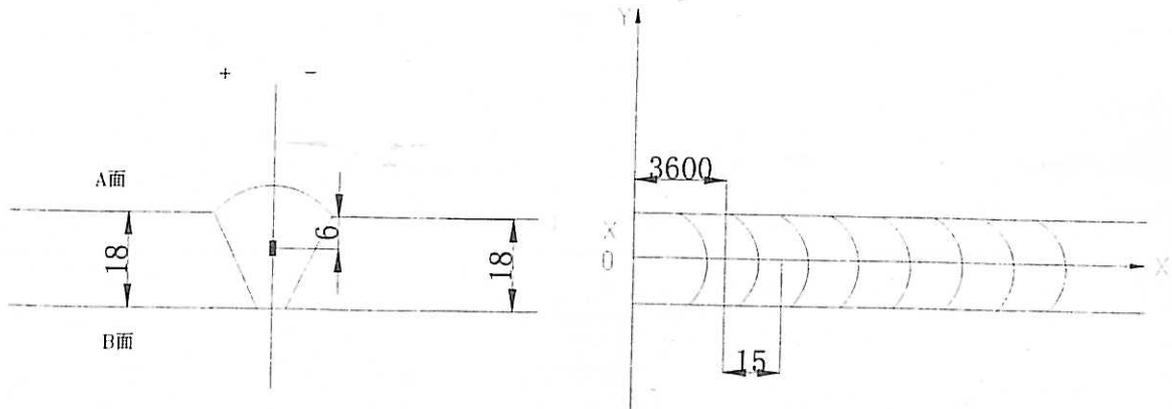
WELD NUMBER: SEG074A-010

(Description of welding discontinuity): Rejected indication found by ultrasonic inspection is less than the maximum allowance aggregate length.

1. Did not clear the weld pass completely in time.

1. Gouge or grind from nearer side from metal edge ($D \leq 0.65T$, "D" is depth of defects, "T" is thickness of metal) to remove all defects;
2. Follow repair WPS for joint preparation, preheat, and weld deposit;
3. Grind the repaired area flush with base metal or the adjacent weld;
4. Check the welds according to the working drawings.

1. Improve monitoring of welding and interpass cleaning.

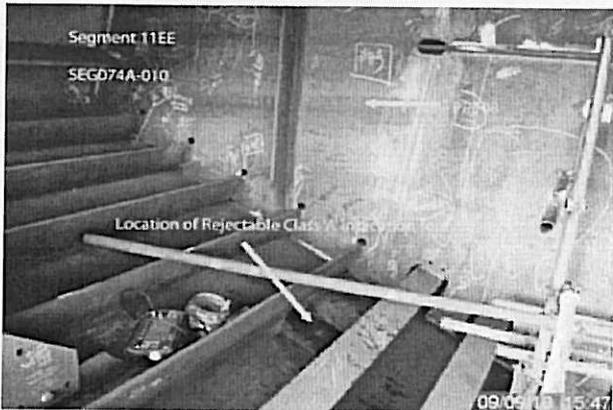
- One (1) Class "A" indication measuring approximately 20 mm in length.
- The dB rating is +9.
- The weld is identified as SEG074A-010.
- The weld is a Complete Joint Penetration (CJP) butt weld joining Side plate SP330A (PL985A) to Side plate SP718A (PL1432 SPCM).
- The Thickness of the Side plate is 18mm.
- The "Y" location is approximately 800mm away from Panel Point 108 towards East side.
- The indication is clearly marked by QA on/near the weld.
- OBG Segment 11EE is located in Repair yard (West side of Bay 14).
- This weld joint is designated as Seismic performance critical weld member (SPCM).

The Notice of Witness Inspection Number (NWIT) is 006616. The indication is located inside the area that has been previously tested and accepted by ZPMC Quality Control (QC) personnel. As per the contract documents, ZPMC's QC personnel are required to perform 100% UT inspection of this weld.

AWS D1.5-2002, Section 6, Table 6.3. Specifies a class A indication as having a dbS rating of +10 and lower for weld thicknesses 8mm through 20mm.

Contractor repaired the indications with WWR document support. UT was performed after repair. UT report showed the weld is acceptable. Contractor also identified the inspector, and issued an internal NCR to him. The inspector's performance is monitored by Contractor.
