Contract #: 04-0120F4  
 Cty: SF/ALA Rte: 80 PM: 13.2/13.9  
 File #: 69.25B

## QUALITY ASSURANCE -- NON-CONFORMANCE REPORT

**Report No:** NCR-000837

**Reference Description:** Missed MT Indication

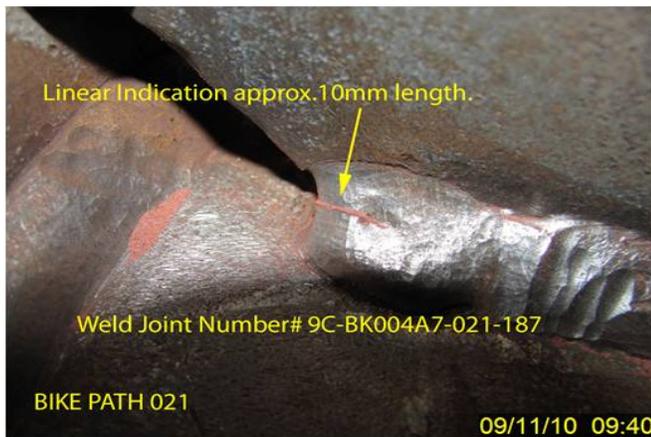
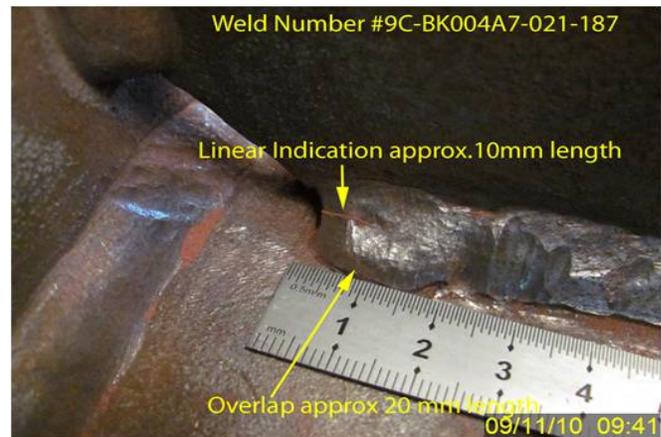
During the Quality Assurance Magnetic Particle Testing (MT) review of welds located on Bike Path 021 this Quality Assurance Inspector (QA) discovered the following issues:

- One linear crack indication in the weld measuring approximately 10mm in length.
- One area of overlap of the fillet weld measuring approximately 20mm in length.
- The weld is identified as 9C-BK004A7-021-187.
- The weld is a fillet T-joint, joining stiffener identified as BKX7L to stringer plate identified as BKX9C.
- The indications are clearly marked on the material near the weld.
- The Bike Path 021 Stringer Plate is located in Bay# 11.

The Notice of Witness Inspection Number (NWIT) is 006640. The indication is located Within an area previously tested and accepted by ZPMC Quality Control (QC) personnel.

AWS D1.5 (02) Section 6.26.2 – “Welds that are subject to MT in addition to visual inspection shall have no cracks.

AWS D1.5 (02) Section 3.6.5 Welds shall be free from overlap.

**Reference Resolution:** ZPMC has repaired the missed indications and is providing the WWR used at the time to repair the weld and the MT report performed after to show that the weld is acceptable.

ZPMC has repaired the missed indications and is providing the WWR used at the time to repair the weld and the MT report performed after to show that the weld is acceptable. To prevent future occurrences ZPCM has written an internal NCR and the inspector who missed the indications has been identified and his performance will be monitored to ensure that he does not continue a pattern of missed indications. Based on this ZPMC requests closure of this NCR.

The visual defects noted in the NCR were corrected at the time the crack was repaired and verified to be visually acceptable. Based on this clarification and previous submitted acceptable NDT documents ZPMC requests closure of this NCR.

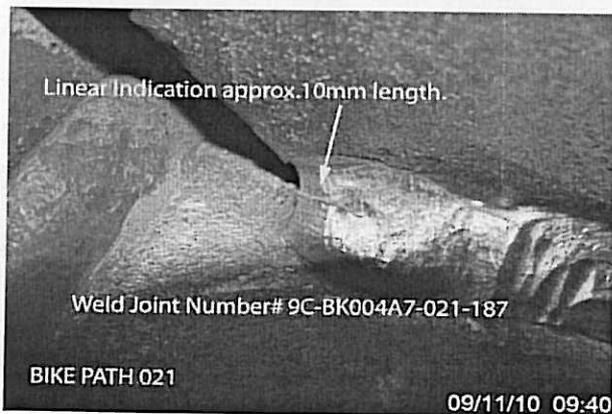
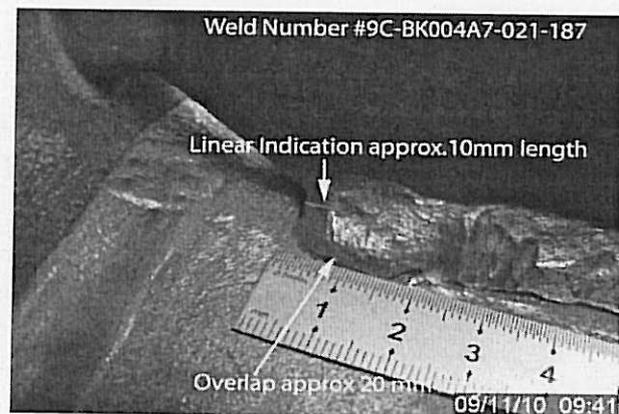
During the Quality Assurance Magnetic Particle Testing (MT) review of welds located on Bike Path 021 this Quality Assurance Inspector (QA) discovered the following issues:

- One linear crack indication in the weld measuring approximately 10mm in length.
- One area of overlap of the fillet weld measuring approximately 20mm in length.
- The weld is identified as 9C-BK004A7-021-187.
- The weld is a fillet T-joint, joining stiffener identified as BKX7L to stringer plate identified as BKX9C.
- The indications are clearly marked on the material near the weld.
- The Bike Path 021 Stringer Plate is located in Bay# 11.

The Notice of Witness Inspection Number (NWIT) is 006640. The indication is located within an area previously tested and accepted by ZPMC Quality Control (QC) personnel.

AWS D1.5 (02) Section 6.26.2 – “Welds that are subject to MT in addition to visual inspection shall have no cracks.

AWS D1.5 (02) Section 3.6.5 Welds shall be free from overlap.

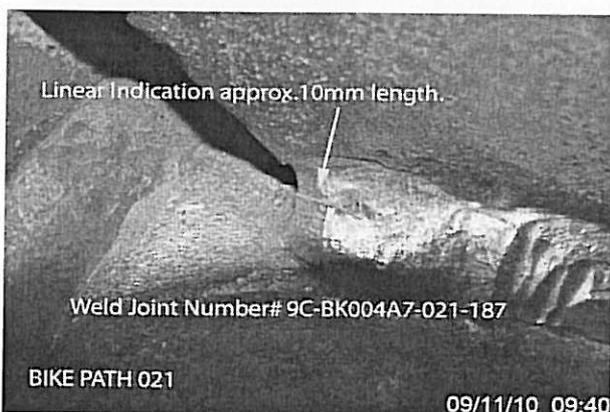
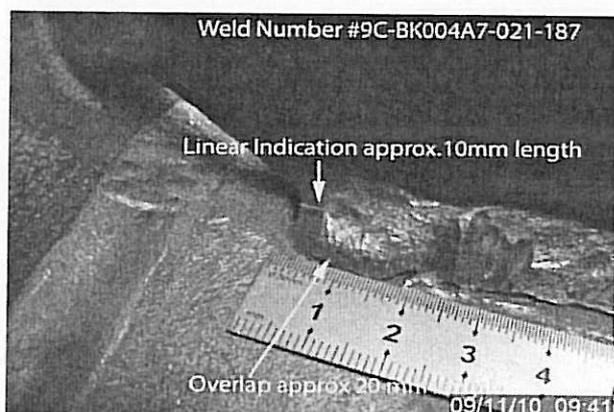
During the Quality Assurance Magnetic Particle Testing (MT) review of welds located on Bike Path 021 this Quality Assurance Inspector (QA) discovered the following issues:

-One linear crack indication in the weld measuring approximately 10mm in length.

-One area of overlap of the fillet weld measuring approximately 20mm in length.

-The weld is identified as 9C-BK004A7-021-187.

-The weld is a fillet T-joint, joining stiffener identified as BKX7L to stringer plate identified as BKX9C.

-The indications are clearly marked on the material near the weld.

-The Bike Path 021 Stringer Plate is located in Bay# 11.

The Notice of Witness Inspection Number (NWIT) is 006640. The indication is located Within an area previously tested and accepted by ZPMC Quality Control (QC) personnel.

AWS D1.5 (02) Section 6.26.2 – “Welds that are subject to MT in addition to visual inspection shall have no cracks.

AWS D1.5 (02) Section 3.6.5 Welds shall be free from overlap.
