Contract #: 04-0120F4
 Cty: SF/ALA Rte: 80 PM: 13.2/13.9
 File #: 69.25B

QUALITY ASSURANCE -- NON-CONFORMANCE REPORT

Report No: NCR-000839

Reference Description: Excessive Heat Utilized during Heat Straightening of CB18 Floorbeam FB3168A

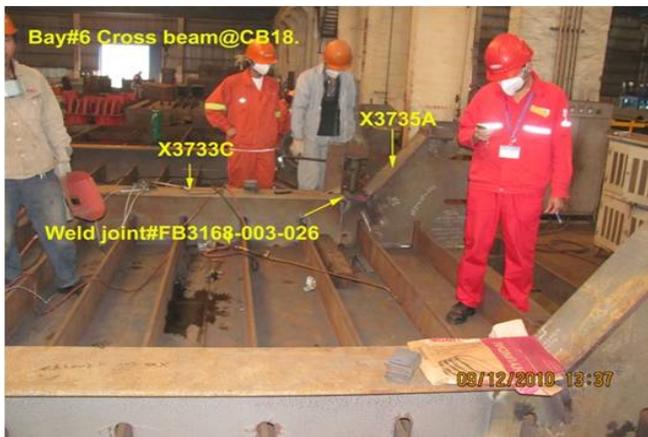
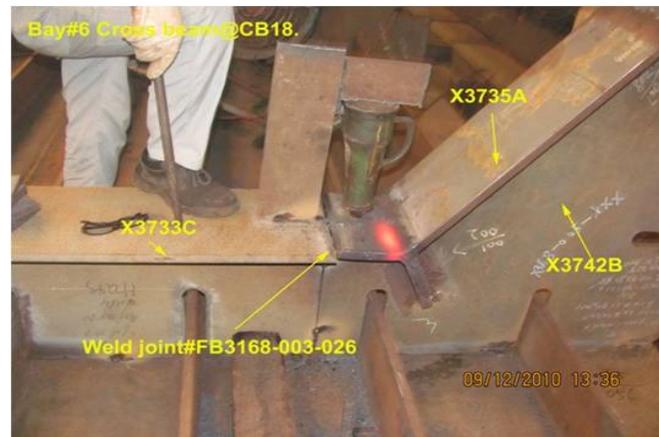
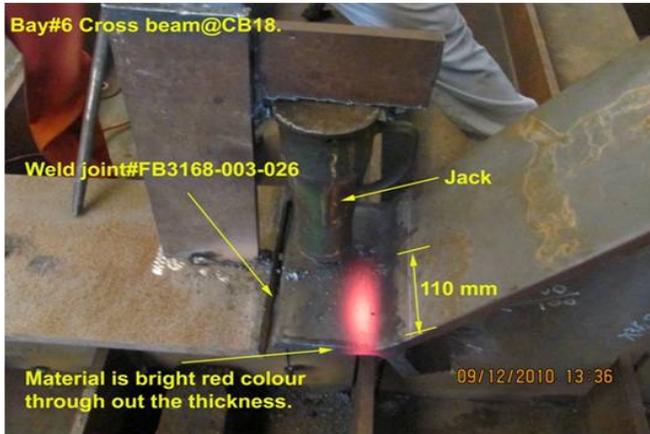
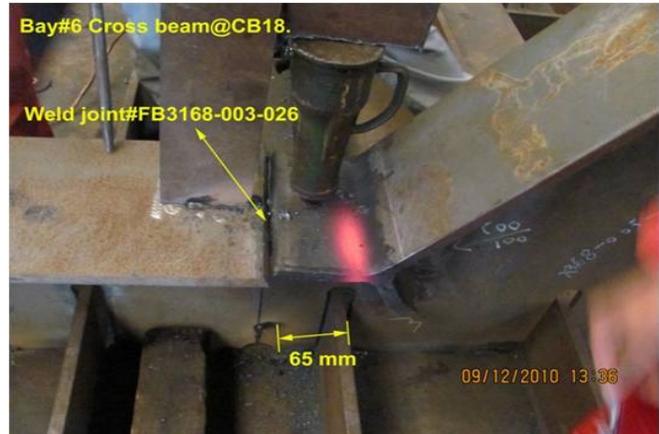
- During the fit up of the Floorbeam Diaphragms on CB18, ZPMC personnel appear to have overheated the flange base metal. The material was heated to a bright red/yellow condition.
- AWS D1.5 2002 defines the color of material heated to 650C as a "dull red color".
- The corner diaphragm flange is identified as X3735A.
- The weld joint number nearest to the heated area is identified as FB3168-003-026.
- The area being heated is approximately 65 mm from the above mentioned weld joint.
- The length of the heated area is approximately 110 mm parallel to the above mentioned weld joint.
- CB18 is located in sub assembly Bay # 6.

AWS 1.5 2002 section 3.7.3 "Members distorted by welding shall be straightened by mechanical means or by carefully supervised application of a limited amount of localized heat as approved by the Engineer. The temperature of the heated areas as measured by approved methods shall not exceed 600°C [1100°F] for quenched and tempered steel nor 650°C [1200°F] (a dull, red color) for other steels. The part to be heated for straightening shall be substantially free of stress and from external forces, except those stresses resulting from the mechanical straightening method used in conjunction with the application of heat."

ZPMC has performed hardness testing on the heated area and is providing the results for the Department's review. Also attached is the NDT done on the adjacent welds to show they were not adversely affected by the heating. In the future, work crews who perform overheating will be fined in order to pay for the overheated part. This financial penalty will be a deterrent to workers performing overheating. In this case, ZPMC conducted hardness testing of the heated area (Area 1-5) and an adjacent area unaffected by overheating to show that the heating did not adversely affect the material hardness. After heating, ZPMC performed NDT and is providing the result to show the material is acceptable. Based on this ZPMC requests closure of this NCR.

Contractor performed the hardness testing of the heated area and the adjacent area affected by overheating to show that the heating did not adversely affect the material. NDT was performed, and material result is acceptable. Contractor has issued notification to fine the work crew who performed the heating.

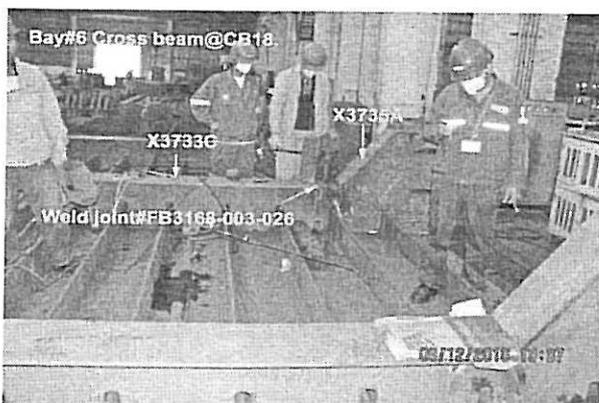
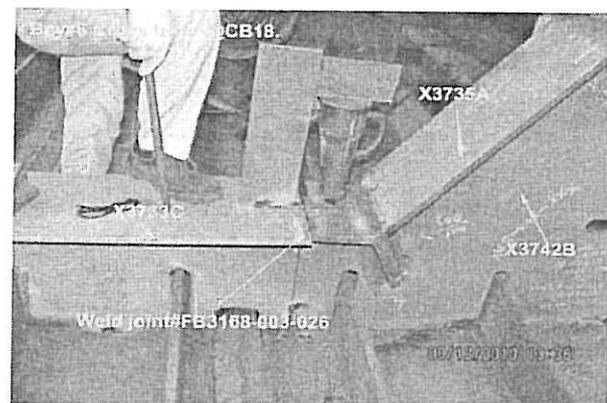
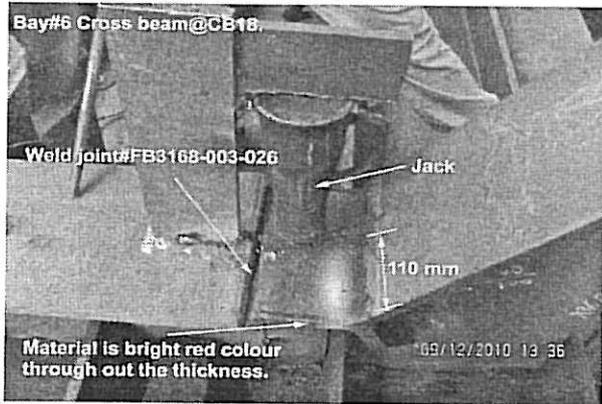
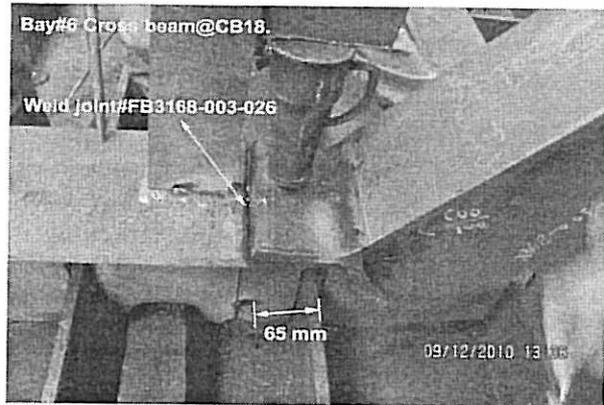
- During the fit up of the Floorbeam Diaphragms on CB18, ZPMC personnel appear to have overheated the flange base metal. The material was heated to a bright red/yellow condition.
- AWS D1.5 2002 defines the color of material heated to 650C as a "dull red color".
- The corner diaphragm flange is identified as X3735A.
- The weld joint number nearest to the heated area is identified as FB3168-003-026.
- The area being heated is approximately 65 mm from the above mentioned weld joint.
- The length of the heated area is approximately 110 mm parallel to the above mentioned weld joint.
- CB18 is located in sub assembly Bay # 6.

AWS 1.5 2002 section 3.7.3 "Members distorted by welding shall be straightened by mechanical means or by carefully supervised application of a limited amount of localized heat as approved by the Engineer. The temperature of the heated areas as measured by approved methods shall not exceed 600°C [1100°F] for quenched and tempered steel nor 650°C [1200°F] (a dull, red color) for other steels. The part to be heated for straightening shall be substantially free of stress and from external forces, except those stresses resulting from the mechanical straightening method used in conjunction with the application of heat."

Contractor will perform hardness test on the heated area, and submit the results to the Department for review. NDT will be performed on the adjacent welds to show the welds are not adversely affected by the heating. Contractor will in pose fine on the work crew perform overheating.
