Contract #: 04-0120F4Cty: SF/ALA Rte: 80 PM: 13.2/13.9File #: 69.25B

QUALITY ASSURANCE -- NON-CONFORMANCE REPORT

Location: Changxing Island, Shanghai, China**Report No:** NCR-000840**Prime Contractor:** American Bridge/Fluor Enterprises, a JV**Date:** 16-Sep-2010**Submitting Contractor:** Zhenhua Port Machinery Company, Ltd (ZPMC), Changxing Island**NCR #:** ZPMC-0802**Type of problem:**

Reference Description: QA found UT indications on Segment 13 LD after ZPMC had tested and accepted the welds

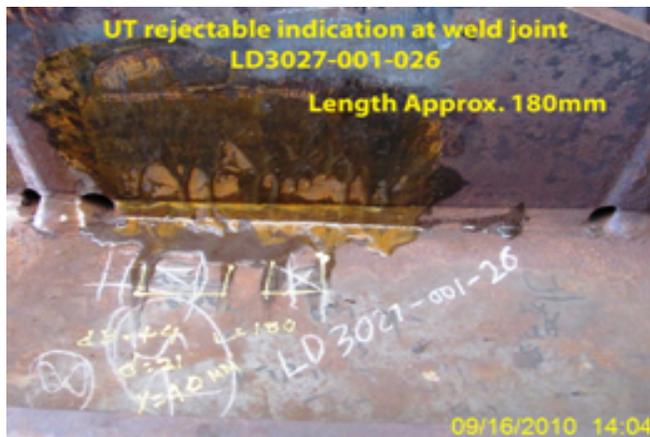
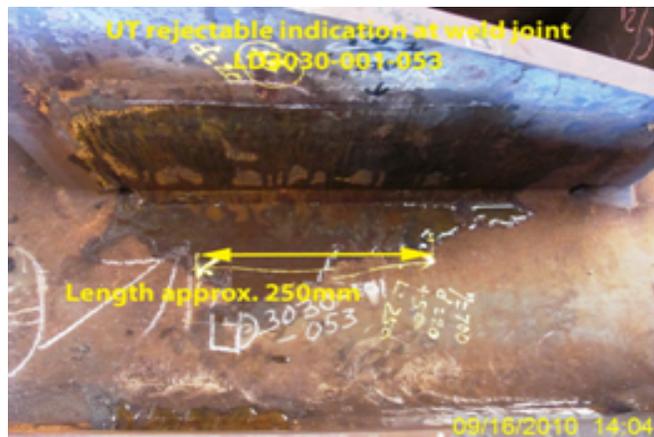
During the Quality Assurance (QA) Ultrasonic Testing (UT) review of welds located on Orthotropic Box Girder (OBG) segment 13BE and 13CE, this QA Inspector discovered the following issues:

- Three (3) longitudinal linear class "A" rejectable indications measuring approximately 180mm~260mm in length.
- The welds are identified as LD3028-001-031, LD3027-001-026 and LD3030-001-053.

- Material thickness for all joints is 30mm.
- The indication db rating for joint LD3028-001-031 is a +6.
- The indication db rating for joint LD3027-001-026 is a +4.

- The indication db rating for joint LD3030-001-053 is a +5.
- The depth of the indications are from 20mm~23mm deep.
- The Weld LD3028-001-031 is joining longitudinal diaphragm (X3682A) to lifting Lug.

- The Weld LD3027-001-026 is joining longitudinal diaphragm (X3684B) to lifting Lug.
- The Weld LD3030-001-053 is joining longitudinal diaphragm (X3685A) to lifting Lug.

- All Welds are Complete Joint Penetration (CJP) "T" joint.
- All welds are Seismic Performance Critical Members (SPCM).
- The Y distance for joint LD3028-001-031 is 110mm from bottom cope hole.

- The Y distance for joint LD3027-001-026 is 40mm from bottom cope hole.
- The Y distance for joint LD3030-001-053 is 700mm from bottom cope hole.
- The indications are clearly marked on or near the weld.

The Notice of Witness Inspection (NWIT) No. is 006680. The indications all joints are located within an area previously tested and accepted by ZPMC Quality Control (QC) personnel.

AWS D1.5-02 Section 6; Table 6.3 specifies a class “A” indication as having a rating of 8d and under for material thicknesses 21mm through 38mm.

"Please see ZPMC's comments. In addition to the repairs and NDT performed, ABFJV has noted which inspector was responsible for the missed indication and is monitoring his performance as well as all inspector performance, if he continues to miss indications disciplinary action will be undertaken. Based on these actions, ZPMC requests closure of this NCR."

The submitted Contractor's NDT records show that the welds are accepted. The proposed resolution is acceptable. This NCR is closed.
