Contract #: 04-0120F4Cty: SF/ALA Rte: 80 PM: 13.2/13.9File #: 69.25B**QUALITY ASSURANCE -- NON-CONFORMANCE REPORT****Location:** Changxing Island, Shanghai, P.R. China**Report No:** NCR-000841**Prime Contractor:** American Bridge/Fluor Enterprises, a JV**Date:** 17-Sep-2010**Submitting Contractor:** Zhenhua Port Machinery Company, Ltd (ZPMC), Changxing Island**NCR #:** ZPMC-0803**Type of problem:**

**Bridge No:** 34-0006**Component:** East Tower Lift-5 Grillage Assembly**Reference Description:** East Lift 5 MT Missed Crack**Description of Non-Conformance:**

**Document No:** 05.03.06-000797

**Subject:** NCR No. ZPMC-0803

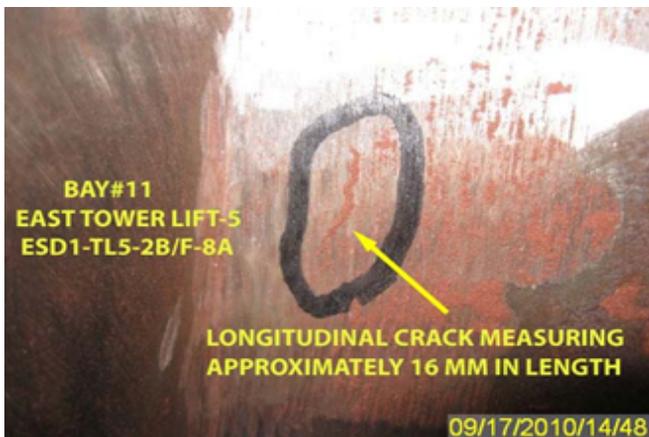
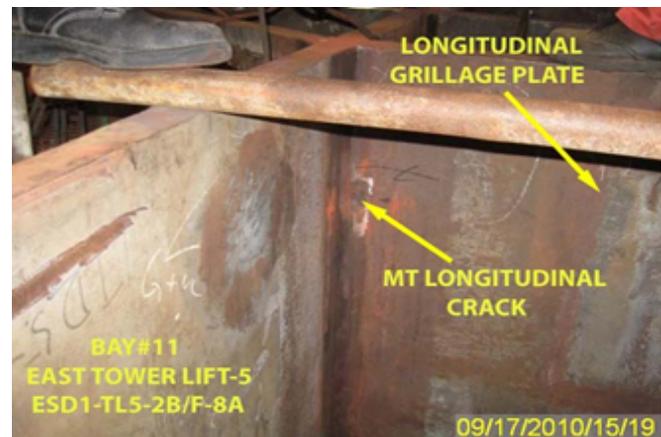
- One (1) longitudinal crack 16mm in length found adjacent to the weld identified as ESD1-TL5-2B/F#8A.
  - The weld is a Complete Joint Penetration (CJP) T-joint, joining the longitudinal to transverse grillage plates.
  - The Y location is 310mm measured from the upper termination of the weld and is clearly marked on the material.
  - East Tower Lift-5 is located at Tower fabrication shop Bay#11.
  - The Notice of Witness Inspection Number (NWIT) is 06691.
  - This weld is within an area previously tested and accepted by ZPMC Quality Control (QC) personnel.
- ZPMC's QC personnel are required to perform 100% MT inspection of these welds.

For further information, please see the attached pictures below.

Once CT inspector found indication on metal adjacent to the weld, ZPMC performed grinding work under approval of CT site inspector. Finally the indication was removed and the area was tested and accepted by using MT manner.

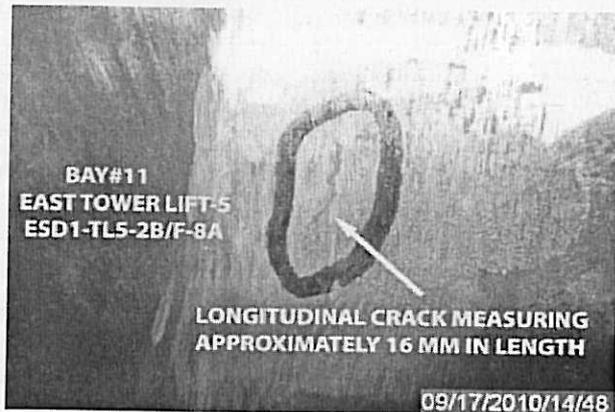
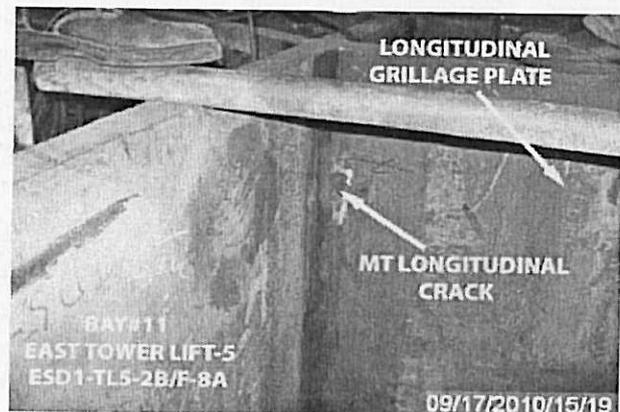
- One (1) longitudinal crack 16mm in length found adjacent to the weld identified as ESD1-TL5-2B/F#8A.
  - The weld is a Complete Joint Penetration (CJP) T-joint, joining the longitudinal to transverse grillage plates.
  - The Y location is 310mm measured from the upper termination of the weld and is clearly marked on the material.
  - East Tower Lift-5 is located at Tower fabrication shop Bay#11.
  - The Notice of Witness Inspection Number (NWIT) is 06691.
  - This weld is within an area previously tested and accepted by ZPMC Quality Control (QC) personnel.
- ZPMC's QC personnel are required to perform 100% MT inspection of these welds.
- For further information, please see the attached pictures below.

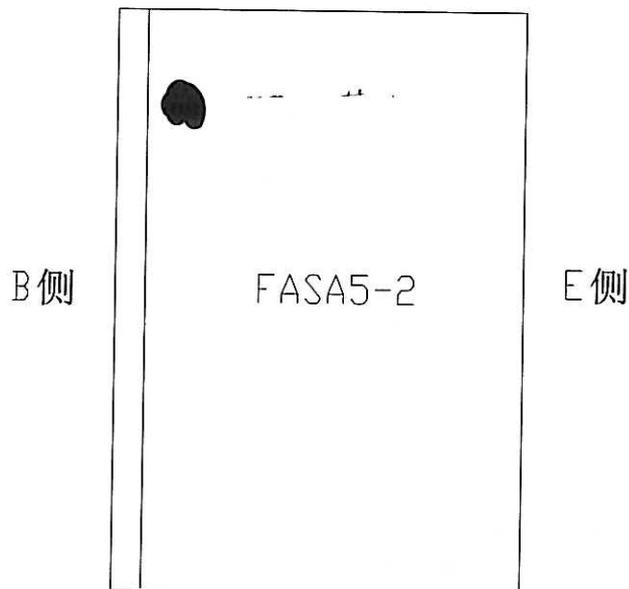
**Draft of welding discontinuity:**

东塔第五吊装段A面板FASA5-2, 母材打磨过度, 最深达3MM, 现需要补焊, 具体位置见下图  
 East tower 5<sup>th</sup> lifting Skin A FASA5-2, the base metal was gouged after grinding, maximum 3mm in depth and needed to repair, the detail position sees the following draft.

Remark: repair area in shadow.

Worker operator error caused base metal gouged.

1. Grind the repair area to a smooth finish according to the approved repair WPS.
2. Prepare the joint according to the approved WPS.
3. Perform 100%MT and 100%VT of the repair area.
4. Remove all defects by grinding to ensure all defects are completely removed if defects still exist, and repeat "step 4" to assure complete removal of all defects if necessary.
5. Clean the repair area of all loose debris including MT powder.
6. Preheat and weld according to the approved WPS.
7. Grind the weld flush after welding.
8. Perform NDT of the repair area.

培训和教育打磨工, 提高打磨水平。
