Contract #: 04-0120F4Cty: SF/ALA Rte: 80 PM: 13.2/13.9File #: 69.25B**QUALITY ASSURANCE -- NON-CONFORMANCE REPORT****Location:** Changxing Island, Shanghai, P.R. China**Report No:** NCR-000842**Prime Contractor:** American Bridge/Fluor Enterprises, a JV**Date:** 19-Sep-2010**Submitting Contractor:** Zhenhua Port Machinery Company, Ltd (ZPMC), Changxing Island**NCR #:** ZPMC-0804**Type of problem:**

**Reference Description:** East Tower Lift 3: Missed MT Crack at 109m**Description of Non-Conformance:**

## NON-CONFORMANCE REPORT TRANSMITTAL

**Subject:** NCR No. ZPMC-0804

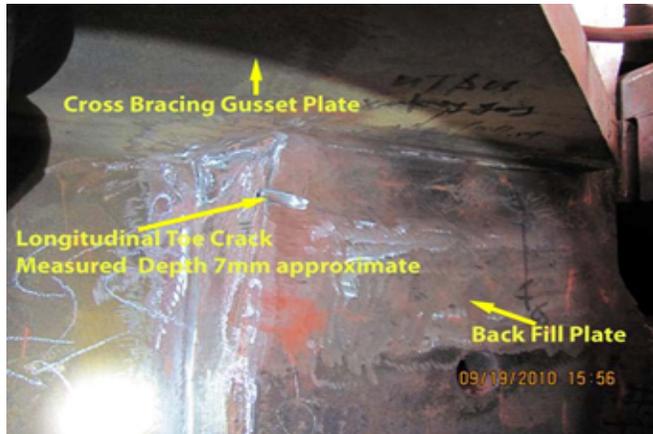
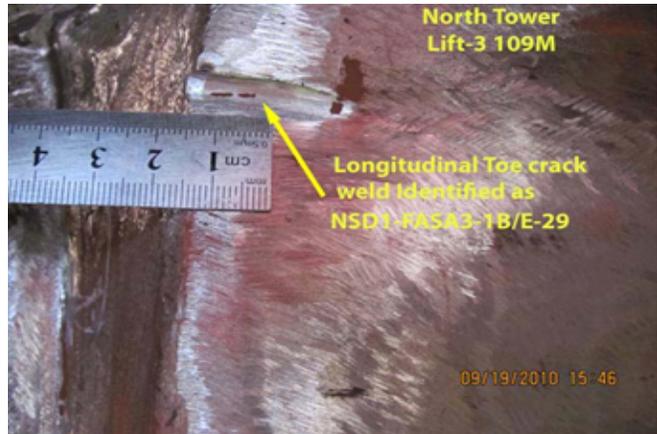
- One (1) longitudinal toe crack indication on the weld identified as NSD1-FASA3-1B/E-29.
- The weld is a Complete Joint Penetration (CJP) weld T-joint, joining the Cross Bracing gusset plate to Back fill Plate.
- Details of the indication are as follows:  
 Length = 16mm approximately  
 Y location = 0 mm from the Cross Bracing gusset Plate  
 X location=22mm.

The indication is clearly marked on the material.

- Quality Control (QC) elected to remove the crack by grinding. QA inspector performed MT during grinding and observed the crack had disappeared at a depth of approximately 7mm and would require repair by welding.
- North Tower Lift-3 is located at Heavy dock, Tower Trial Assembly .
- The Notice of Witness Inspection Number (NWIT) is 06717.
- This weld is within an area previously tested and accepted by ZPMC (QC) personnel. ZPMC's QC personnel are required to perform 100% MT inspection of these welds.

For further information, please see the pictures below.

Propose a resolution for this non-conformance and provide documentation that the deficiency has been brought into compliance with the contract requirements. Propose a resolution that addresses the apparent failure of Quality Control to identify the indication. Additionally, provide documentation of the steps taken by the Quality Control Manager to prevent future occurrences.

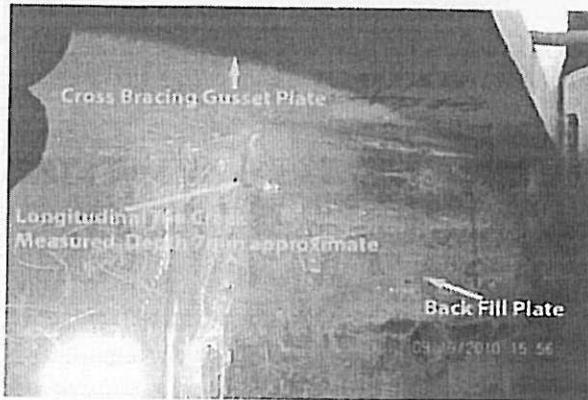
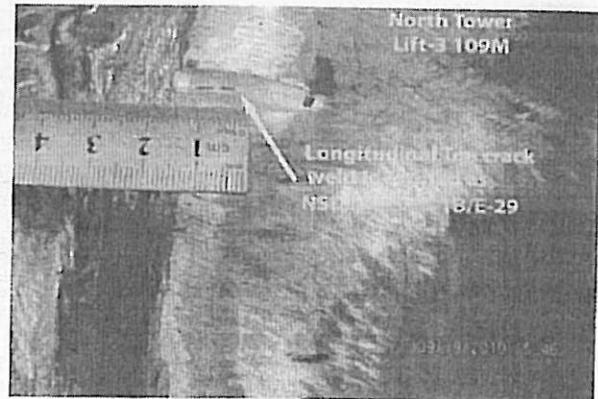
-One (1) longitudinal toe crack indication on the weld identified as NSD1-FASA3-1B/E-29.

-The weld is a Complete Joint Penetration (CJP) weld T-joint, joining the Cross Bracing gusset plate to Back fill Plate.

Length = 16mm approximately

Y location = 0 mm from the Cross Bracing gusset Plate

X location=22mm.

The indication is clearly marked on the material.

-Quality Control (QC) elected to remove the crack by grinding. QA inspector performed MT during grinding and observed the crack had disappeared at a depth of approximately 7mm and would require repair by welding.

For further information, please see the pictures below.
