Contract #: 04-0120F4Cty: SF/ALA Rte: 80 PM: 13.2/13.9File #: 69.25B**QUALITY ASSURANCE -- NON-CONFORMANCE REPORT****Location:** Changxing Island, Shanghai, P.R. China**Report No:** NCR-000845**Prime Contractor:** American Bridge/Fluor Enterprises, a JV**Date:** 21-Sep-2010**Submitting Contractor:** Zhenhua Port Machinery Company, Ltd (ZPMC), Changxing Island**NCR #:** ZPMC-0807**Type of problem:**

Reference Description: QA found a missed MT transverse crack after ZPMC had tested and accepted the weld in East Tower Lift 5

Job Name: SAS Superstructure

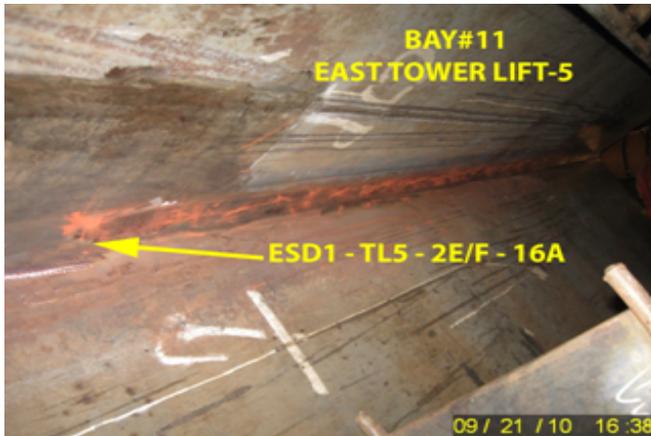
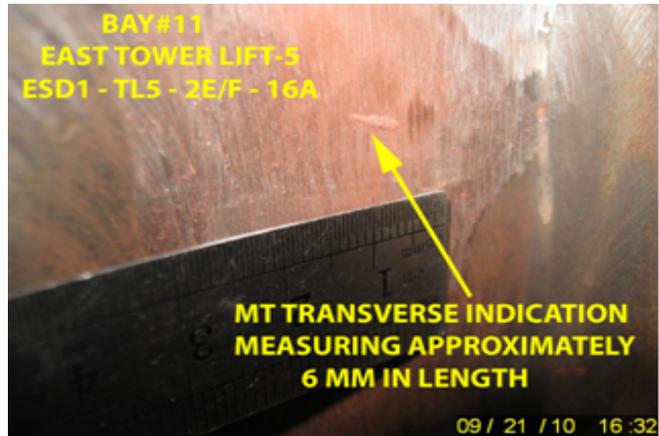
During Magnetic Particle Testing (MT) review of welds on grillage assembly of East Tower Lift-5, this Quality Assurance Inspector (QA) discovered the following issues:

- Transverse linear crack measuring approximately 6 mm in length.
- The member is identified as Grillage Plate.
- The weld is identified as ESD1-TL5-2E/F #16A.
- The weld is a Complete Joint Penetration (CJP) T-joint joining the Longitudinal grillage stiffener to Transverse grillage stiffener.
- The member is Non-Seismic Performance critical Member (SPCM).
- The member is located in Tower fabrication Bay # 11.

The Notice of Witness Inspection Number (NWIT) is 06730. The indication is located within the area that has been previously tested and accepted by ZPMC Quality Control (QC) personnel. As per the contract documents, ZPMC's QC personnel are required to perform 100% MT inspection of these welds.

AWS D1.5 (02) Section 6.26.2 – “Welds that are subject to MT in addition to visual inspection shall have no cracks.

Reference Resolution: ZPMC repaired this indication immediately after it was found by grinding.

ZPMC repaired this indication immediately after it was found by grinding. The weld was then tested at the same time using MT and found to be free of defect by both ZPMC and the Department. Based on this immediate action and acceptable NDT results after, ZPMC requests closure of this NCR.

Contractor repaired the indication by grinding immediately after CT tested, and provided the NDT documentation to prove the indication have been removed satisfactorily.
