QUALITY ASSURANCE -- NON-CONFORMANCE REPORT

Report No: NCR-000847

NCR #: ZPMC-0809

Reference Description: QA found a missed MT transverse crack after ZPMC had tested and accepted the weld in the Bikepath

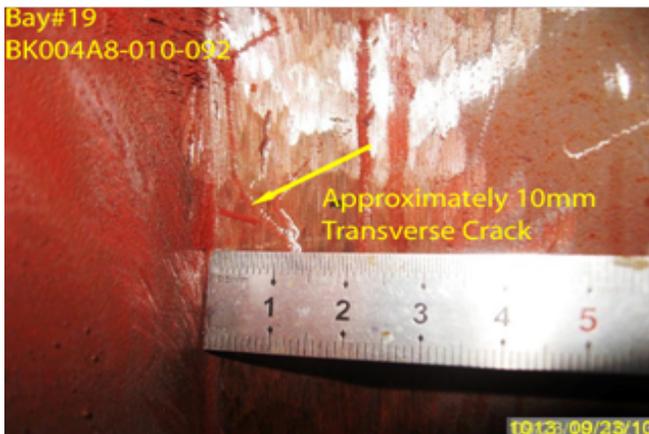
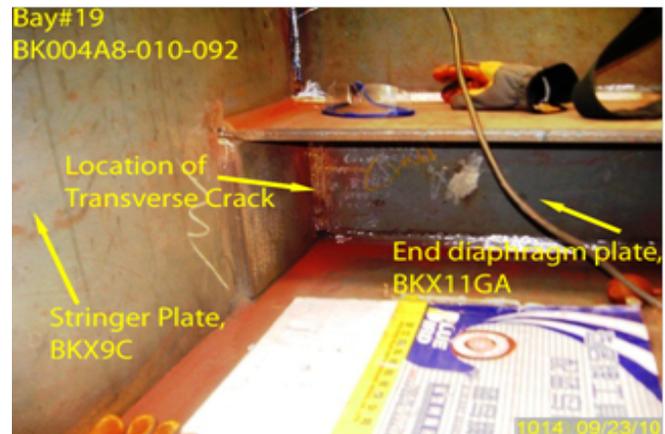
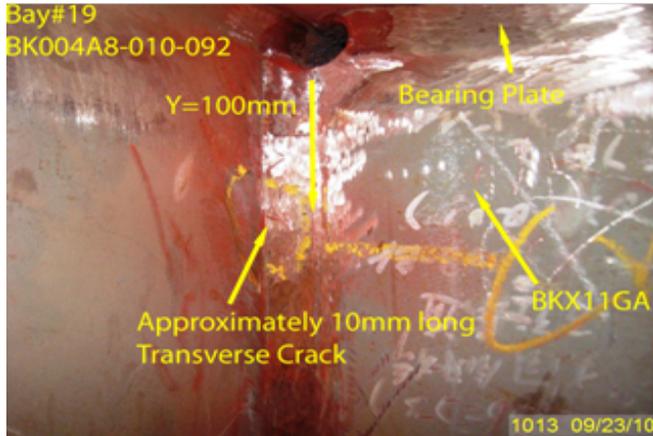
During the Quality Assurance (QA) Magnetic particle Testing (MT) review of welds located on OBG Bike path BK004A-010, this QA Inspector discovered the following issue:

- One transverse crack that measured approximately 10mm in length.
- The weld is identified as BK004A8-010-092.
- The weld is a Partial joint penetration (PJP) T joint, joining the Stringer plate (BKX9C) to the End diaphragm plate (BKX11GA).
- The Y Location is 100mm from the bearing plate.
- The OBG Bike path is located in BAY#19.
- This crack is clearly marked on the material on/near the weld.
- This weld joint is designated as Non-Seismic performance critical (Non-SPCM) weld member.
- The Notice of Witness Inspection Number (NWIT) is 006731.
- The crack is located within the area that has been re-tested and accepted by ZPMC Quality Control (QC) subsequent to the heat straightening procedure.

AWS D1.5 (02) Section 6.26.2 – “Welds that are subject to MT in addition to visual inspection shall have no cracks.

Contractor repaired and provided acceptable NDT records to close the issues. The proposed resolution is acceptable. This NCR is closed.

ZPMC acknowledged the indication was missed and has issued an internal NCR to address this problem. ZPMC has repaired the indication and is providing the NDT record to show the acceptance of this weld. Based on this, ZPMC is requesting closure of this NCR.

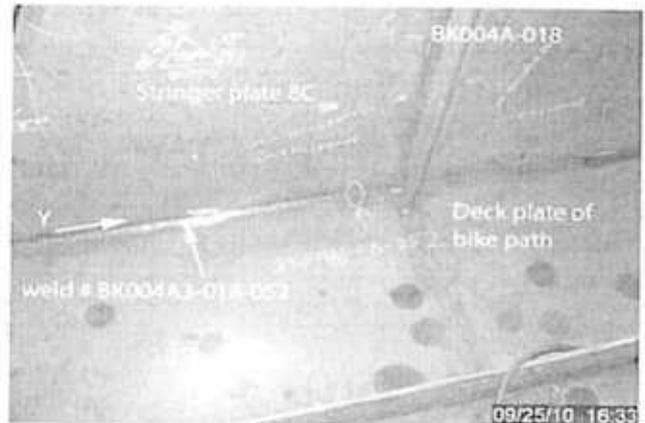
Reference Description: QA found a missed MT transverse crack and MT longitudinal crack after ZPMC had tested and accepted the welds in Bikepath Assembly

- One Longitudinal linear crack in the weld measuring approximately 15mm in length.
- The weld is identified as BK004A6-008-080.
- The weld is partial joint penetration (PJP), joining the End Diaphragm plate identified as BKX11G to the Deck Plate identified as BKPL1A.
- This weld joint is designated as Non-Seismic performance critical (Non-SPCM) weld member.
- The crack is clearly marked on the material near the weld.
- The OBG Bike Path 008 is located in Bay #19.

- One (1) transverse crack found on the weld measuring approximately 6mm in length.
- Y location of the indication is measured to be 2160mm.
- The crack is clearly marked on the weld joint.
- The weld is identified as: BK004A3-018-052.
- The Weld is a fillet weld joining the stringer plate (8C) to the deck plate of bike path.
- The member is located in bay 11.

AWS D1.5 (02) Section 6.26.2 – "Welds that are subject to MT in addition to visual inspection shall have no cracks."
