Contract #: 04-0120F4Cty: SF/ALA Rte: 80 PM: 13.2/13.9File #: 69.25B**QUALITY ASSURANCE -- NON-CONFORMANCE REPORT****Location:** Changxing Island, Shanghai, P.R. China**Report No:** NCR-000848**Prime Contractor:** American Bridge/Fluor Enterprises, a JV**Date:** 23-Sep-2010**Submitting Contractor:** Zhenhua Port Machinery Company, Ltd (ZPMC), Changxing Island**NCR #:** ZPMC-0810**Type of problem:**

Reference Description: Missed UT Indication: North Tower Lift 5**Description of Non-Conformance:**

QUALITY ASSURANCE -- NON-CONFORMANCE REPORT

Job Name: SAS Superstructure
Document No: 05.03.06-000804

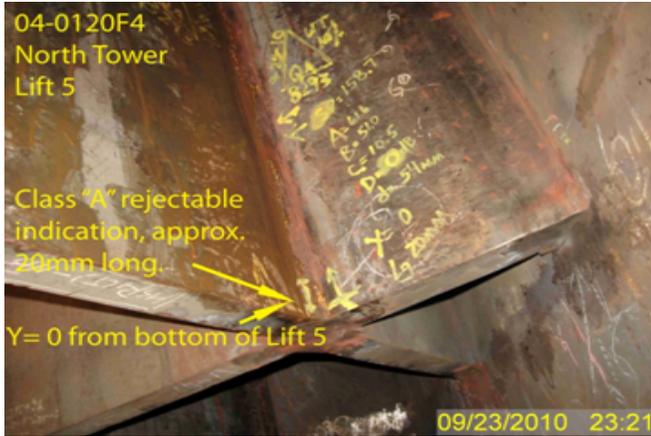
- One (1) UT indication measuring approximately 20mm in length, bottom quarter.
- The indication dB rating is a 0 dB.
- The Y distance for this indication is 0 mm from bottom of Transverse grillage plate.
- Material thickness is 65mm.
- The depth of the indication is approximately 54mm.
- The weld is identified as NSD1-TL5-3F-F-28B.
- The weld is a complete joint penetration T-joint weld.
- The indication is clearly marked on or near the weld.
- North Tower Lift 5 is located in Bay 10.

The Notice of Witness Inspection (NWIT) No. is 006751. The indication is located in an area previously tested and accepted by ZPMC Quality Control (QC) personnel. As per the contract documents, ZPMC's QC personnel are required to perform one hundred (100%) percent UT inspection of this weld.

AWS D1.5-02 Section 6; Table 6.3 specifies a class "A" indication as having a rating of +1db and lower for material thicknesses >60mm through 100mm. Table 6.2 specifies 70 degree testing angle for bottom quarter of the weld.

Reference Resolution: ZPMC has repaired the indication noted in the NCR and is providing NDT documentation after the repair to show the indication has been removed.

ZPMC has repaired the indication noted in the NCR and is providing NDT documentation after the repair to show the indication has been removed. ABFJV has noted which inspector was responsible for this missed indication and is monitoring his performance as well as all inspector performance, if he continues to miss indications disciplinary action will be undertaken. Based on these actions, ZPMC requests closure of this NCR.
