DEPARTMENT OF TRANSPORTATION

Contract #: 04-0120F4Cty: SF/ALA Rte: 80 PM: 13.2/13.9File #: 69.25B**QUALITY ASSURANCE -- NON-CONFORMANCE REPORT****Location:** Changxing Island, Shanghai, P.R. China**Report No:** NCR-000851**Prime Contractor:** American Bridge/Fluor Enterprises, a JV**Date:** 27-Sep-2010**Submitting Contractor:** Zhenhua Port Machinery Company, Ltd (ZPMC), Changxing Island**NCR #:** ZPMC-0813**Type of problem:**

Reference Description: Excessive heat was utilized during heat straightening of the top anchorage plate stiffener

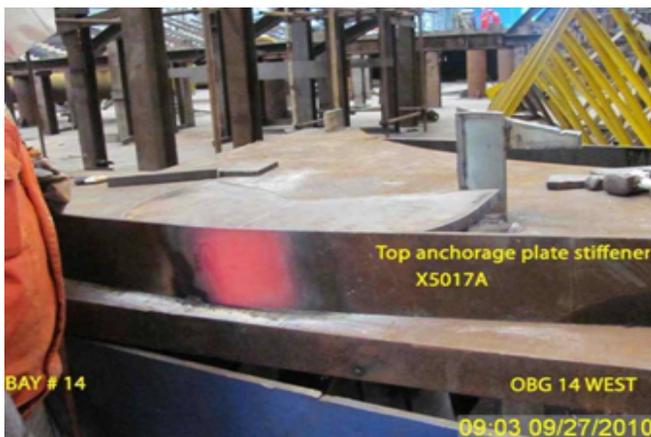
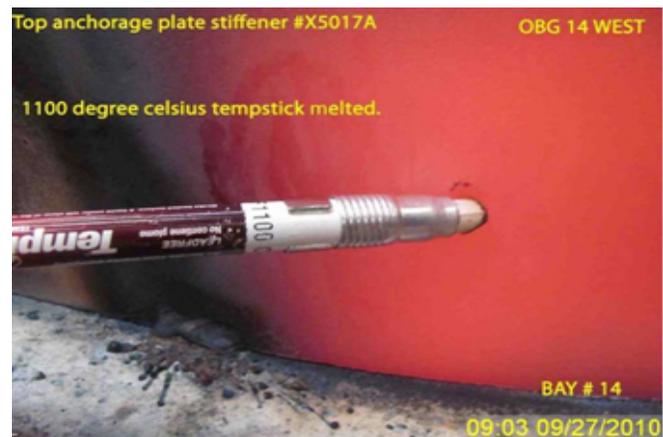
- ZPMC personnel performing hot bending on the top anchorage plate stiffener identified as X5017A.
- This QA Inspector observed the 1100°C Tempstick was melted when struck against the red base metal.
- The material was heated to a bright red condition and the temperature is above 1100°C.
- Thickness of the stiffener measured 14mm.
- This stiffener in OBG Fabrication Bay #14.

AWS D1.5 2002; 3.7.3 - Members distorted by welding shall be straightened by mechanical means or by carefully supervised application of a limited amount of localized heat as approved by the Engineer. The temperature of the heated areas as measured by approved methods shall not exceed 600C for quenched and

tempered steel nor 650C for other steels.

AASHTO 2004; 11.4.3.3.3 Hot-Bending

If a radius shorter than the minimum specified for cold-bending is essential, the plates shall be bent hot at a temperature not greater than 1200°F (650°C).

Reference Resolution: ZPMC acknowledges that this piece was overheated. This piece has been rejected by ZPMC and will not be used.

Contractor rejected the material and will re-fabricate a new piece. This NCR is closed.

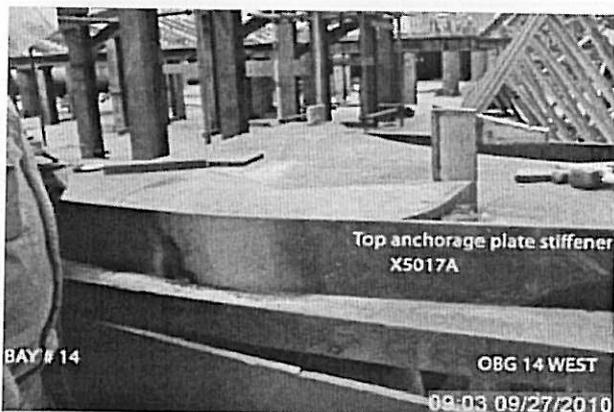
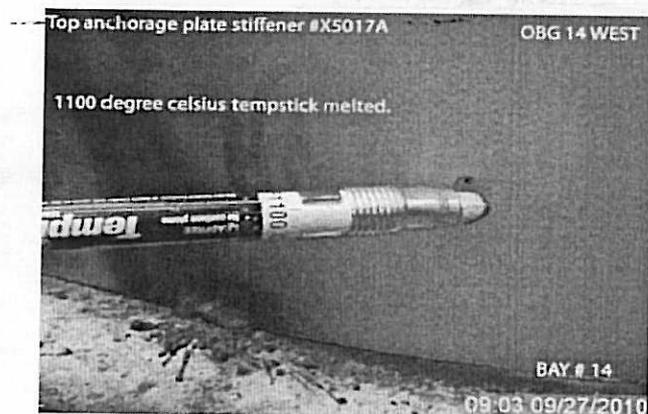
- ZPMC personnel performing hot bending on the top anchorage plate stiffener identified as X5017A.
- This QA Inspector observed the 1100°C Tempstick was melted when struck against the red base metal.
- The material was heated to a bright red condition and the temperature is above 1100°C.
- Thickness of the stiffener measured 14mm.
- This stiffener in OBG Fabrication Bay #14.

AWS D1.5 2002; 3.7.3 - Members distorted by welding shall be straightened by mechanical means or by carefully supervised application of a limited amount of localized heat as approved by the Engineer. The temperature of the heated areas as measured by approved methods shall not exceed 600C for quenched and

tempered steel nor 650C for other steels.

AASHTO 2004; 11.4.3.3.3 Hot-Bending

If a radius shorter than the minimum specified for cold-bending is essential, the plates shall be bent hot at a temperature not greater than 1200°F (650°C).

Reject the material and re-fabricate a new piece.
