Contract #: 04-0120F4Cty: SF/ALA Rte: 80 PM: 13.2/13.9File #: 69.25B**QUALITY ASSURANCE -- NON-CONFORMANCE REPORT****Location:** Changxing Island, Shanghai, P.R. China**Report No:** NCR-000852**Prime Contractor:** American Bridge/Fluor Enterprises, a JV**Date:** 01-Oct-2010**Submitting Contractor:** Zhenhua Port Machinery Company, Ltd (ZPMC), Changxing Island**NCR #:** ZPMC-0814**Type of problem:**

Reference Description: Contractor performed CJP welding on Bikepath without following the D1.5 requirements (No run-off tap, improper fit-up)

Dear: Mr. Charles Kanapicki
Job Name: SAS Superstructure

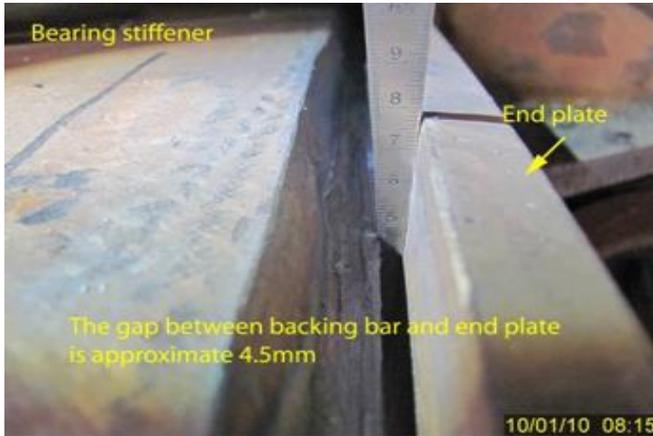
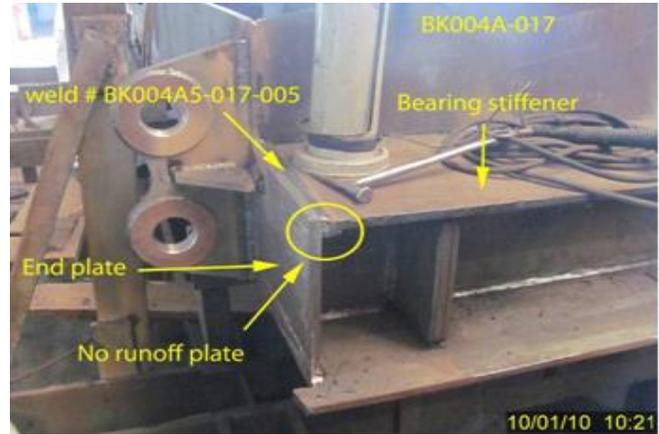
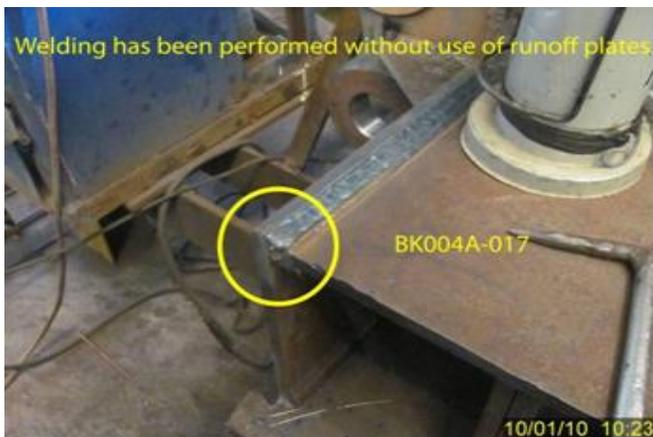
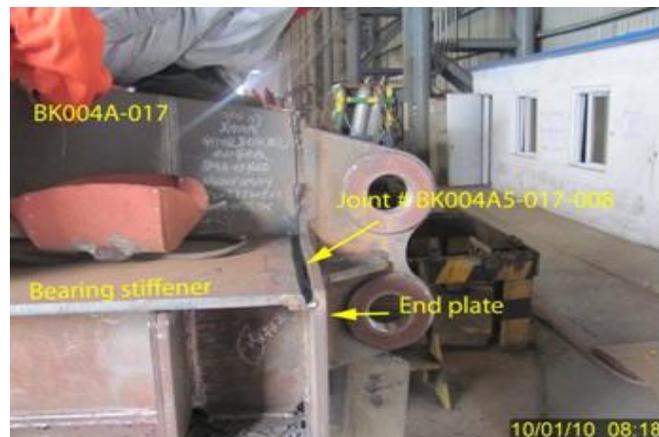
- The welding has been performed without the use of runoff plates.
- The welds are Complete Joint Penetration (CJP) with steel backing joining the Bearing Plate (BKPL7A/B) and end plate (BKPL3A/B).
- The welds are identified as: BK004A5-017-005 and BK004A3-017-002.

- Steel backing that was tacked on the bearing plate (horizontal plate) was not properly "placed and held in intimate contact" with the end plate.
- The maximum gap between the steel backing and end plate is over 4mm.
- The weld is Complete Joint Penetration (CJP) with steel backing joining the Bearing Plate (BKPL7B) and End Plate (BKPL3B) of bike path.
- The weld is identified as: BK004A5-017-008.

-AWS D1.5 (02) Section 3.12.1 – “Welds shall be terminated at the end of a joint in a manner that will ensure sound welds. Whenever possible, this shall be done by use of weld tabs (extension bars and runoff plates) placed in a manner that will duplicate the joint detail being welded.”

-AWS D1.5 (02) Section 3.13.5 – “Steel backing shall be placed and held in intimate contact with the base metal. The maximum gap between steel backing and the base metal at the weld root shall be 2 mm [U16 in.]”

Please propose a resolution for the identified non-conformance with revised procedures to prevent future occurrences. A response for the resolution of these issues is expected within 7 days.

ZPMC has discussed this issue with the Production personnel to ensure they understand the requirements of runoff tabs and backing bars. In addition, ZPMC has written an internal NCR regarding this to make this non conformance known. As this has not occurred widespread in the project, ZPMC is confident that this will non conformance will be resolved. Based on this ZPMC requests closure of this NCR.

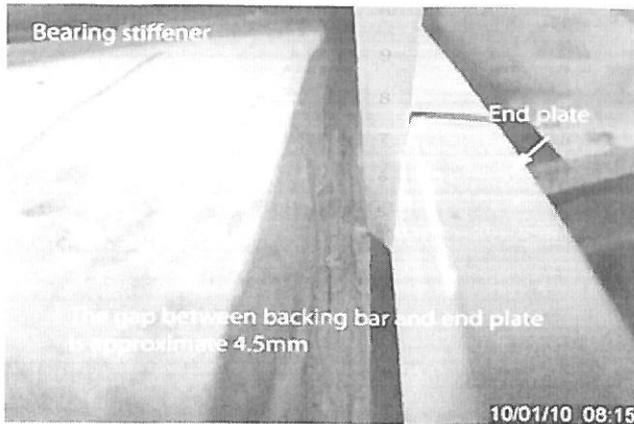
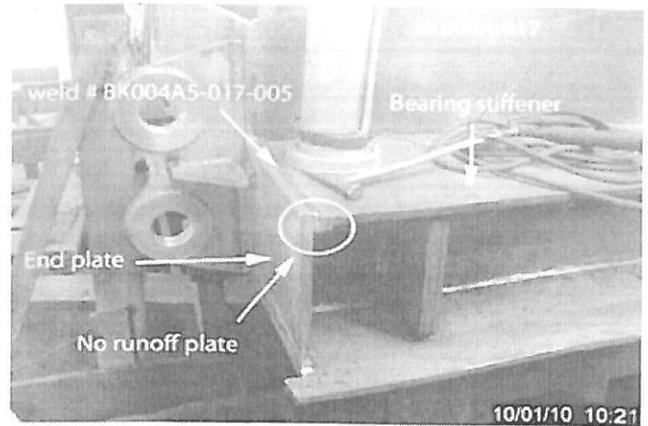
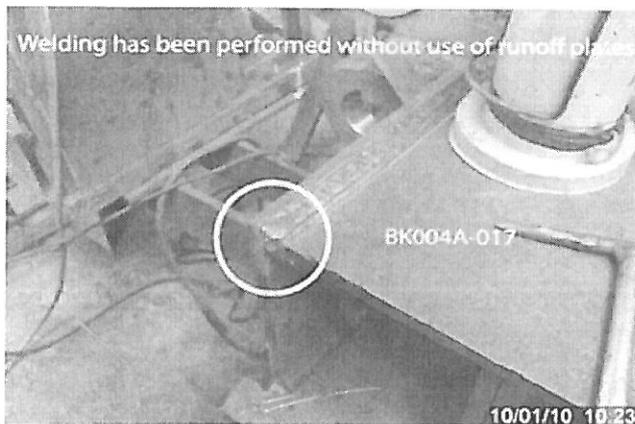
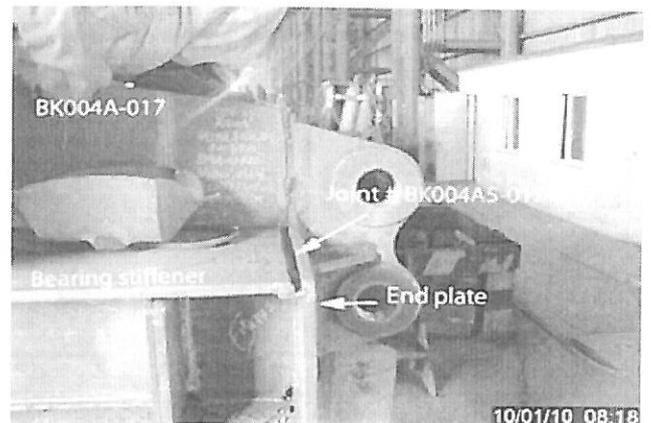
-The welding has been performed without the use of runoff plates.

-The welds are identified as: BK004A5-017-005 and BK004A3-017-002.

-Steel backing that was tacked on the bearing plate (horizontal plate) was not properly "placed and held in intimate contact" with the end plate.

-The maximum gap between the steel backing and end plate is over 4mm.

-The weld is identified as: BK004A5-017-008.

-AWS D1.5 (02) Section 3.12.1 – “Welds shall be terminated at the end of a joint in a manner that will ensure sound welds. Whenever possible, this shall be done by use of weld tabs (extension bars and runoff plates) placed in a manner that will duplicate the joint detail being welded.”

-AWS D1.5 (02) Section 3.13.5 – “Steel backing shall be placed and held in intimate contact with the base metal. The maximum gap between steel backing and the base metal at the weld root shall be 2 mm [U16 in.]”

Contractor discussed with the Production personnel to ensure that they understand the requirements of runoff tabs and backing bars. Contractor issued an internal NCR to the inspector involved.
