Contract #: 04-0120F4  
 Cty: SF/ALA Rte: 80 PM: 13.2/13.9  
 File #: 69.25B

## QUALITY ASSURANCE -- NON-CONFORMANCE REPORT

**Report No:** NCR-000855

**Reference Description:** East and North Shaft at 119m: Skin E - Fit Lug removal without Engineer's approval

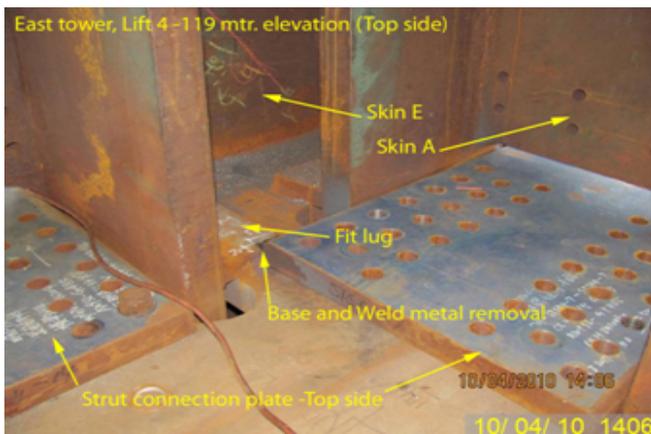
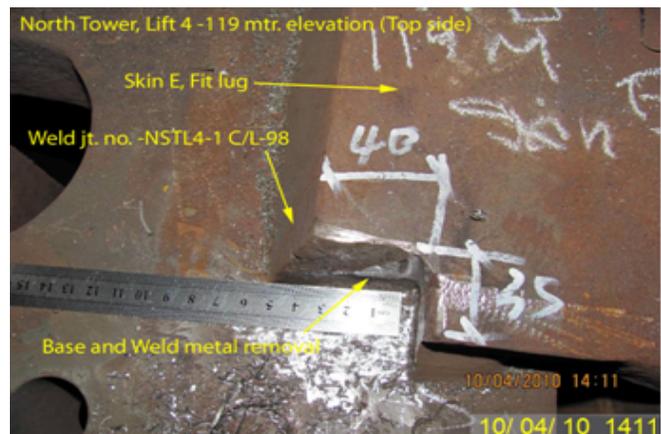
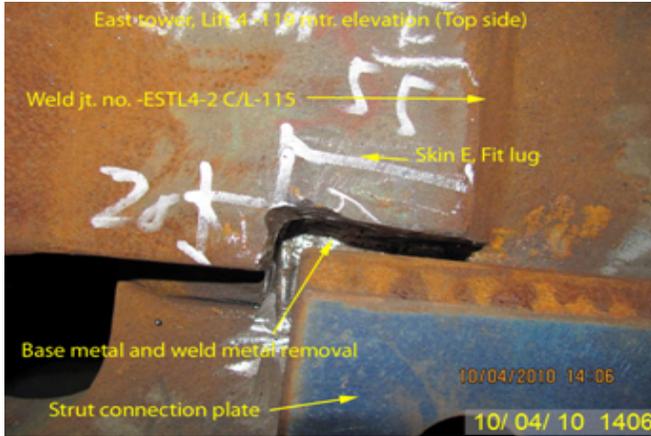
-Approx. 55 mm length, 25 mm width, weld metal and base metal removal observed in Skin E, fit lug weld without Engineer's approval.

-The fit lug found in East Tower, Lift 4- 119m top diaphragm.

-The weld joint no. of the fit lug weld found to be ESTL4-2 C/L-115.

-Approx. 50 mm length, 35 mm width, weld metal and base metal removal observed in Skin E, fit lug weld without engineer's approval.

-The fit lug found in North Tower, Lift 4- 119m top diaphragm.

-The weld joint no. of the fit lug weld found to be NSTL4-1 C/L-98.

This proposed resolution is accepted with action pending. The retrofit work per TC-RFI 0166 for the fit lug on the North Shaft shall be completed and related NDT reports for Weld No. NSTL4-1C/L-98 submitted and reviewed.

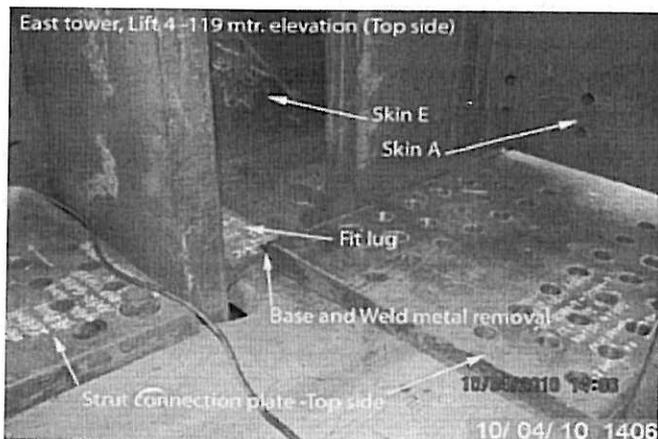
-Approx. 55 mm length, 25 mm width, weld metal and base metal removal observed in Skin E, fit lug weld without Engineer's approval.

-The fit lug found in East Tower, Lift 4- 119m top diaphragm.

-The weld joint no. of the fit lug weld found to be ESTL4-2 C/L-115.

-Approx. 50 mm length, 35 mm width, weld metal and base metal removal observed in Skin E, fit lug weld without engineer's approval.

-The fit lug found in North Tower, Lift 4- 119m top diaphragm.

-The weld joint no. of the fit lug weld found to be NSTL4-1 C/L-98.
