Contract #: 04-0120F4Cty: SF/ALA Rte: 80 PM: 13.2/13.9File #: 69.25B**QUALITY ASSURANCE -- NON-CONFORMANCE REPORT****Location:** Changxing Island, Shanghai, China**Report No:** NCR-000857**Prime Contractor:** American Bridge/Fluor Enterprises, a JV**Date:** 06-Oct-2010**Submitting Contractor:** Zhenhua Port Machinery Company, Ltd (ZPMC), Changxing Island**NCR #:** ZPMC-0819**Type of problem:**

Reference Description: Base Metal Repair and inadequate preheat on CB18 Anchor Seat Plates**Description of Non-Conformance:**

Subject: NCR No. ZPMC-0819

Contract #: 04-0120F4Cty: SF/ALA Rte: 80 PM: 13.2/13.9File #: xx.25A**QUALITY ASSURANCE -- NON-CONFORMANCE RESOLUTION****Location:** Changxing Island, Shanghai, China**Report No:** NCS-000870**Prime Contractor:** American Bridge/Fluor Enterprises, a JV**Date:** 01-Nov-2010**Submitting Contractor:** Zhenhua Port Machinery Company, Ltd (ZPMC), Changxing Island **NCR #:** ZPMC-0819**Type of problem:**

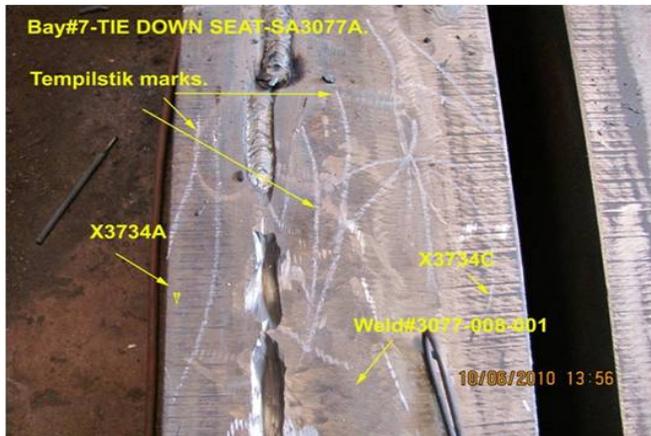
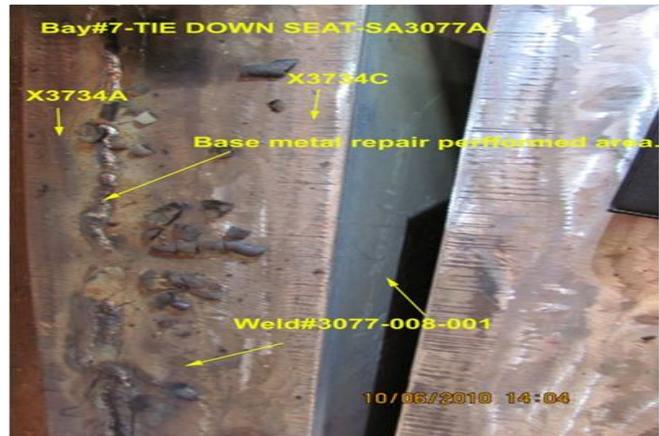
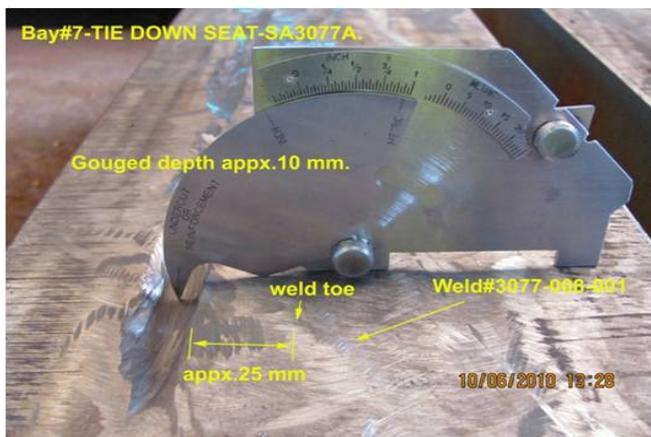
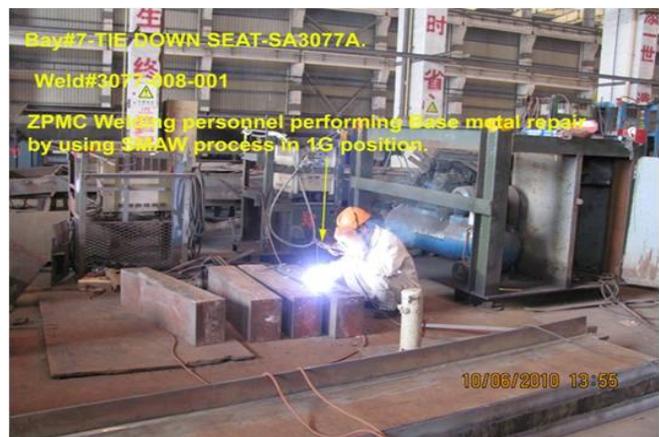
- ZPMC Welding personnel performing base metal repair (BMR) on the top bearing plate without the Engineer's approval.
- Base metal depth of excavation, as measured by this QA is approximately 10 mm.

- Additionally, welding was being performed without sufficient preheat.
- This QA Inspector observed a 100 degree Celsius Tempilstik temperature indicator mark applied to the adjacent base material within approximately 30mm from the point of welding did not melt.

- As per the applicable WPS No: 345-SMAW-1G (1F) Repair, required min temperature is 200 degree Celsius.
- The welding was being performed using Shielded Metal Arc Welding (SMAW) in the flat (1G) position.

- The Top Bearing plate is identified as X3734A.
- The nearest weld is identified as SA3077-008-001.
- The Y location is approximately 25 mm from the above mentioned weld toe.

- The Tie Down Seat Bearing plate's material thickness is 100 mm.
- CB18 Tie Down Seat SA3077A is located in the Sub assembly Bay#7.

For additional information, please see the attached pictures below.

Reference Resolution: ZPMC Production acknowledges that the temperature was not sufficient, in order to resolve this and show the weld is acceptable ZPMC is providing NDT of the weld.

The weld has been accepted with NDT verification. This NCR is closed.

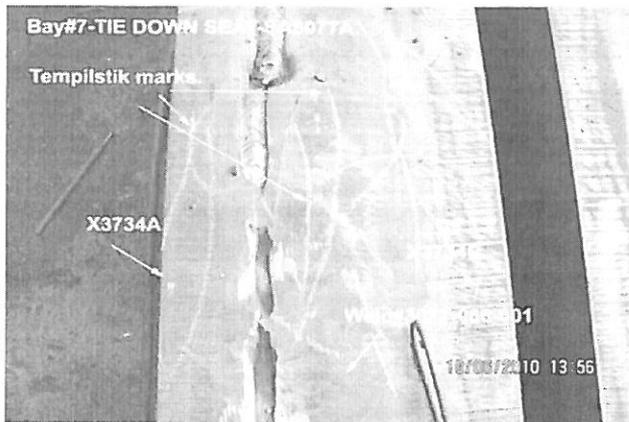
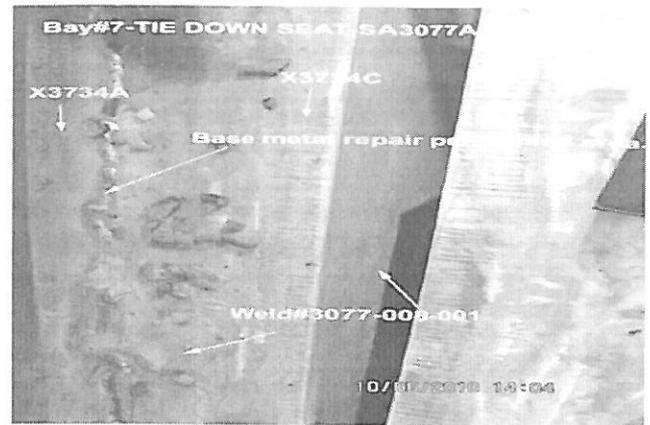
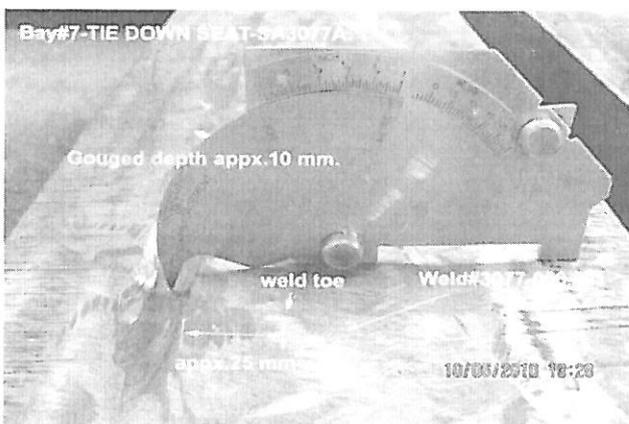
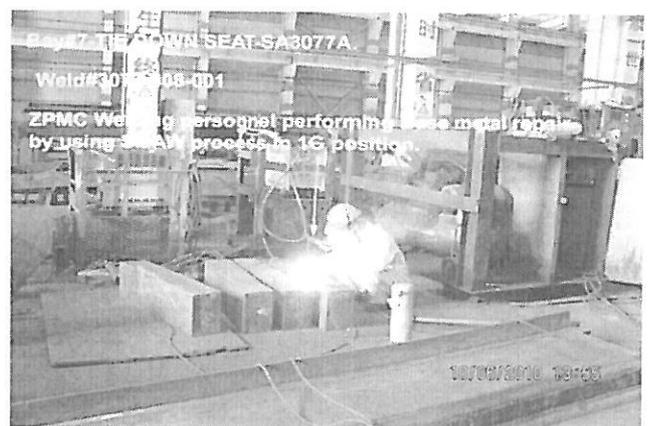
-Additionally, welding was being performed without sufficient preheat.

-This QA Inspector observed a 100 degree Celsius Tempilstik temperature indicator mark applied to the adjacent base material within approximately 30mm from the point of welding did not melt.

-As per the applicable WPS No: 345-SMAW-1G (1F) Repair, required min temperature is 200 degree Celsius.

-The welding was being performed using Shielded Metal Arc Welding (SMAW) in the flat (1G) position.

-The Top Bearing plate is identified as X3734A.

Contractor will provide NDT report of the weld to prove the weld is still acceptable. Contractor will issue an internal NCR to notify the workers to avoid similar issue for future occurrences.

Contractor provided NDT report to prove the weld is acceptable. Contractor also issued an internal NCR to the workers.
