Contract #: 04-0120F4Cty: SF/ALA Rte: 80 PM: 13.2/13.9File #: 69.25B**QUALITY ASSURANCE -- NON-CONFORMANCE REPORT****Location:** Changxing Island, Shanghai, P.R. China**Report No:** NCR-000858**Prime Contractor:** American Bridge/Fluor Enterprises, a JV**Date:** 10-Oct-2010**Submitting Contractor:** Zhenhua Port Machinery Company, Ltd (ZPMC), Changxing Island**NCR #:** ZPMC-0820**Type of problem:**

Reference Description: QA found 2 missed UT indications after ZPMC had tested and accepted these weld in bikepath assembly BK004A5

NON-CONFORMANCE REPORT TRANSMITTAL

NCR PROPOSED RESOLUTION

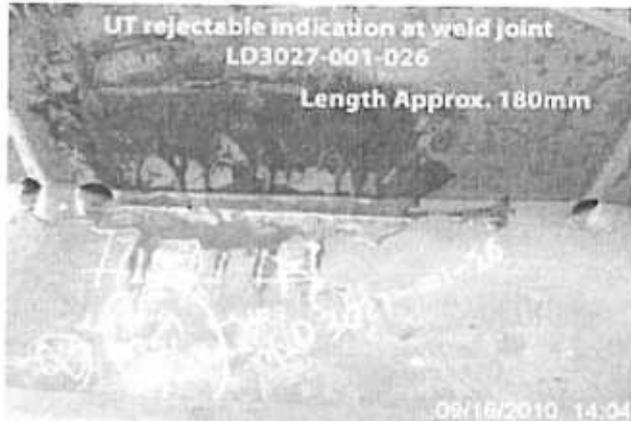
During the Quality Assurance (QA) Ultrasonic Testing (UT) review of welds located on Orthotropic Box Girder (OBG) segment 13BE and 13CE, this QA Inspector discovered the following issues:

- Three (3) longitudinal linear class "A" rejectable indications measuring approximately 180mm~260mm in length.
- The welds are identified as LD3028-001-031, LD3027-001-026 and LD3030-001-053.

- Material thickness for all joints is 30mm.
- The indication db rating for joint LD3028-001-031 is a +6.
- The indication db rating for joint LD3027-001-026 is a +4.

- The indication db rating for joint LD3030-001-053 is a +5.
- The depth of the indications are from 20mm~23mm deep.
- The Weld LD3028-001-031 is joining longitudinal diaphragm (X3682A) to lifting Lug.

- The Weld LD3027-001-026 is joining longitudinal diaphragm (X3684B) to lifting Lug.
- The Weld LD3030-001-053 is joining longitudinal diaphragm (X3685A) to lifting Lug.

AWS D1.5-02 Section 6; Table 6.3 specifies a class "A" indication as having a rating of 8d and under for material thicknesses 21mm through 38mm.

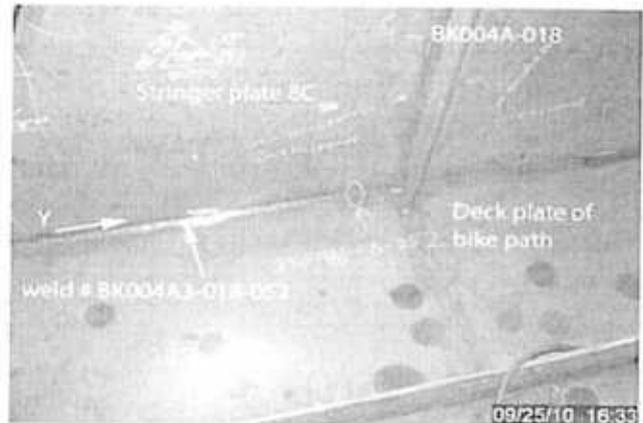
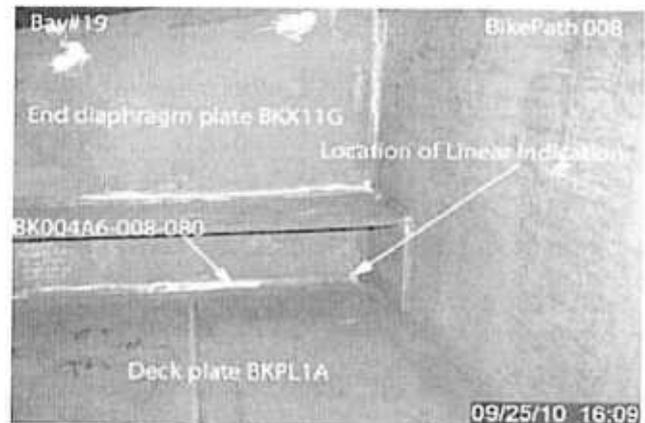
- One Longitudinal linear crack in the weld measuring approximately 15mm in length.
- The weld is identified as BK004A6-008-080.
- The weld is partial joint penetration (PJP), joining the End Diaphragm plate identified as BKX11G to the Deck Plate identified as BKPL1A.
- This weld joint is designated as Non-Seismic performance critical (Non-SPCM) weld member.
- The crack is clearly marked on the material near the weld.
- The OBG Bike Path 008 is located in Bay #19.

- One (1) transverse crack found on the weld measuring approximately 6mm in length.
- Y location of the indication is measured to be 2160mm.
- The crack is clearly marked on the weld joint.
- The weld is identified as: BK004A3-018-052.
- The Weld is a fillet weld joining the stringer plate (8C) to the deck plate of bike path.
- The member is located in bay 11.

AWS D1.5 (02) Section 6.26.2 – "Welds that are subject to MT in addition to visual inspection shall have no cracks."

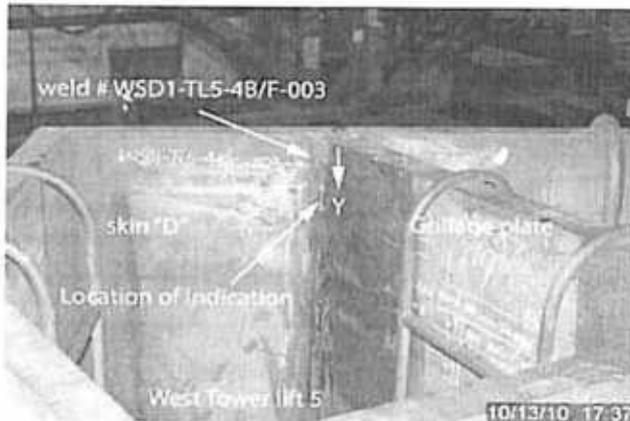
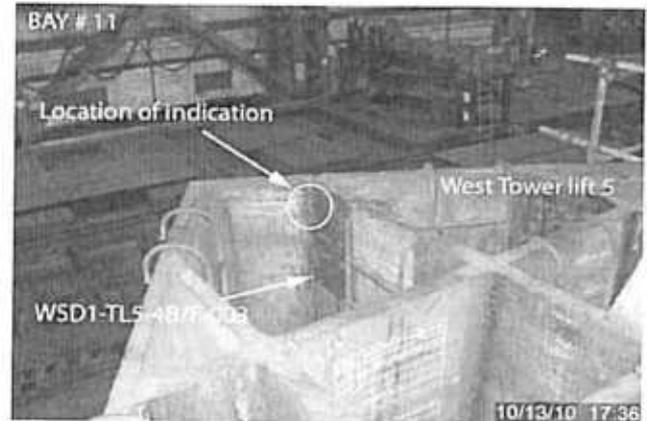
AWS D1.5-02 Section 6.6.2 "The Contractor shall be responsible for visual inspection and NDT described in 6.7 and necessary correction of all deficiencies in materials and workmanship in conformance with the requirements of Clause 3 and 6.26 and as specified elsewhere in the contract documents."

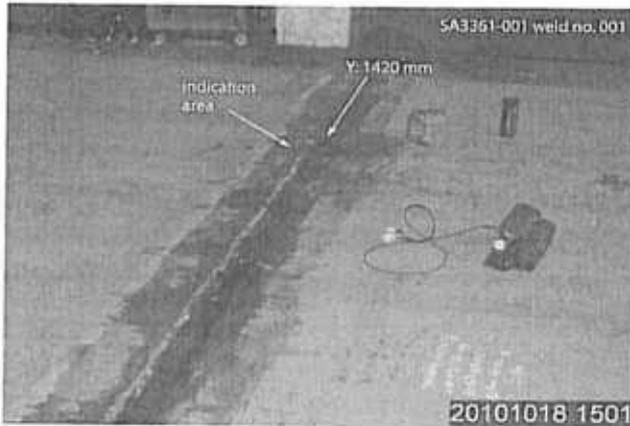
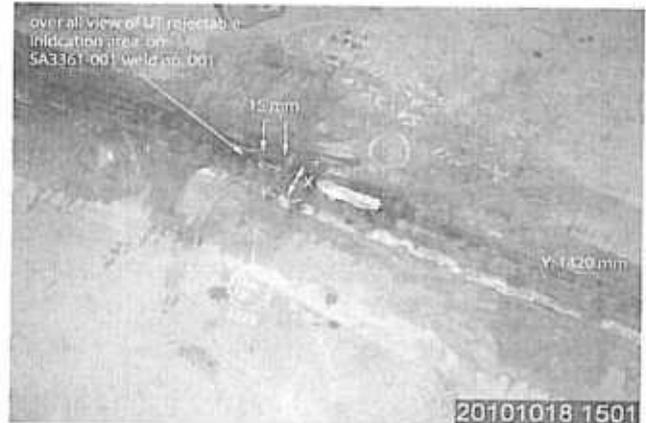
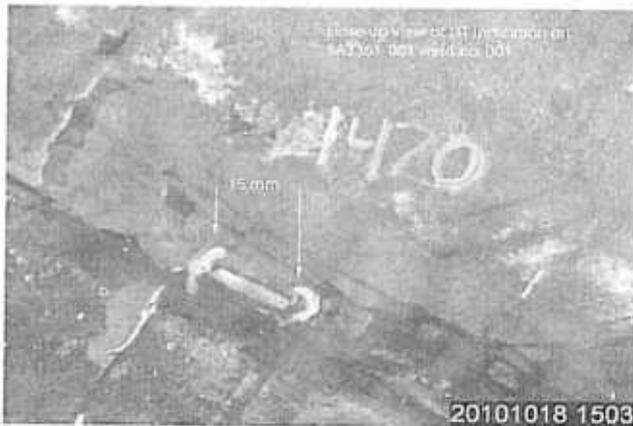
Special Provisions Section 8.3 – “Quality Control (QC) shall be the responsibility of the Contractor. As a minimum, the Contractor shall perform inspection and testing of each weld joint prior to welding, during welding, and after welding as specified in this section and to ensure that materials and workmanship conform to the requirements of the contract documents.”

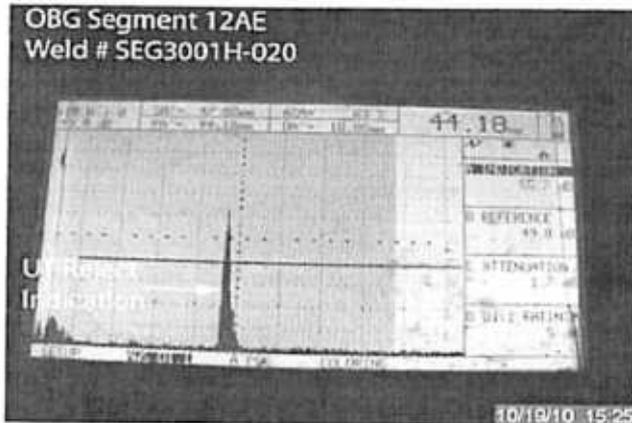
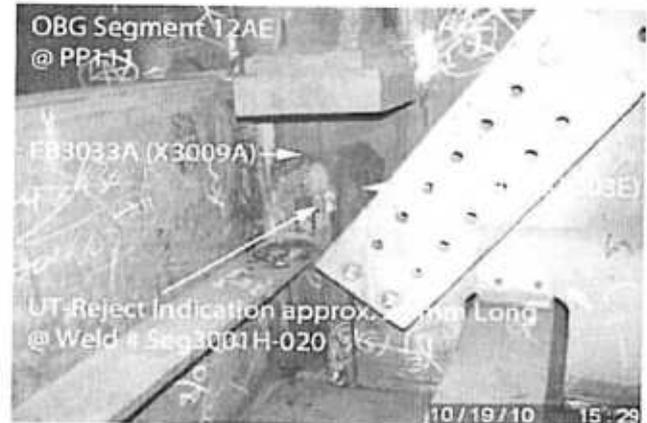
-AWS D1.5-2002, Section 6, Table 6.3; "Specifies a class A indication as having a dBs rating of +8 and lower for weld thicknesses 21mm through 38mm."
