Contract #: 04-0120F4Cty: SF/ALA Rte: 80 PM: 13.2/13.9File #: xx.25B**QUALITY ASSURANCE -- NON-CONFORMANCE REPORT****Location:** Changxing Island, Shanghai, China**Report No:** NCR-000860**Prime Contractor:** American Bridge/Fluor Enterprises, a JV**Date:** 11-Oct-2010**Submitting Contractor:** Zhenhua Port Machinery Company, Ltd (ZPMC), Changxing Island**NCR #:** ZPMC-0822**Type of problem:****Welding****Concrete****Other****Welding****Curing****Procedural****Bridge No:** 34-0006**Joint fit-up****Coating****Other****Component:** FB3286A, SA8003 Lift 14E**Procedural****Procedural****Description:****Reference Description:** Base Metal Repair without Prior Approval from Engineer**Description of Non-Conformance:**

Job Name: SAS Superstructure

Subject: NCR No. ZPMC-0822

Reference Description: Base Metal Repair without Prior Approval from Engineer

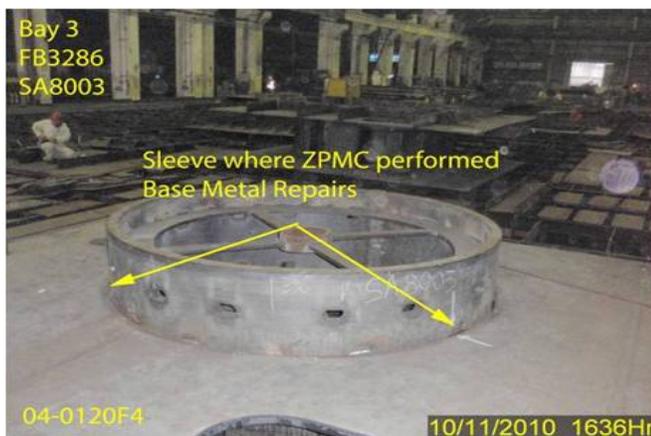
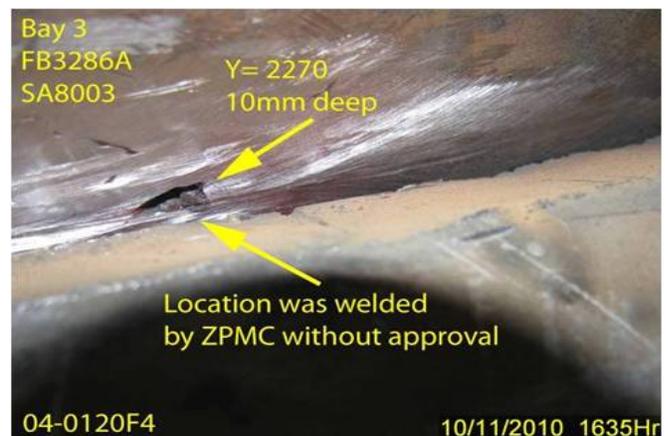
During Quality Assurance random in-process observations of the fabrication of OBG lift 14, East Floorbeam FB3286A, this Quality Assurance Inspector (QA) discovered the following issue:

- ZPMC Welding personnel performed base metal repair (BMR) on the sleeve plate without the Engineers approval.
- Total of 2 areas repaired.
- The welding was performed using Shielded Metal Arc Welding (SMAW) in the Horizontal (2G) position.
- The sleeve plate is identified as SA8003.
- The Y locations are approximately 2270 mm and 5150mm from the toe of the weld identified as SA8003-001-001(measured clock wise and looking from top of the sleeve).
- FB3286A –SA8003 is located in the Sub assembly Bay#3.

Reference Resolution: ZPMC has repaired the base metal repairs using and approved CWR and is providing the NDT done after to show the repair was free of defect.

ZPMC provided a Critical Weld Repair (CWR) Report for Engineer's approval subsequently. The performed repair was done according to the CWR report with NDT verification. The proposed resolution is acceptable. This NCR is closed.

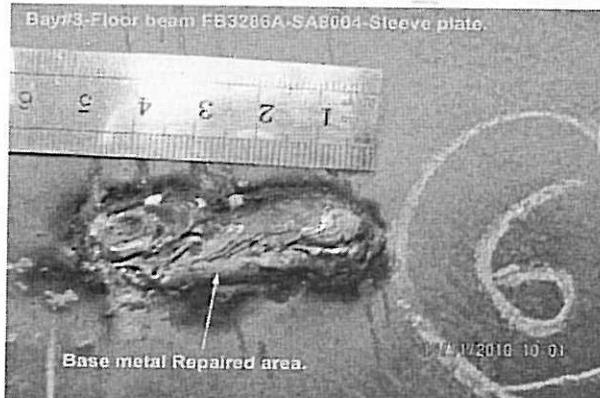
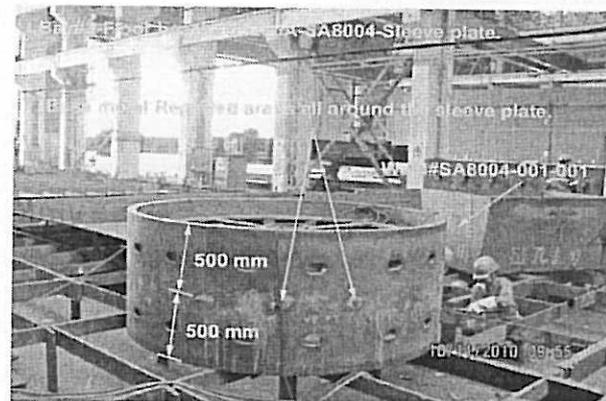
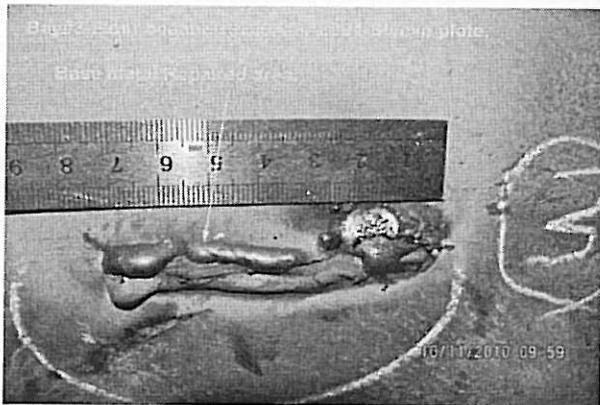
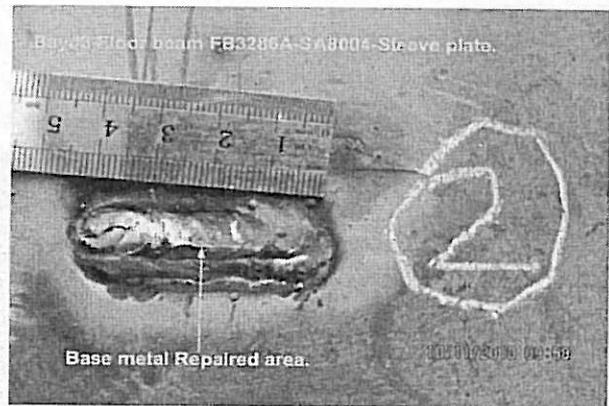
During Quality Assurance random in-process observations of the fabrication of OBG lift 14E, East Floor beam FB3286A, this Quality Assurance Inspector (QA) discovered the following issue:

- ZPMC Welding personnel performed base metal repair (BMR) on the sleeve plate without the Engineers approval.
- Total of 7 areas repaired.
- The welding was performed using Shielded Metal Arc Welding (SMAW) in the Horizontal (2G) position.
- The sleeve plate is identified as SA8004.
- The Y locations are approximately 410 mm, 1375 mm, 1810 mm, 3750 mm, 4630 mm, 5120 mm and 7180 mm from the toe of the weld identified as SA8004-001-001 (measured clock wise and looking from top of the sleeve).
- FB3286A – SA8004 is located in the Sub assembly Bay#3.

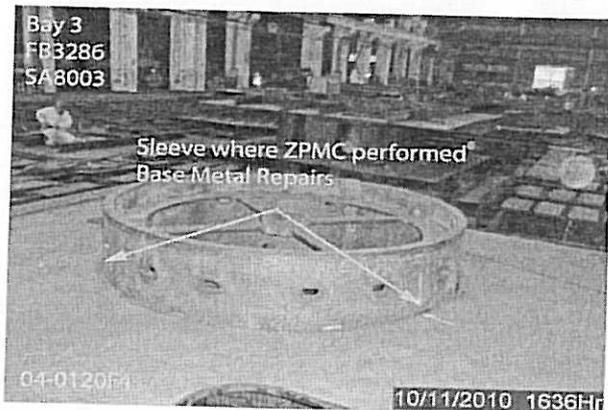
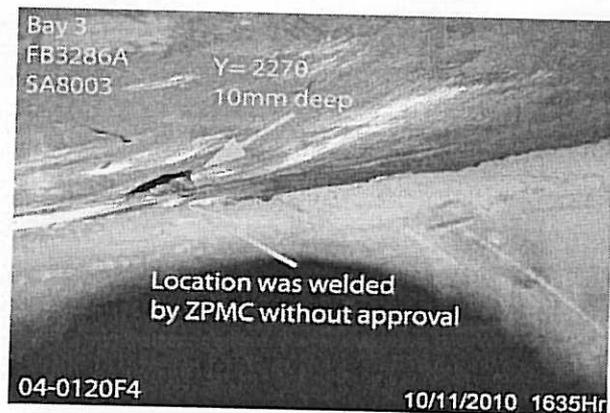
During Quality Assurance random in-process observations of the fabrication of OBG lift 14, East Floorbeam FB3286A, this Quality Assurance Inspector (QA) discovered the following issue:

-ZPMC Welding personnel performed base metal repair (BMR) on the sleeve plate without the Engineers approval.

- Total of 2 areas repaired.

-The welding was performed using Shielded Metal Arc Welding (SMAW) in the Horizontal (2G) position.

-The sleeve plate is identified as SA8003.

-The Y locations are approximately 2270 mm and 5150mm from the toe of the weld identified as SA8003-001-001 (measured clock wise and looking from top of the sleeve).

- FB3286A -SA8003 is located in the Sub assembly Bay#3.

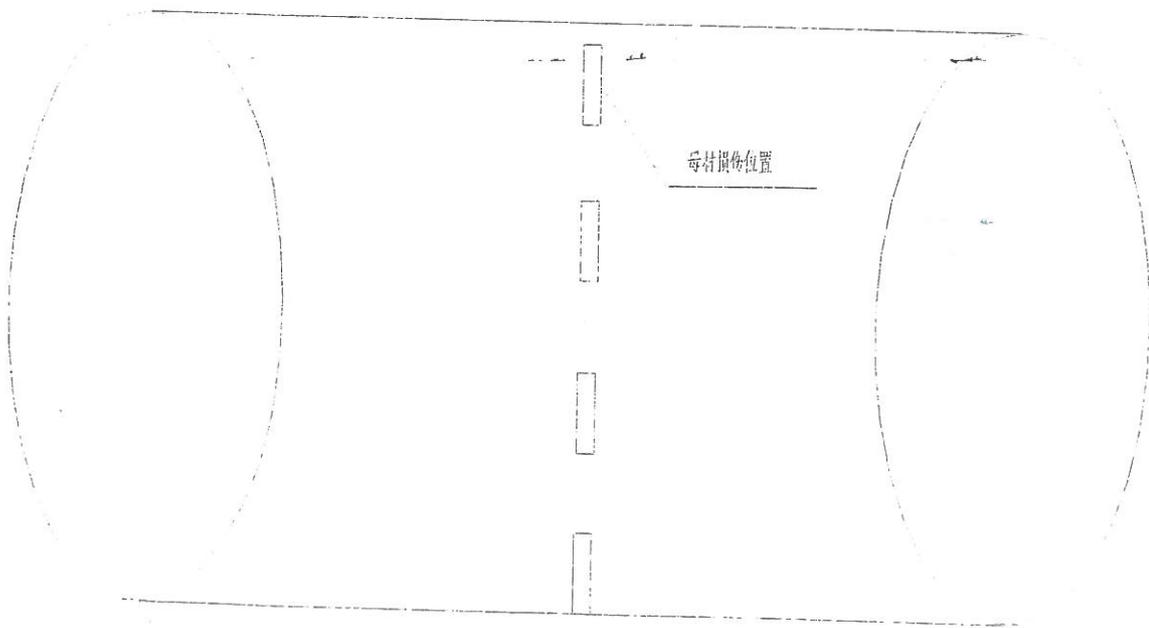
Draft of welding discontinuity:

When removing tack weld of SA8003(X8005A/X8006A)、SA8004(X8005B/X8006B), base metal was damaged by 10mm due to incorrect gouging, which need repairing. Please see the details in the following sketch.

Worker operated error caused base metal gouged.

1. QC and CWI should be present to witness the repair, direct and supervise all repair operations during this repair to ensure the repair is per the disposition requirements, and the AWS D1.5 code requirements.
2. Grind the repair area to a smooth finish according to the approved repair WPS.
3. Prepare the joint according to the approved WPS.
4. Notify QA verbally prior to NDT. Perform 100%MT and 100%VT of the repair area.
5. Remove all defects by grinding to ensure all defects are completely removed if defects still exist, and repeat "step 4" to assure complete removal of all defects if necessary.
6. Clean the repair area of all loose debris including MT powder.
7. Preheat and weld according to the approved WPS.
8. Grind the weld flush after welding.
9. Notify QA verbally prior to NDT. Perform 100%MT and 100%VT of the repair area.

Train and educate operator to improve operation skill.
