Contract #: 04-0120F4
 Cty: SF/ALA Rte: 80 PM: 13.2/13.9
 File #: 69.25B

QUALITY ASSURANCE -- NON-CONFORMANCE REPORT

Report No: NCR-000861

Reference Description: Lift 5 West Shaft: Missed MT Crack at Skin D and Transverse Plate

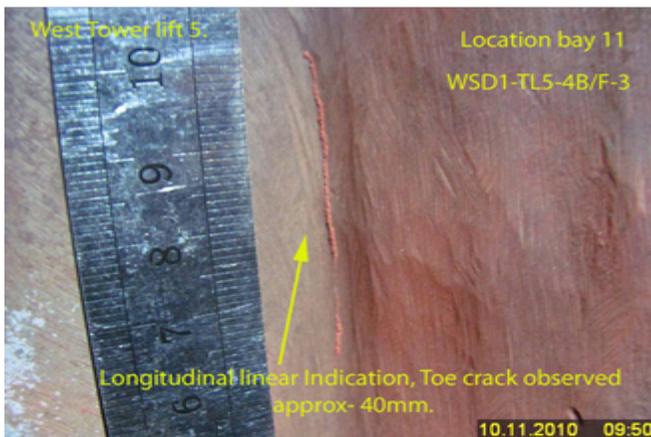
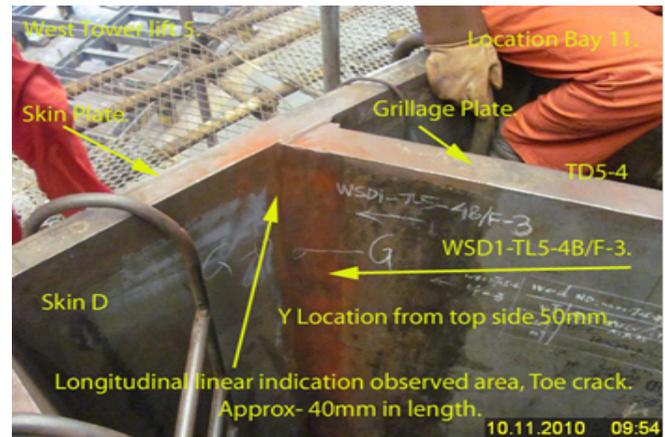
During the Quality Assurance (QA) Magnetic Particle Testing (MT) review of welds located in West Tower lift 5 Grillage plate, WSD1-TL5-4B/F-3, this Quality Assurance (QA) Inspector discovered the following issues:

- One longitudinal toe crack measuring approximately 40mm in length.
 - The weld is identified as: WSD1-TL5-4B/F-3.
 - The Weld is a Complete Joint Penetration (CJP) weld, joining the grillage plate to skin plate.
 - The material is Non Seismic Performance Critical Member (NON SPCM)
 - The member is located in Bay 11.
- The Notice of Witness Inspection Number (NWIT) is 06917. The indication is located on CJP weld area that has been previously tested and accepted by ZPMC Quality Control (QC) personnel. As per the contract documents, ZPMC's QC personnel are required to perform 100% MT inspection of this weld. The attached photographs provide additional detail.

AWS D1.5 2002 section 6.26.2 “Welds that are subject to RT or MT in addition to visual inspection shall have no cracks...”

This proposed resolution is acceptable. The documentation received is sufficient and the Department concurs that Non-Conformance ZPMC-0823 is closed.

ZPMC acknowledged the indication was missed and has issued an internal NCR to address this problem. ZPMC has repaired the indication and is providing the NDT record to show the acceptance of this weld. Based on this, ZPMC is requesting closure of this NCR.

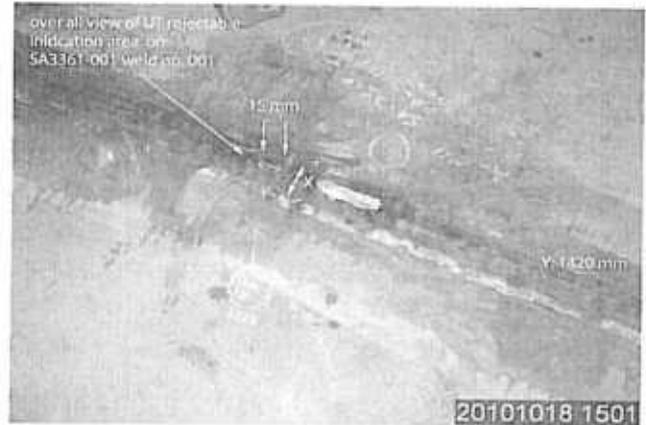
Special Provisions Section 8.3 – “Quality Control (QC) shall be the responsibility of the Contractor. As a minimum, the Contractor shall perform inspection and testing of each weld joint prior to welding, during welding, and after welding as specified in this section and to ensure that materials and workmanship conform to the requirements of the contract documents.”
