Contract #: 04-0120F4Cty: SF/ALA Rte: 80 PM: 13.2/13.9File #: 69.25B**QUALITY ASSURANCE -- NON-CONFORMANCE REPORT****Location:** Changxing Island, Shanghai, P.R. China**Report No:** NCR-000862**Prime Contractor:** American Bridge/Fluor Enterprises, a JV**Date:** 13-Oct-2010**Submitting Contractor:** Zhenhua Port Machinery Company, Ltd (ZPMC), Changxing Island**NCR #:** ZPMC-0824**Type of problem:**

Reference Description: Missed UT Indication: West Lift 5 Grillage Plate**Description of Non-Conformance:**

Job Name: SAS Superstructure

Subject: NCR No. ZPMC-0824

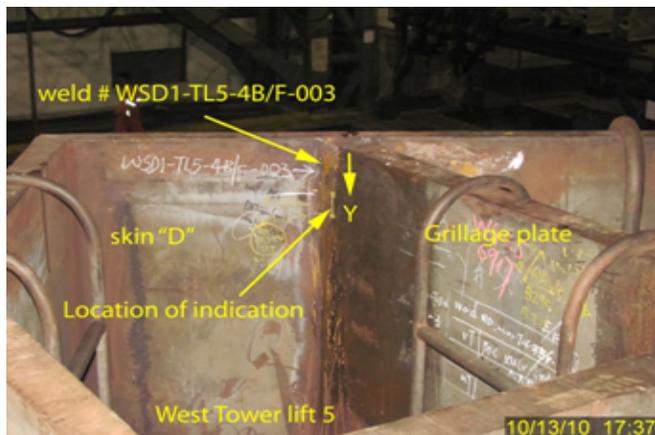
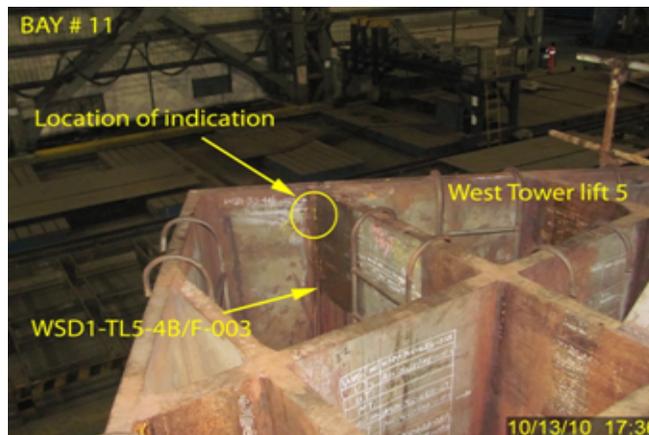
During the Quality Assurance Ultrasonic Testing (UT) verification of welds located on grillage plate of West Tower lift 5, this Quality Assurance (QA) Inspector discovered the following issues:

- One class "A" longitudinal indication measuring approximately 50mm in length.
- The depth of the indication is 57mm.
- The db rating is -2.
- The material thickness is 65mm.
- The weld is identified as: WSD1-TL5-4B/F-003.
- The Weld is a Complete Joint Penetration (CJP) with steel backing, T-joint, joining the grillage plate to the skin plate (skin "D").
- The "Y" location of the indication is 110mm from top side
- The indication is clearly marked on the component.
- The member is located in Bay 11.

The Notice of Witness Inspection Number (NWIT) is 06938. The indication is located inside the area that has been previously tested and accepted by ZPMC Quality Control (QC) personnel. As per the contract documents, ZPMC's QC personnel are required to perform 100% UT inspection of this weld.

- Attached photographs provide additional location details.

AWS D1.5-02 Table 6.3 Specifies a class A indication for material thicknesses between 60mm and 100mm as having a dbb rating of +1 and lower.

ZPMC acknowledged the indication was missed and has issued an internal NCR to address this problem. ZPMC has repaired the indication and is providing the NDT record to show the acceptance of this weld. Based on this, ZPMC is requesting closure of this NCR.

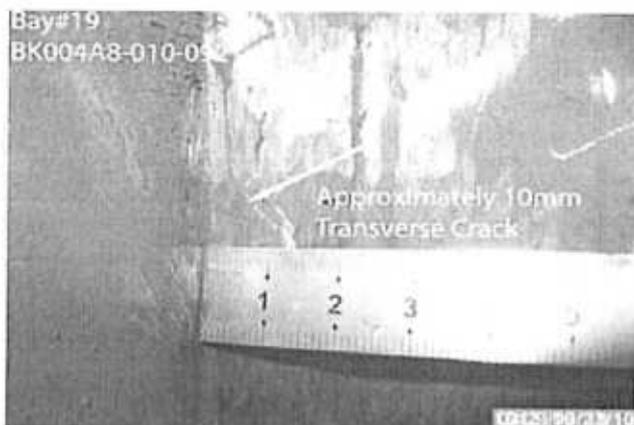
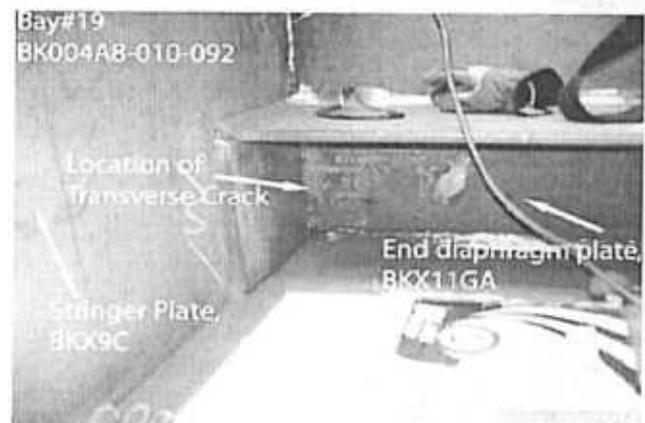
During the Quality Assurance (QA) Magnetic particle Testing (MT) review of welds located on OBG Bike path BK004A-010, this QA Inspector discovered the following issue:

- One transverse crack that measured approximately 10mm in length.
- The weld is identified as BK004A8-010-092.
- The weld is a Partial joint penetration (PJP) T joint, joining the Stringer plate (BKX9C) to the End diaphragm plate (BKX11GA).
- The Y Location is 100mm from the bearing plate.
- The OBG Bike path is located in BAY#19.
- This crack is clearly marked on the material on/near the weld.
- This weld joint is designated as Non-Seismic performance critical (Non-SPCM) weld member.
- The Notice of Witness Inspection Number (NWIT) is 006731.
- The crack is located within the area that has been re-tested and accepted by ZPMC Quality Control (QC) subsequent to the heat straightening procedure.

AWS D1.5 (02) Section 6.26.2 – "Welds that are subject to MT in addition to visual inspection shall have no cracks."

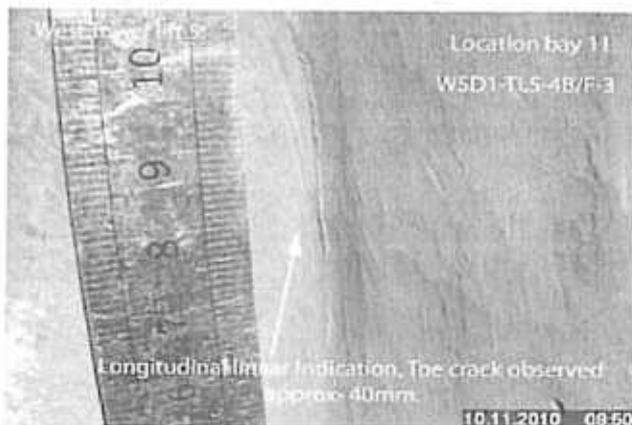
Reference Description: Lift 5 West Shaft: Missed MT Crack at Skin D and Transverse Plate

-One longitudinal toe crack measuring approximately 40mm in length.

-The Notice of Witness Inspection Number (NWIT) is 06917. The indication is located on CJP weld area that has been previously tested and accepted by ZPMC Quality Control (QC) personnel. As per the contract documents, ZPMC's QC personnel are required to perform 100% MT inspection of this weld. The attached photographs provide additional detail.

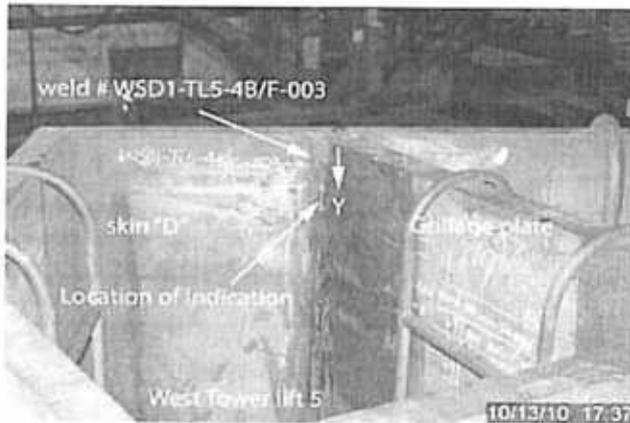
AWS D1.5-02 Section 6.6.2 "The Contractor shall be responsible for visual inspection and NDT described in 6.7 and necessary correction of all deficiencies in materials and workmanship in conformance with the requirements of Clause 3 and 6.26 and as specified elsewhere in the contract documents."

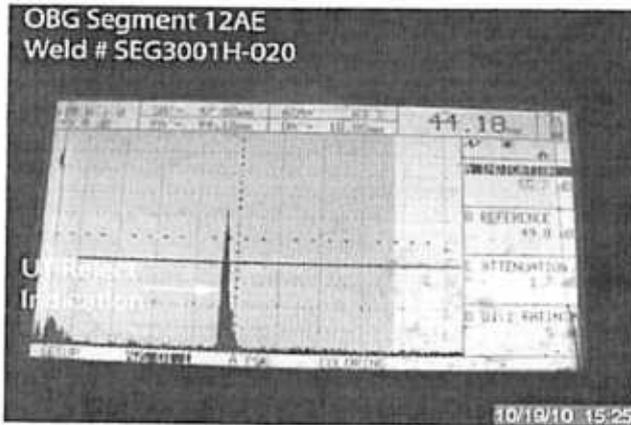
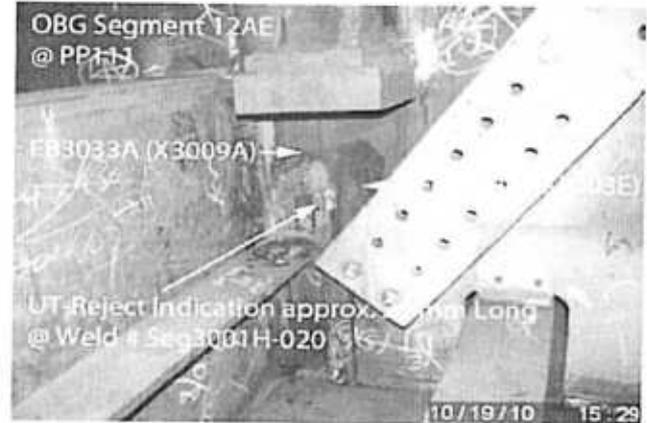
-AWS D1.5-2002, Section 6, Table 6.3; "Specifies a class A indication as having a dBs rating of +8 and lower for weld thicknesses 21mm through 38mm."

Contractor repaired the weld, and issued an internal NCR to the inspector. In addition, Contractor provided NDT report with acceptable results to the Department proving the weld now meets contract requirements.
