QUALITY ASSURANCE -- NON-CONFORMANCE REPORT

Location: Changxing Island, Shanghai, P.R. China**Report No:** NCR-000866**Prime Contractor:** American Bridge/Fluor Enterprises, a JV**Date:** 17-Oct-2010**Submitting Contractor:** Zhenhua Port Machinery Company, Ltd (ZPMC), Changxing Island**NCR #:** ZPMC-0828**Type of problem:**

Reference Description: QA found a missed UT indication after ZPMC had tested and accepted these weld in Segment 12AE Deck Panel Diaphragm

| Subject: | NCR No. ZPMC-0828 | Document No: | 05.03.06-000823 |

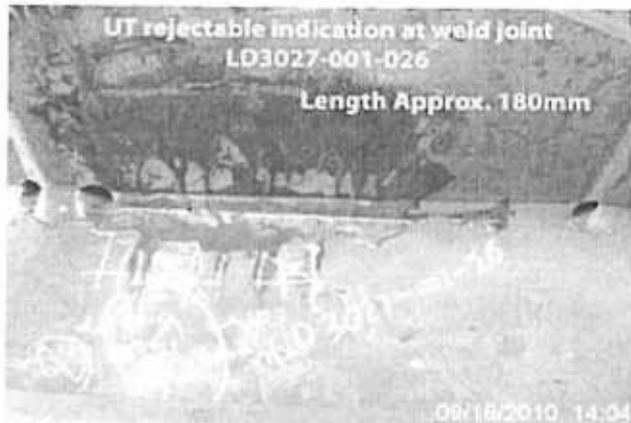
During the Quality Assurance (QA) Ultrasonic Testing (UT) review of welds located on Orthotropic Box Girder (OBG) segment 13BE and 13CE, this QA Inspector discovered the following issues:

- Three (3) longitudinal linear class "A" rejectable indications measuring approximately 180mm~260mm in length.
- The welds are identified as LD3028-001-031, LD3027-001-026 and LD3030-001-053.

- Material thickness for all joints is 30mm.
- The indication db rating for joint LD3028-001-031 is a +6.
- The indication db rating for joint LD3027-001-026 is a +4.

- The indication db rating for joint LD3030-001-053 is a +5.
- The depth of the indications are from 20mm~23mm deep.
- The Weld LD3028-001-031 is joining longitudinal diaphragm (X3682A) to lifting Lug.

- The Weld LD3027-001-026 is joining longitudinal diaphragm (X3684B) to lifting Lug.
- The Weld LD3030-001-053 is joining longitudinal diaphragm (X3685A) to lifting Lug.

- All Welds are Complete Joint Penetration (CJP) "T" joint.
- All welds are Seismic Performance Critical Members (SPCM).
- The Y distance for joint LD3028-001-031 is 110mm from bottom cope hole.

- The Y distance for joint LD3027-001-026 is 40mm from bottom cope hole.
- The Y distance for joint LD3030-001-053 is 700mm from bottom cope hole.
- The indications are clearly marked on or near the weld.

These welds were designated to be PJP welds and no UT is required. The NWIT were submitted due to the internal fault between the floor QC & NDT operator of ZPMC. ZPMC is providing the MT records to show the acceptance of these welds and is requesting closure of this NCR.

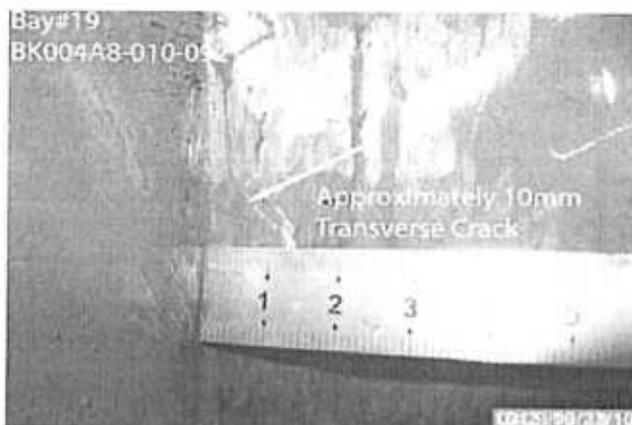
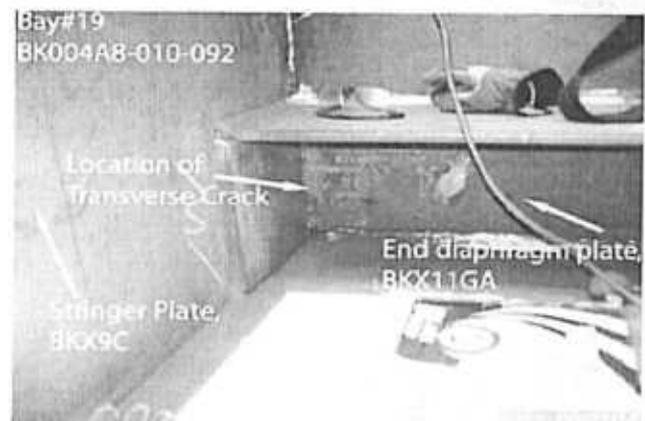
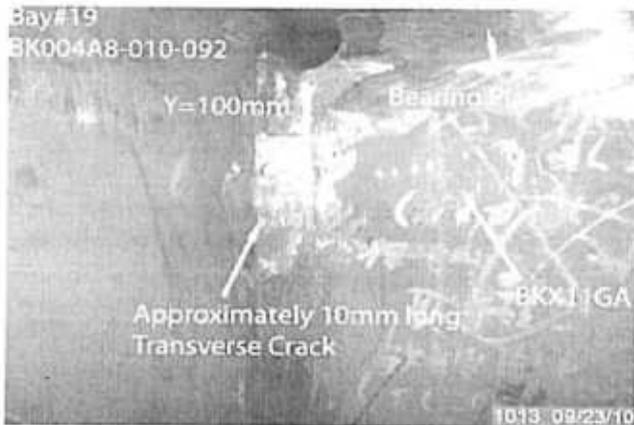
During the Quality Assurance (QA) Magnetic particle Testing (MT) review of welds located on OBG Bike path BK004A-010, this QA Inspector discovered the following issue:

- One transverse crack that measured approximately 10mm in length.
- The weld is identified as BK004A8-010-092.
- The weld is a Partial joint penetration (PJP) T joint, joining the Stringer plate (BKX9C) to the End diaphragm plate (BKX11GA).
- The Y Location is 100mm from the bearing plate.
- The OBG Bike path is located in BAY#19.
- This crack is clearly marked on the material on/near the weld.
- This weld joint is designated as Non-Seismic performance critical (Non-SPCM) weld member.
- The Notice of Witness Inspection Number (NWIT) is 006731.
- The crack is located within the area that has been re-tested and accepted by ZPMC Quality Control (QC) subsequent to the heat straightening procedure.

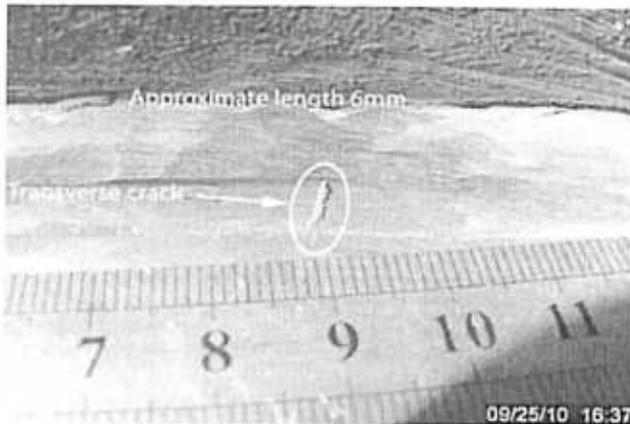
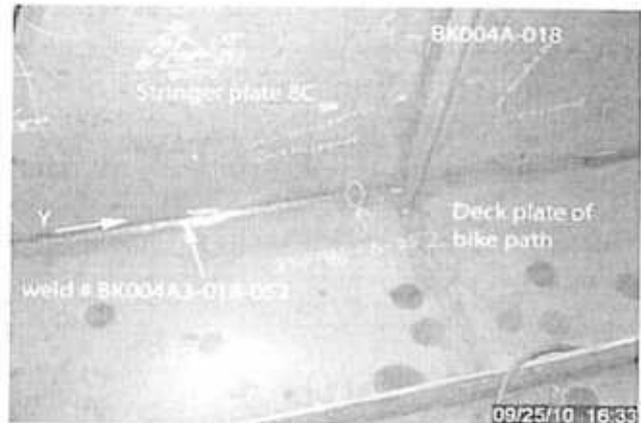
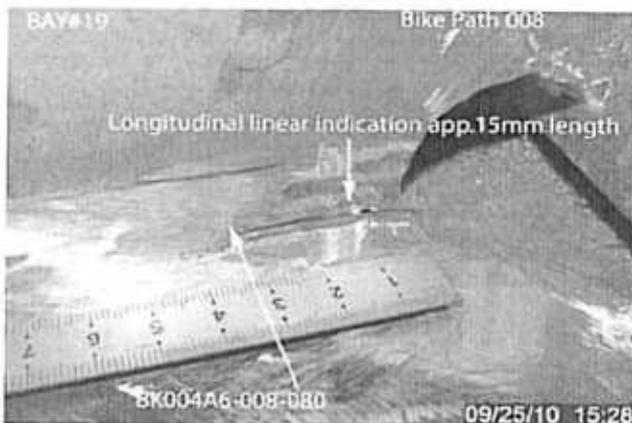
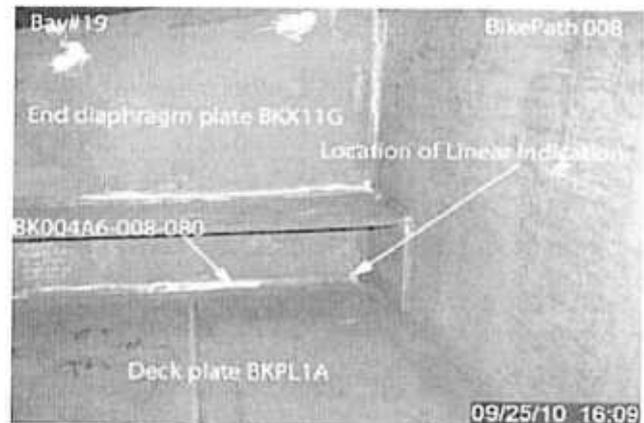
- One Longitudinal linear crack in the weld measuring approximately 15mm in length.
- The weld is identified as BK004A6-008-080.
- The weld is partial joint penetration (PJP), joining the End Diaphragm plate identified as BKX11G to the Deck Plate identified as BKPL1A.
- This weld joint is designated as Non-Seismic performance critical (Non-SPCM) weld member.
- The crack is clearly marked on the material near the weld.
- The OBG Bike Path 008 is located in Bay #19.

- One (1) transverse crack found on the weld measuring approximately 6mm in length.
- Y location of the indication is measured to be 2160mm.
- The crack is clearly marked on the weld joint.
- The weld is identified as: BK004A3-018-052.
- The Weld is a fillet weld joining the stringer plate (8C) to the deck plate of bike path.
- The member is located in bay 11.

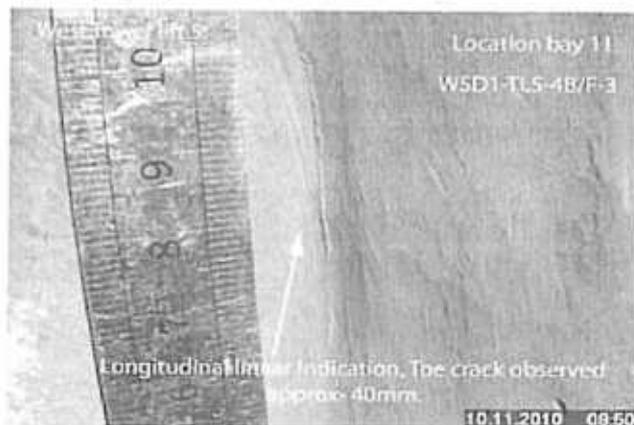
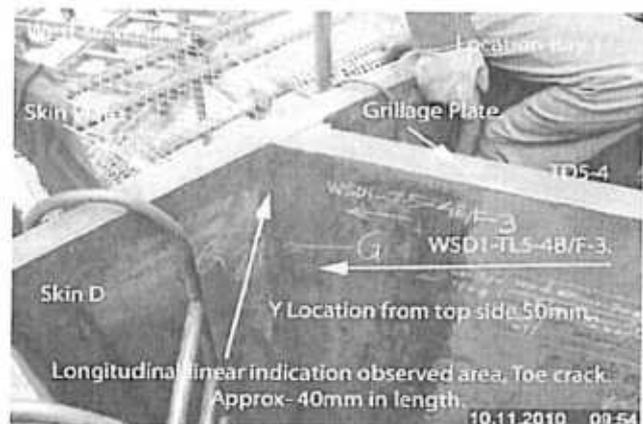
Reference Description: Lift 5 West Shaft: Missed MT Crack at Skin D and Transverse Plate

-One longitudinal toe crack measuring approximately 40mm in length.

-The Notice of Witness Inspection Number (NWIT) is 06917. The indication is located on CJP weld area that has been previously tested and accepted by ZPMC Quality Control (QC) personnel. As per the contract documents, ZPMC's QC personnel are required to perform 100% MT inspection of this weld. The attached photographs provide additional detail.
