Contract #: 04-0120F4  
 Cty: SF/ALA Rte: 80 PM: 13.2/13.9  
 File #: 69.25B

## QUALITY ASSURANCE -- NON-CONFORMANCE REPORT

**Report No:** NCR-000871

**Reference Description:** Excessive Root Gap on Fillet Welds

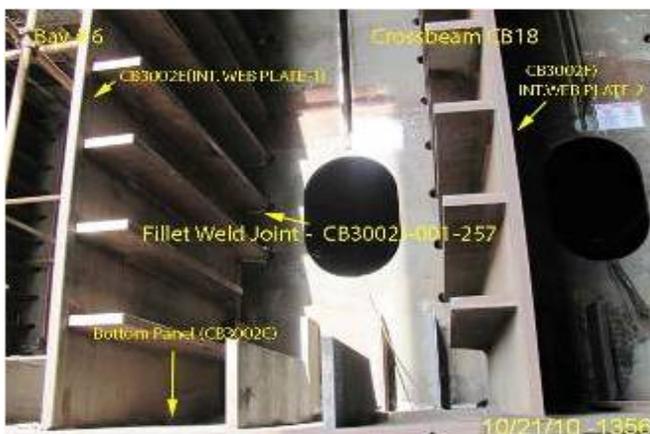
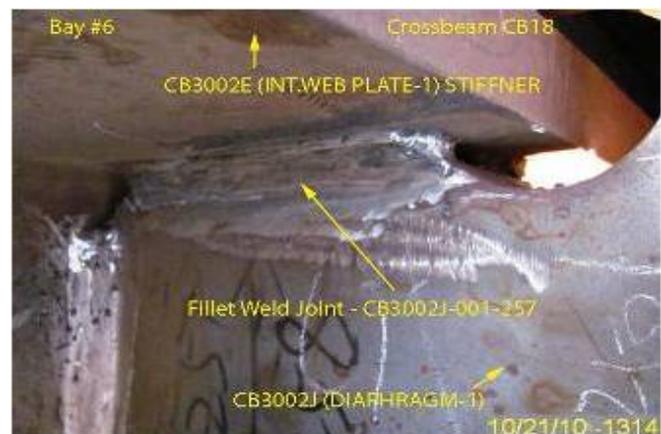
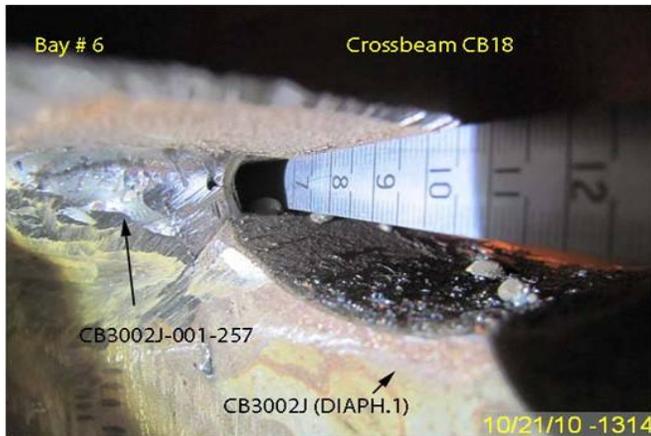
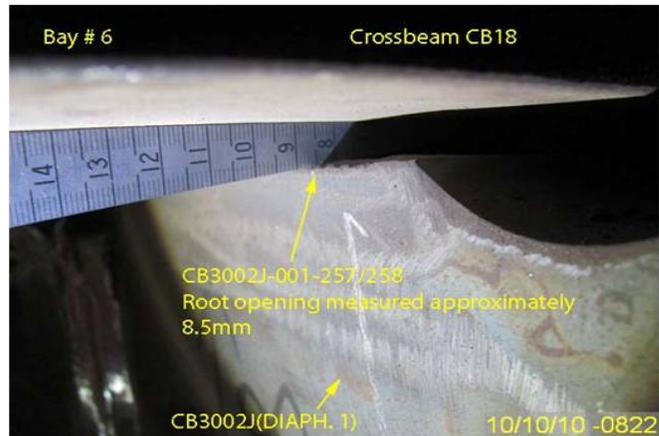
- ZPMC personnel performed the Flux Cored Arc Welding process on fillet welds, which the root opening exceeded the maximum tolerance specified in the Welding Procedure Specification (WPS) and welding code.
- WPS # WPS-B-T-2134 and AWS D1.5 2002 specifies a root opening maximum of 5mm.
- The root openings on twenty six (26) welded joints were measured between 8.5mm and 10mm.
- The affected welds are identified as CB3002J-001- welds 253, 254, 257, 258, 261, 262, 075 and 076. CB3002J-002- welds 251, 252, 259, 260, 073 and 074. CB3002K-003- welds 251, 252, 255, 256, 167 and 168. CB3002K-004- Welds 251, 252, 255, 256, 073 and 074.
- These fillet welds join the Intermediate Web Panel-1 (CB3002E) Stiffener to the Longitudinal Diaphragm-1 Sub Assembly identified as CB3002J-001.
- This Crossbeam CB18 is located in Sub Assembly Bay #6.

Approved WPS # WPS-B-T-2134 specifies maximum root opening 0 to 5mm.

AWS D1.5 2002 section 3.3.1: "The part to be joined by fillet welds shall be brought into as close contact as practicable. The root opening shall not exceed 5mm."

Rectification was performed as the approved TC-RFI response. Partional fillets were changed to CJP where the root gap was over 5mm. The other locations were fixed with the installation of fit lags. ZPMC is providing the NDT record and revised weld maps for the CJPs and the fillet welds used to weld the fit lugs. Based on this, ZPMC is requesting closure of this NCR.

Contractor proposes to change the fillet weld to CJP. NDT will be performed after welding. Contractor will provide a revised weld map, and NDT report to prove the weld is acceptable.

Contractor repaired the welds, and NDT was performed. The NDT weld result is acceptable. The revised weld map have been submitted.
