QUALITY ASSURANCE -- NON-CONFORMANCE REPORT

Location: Changxing Island, Shanghai, PR China**Report No:** NCR-000877**Prime Contractor:** American Bridge/Fluor Enterprises, a JV**Date:** 27-Oct-2010**Submitting Contractor:** Zhenhua Port Machinery Company, Ltd (ZPMC), Changxing Island**NCR #:** ZPMC-0839**Type of problem:**

Reference Description: Repair of Backing Bars for CJP weld joints**Description of Non-Conformance:**

Job Name: SAS Superstructure

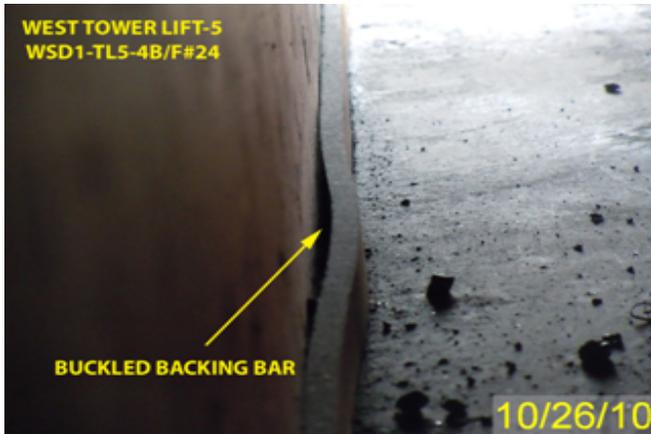
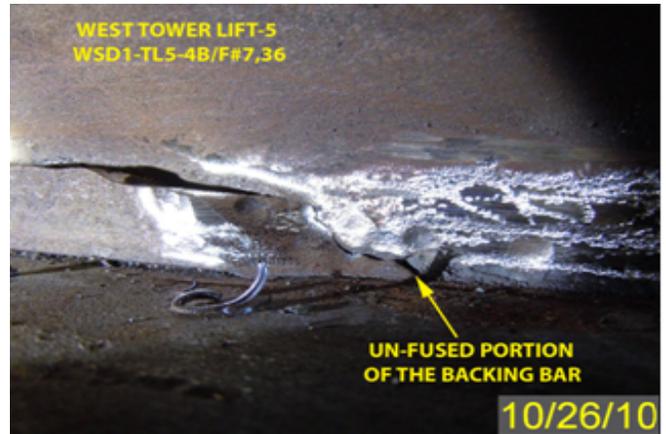
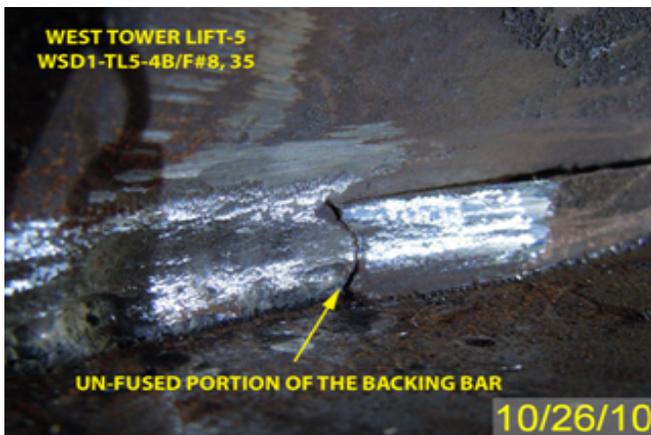
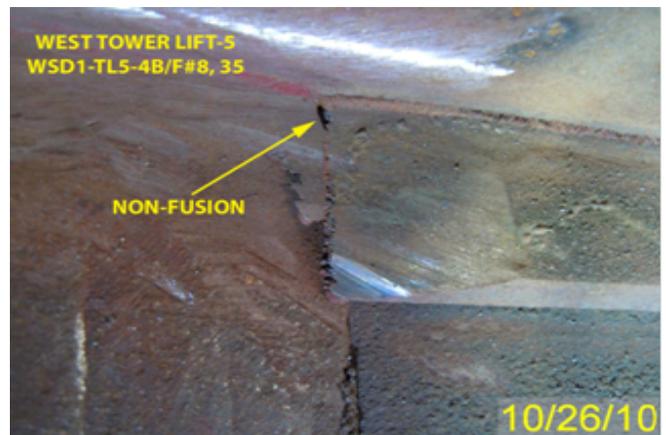
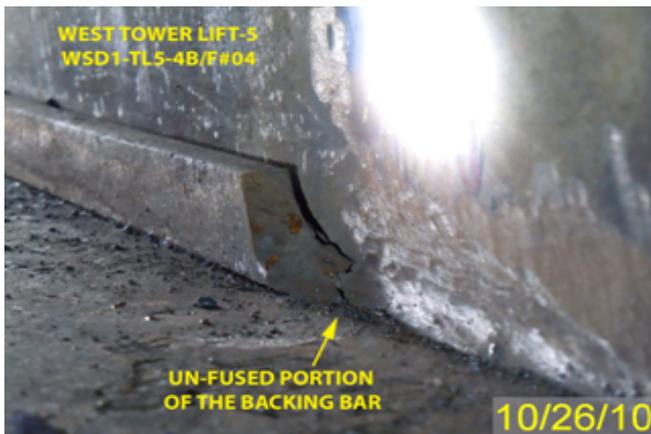
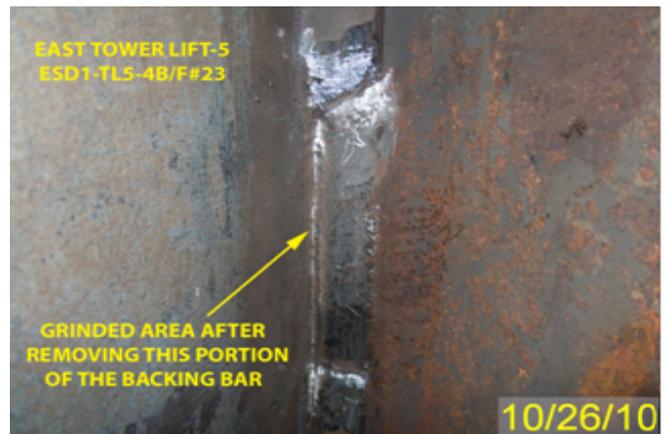
- 1) Non-Fused backing bar requires removal -joint -WSD1-TL5-4B/F#7,36
- 2) Non-Fused backing bar requires removal -joint-WSD1-TL5-4B/F#8,35
- 3) Buckled backing bar requires removal -joint-WSD1-TL5-4B/F#24
- 4) Non-Fused backing bar requires removal -joint-WSD1-TL5-4B/F#4

- 1) Area where backing bar has been removed requires back welding -joint ESD1-TL5-2B/F#23

-As per AWS D1.5 the RFI-002099R0 the groove welds made with steel backing shall have the weld metal thoroughly fused. The remaining ends of the backing bar shall be tapered in with and in depth at a slope no steeper than 1:2.5, as shown in the sketch attached with the referenced RFI.

-Above mentioned welds are T-joint complete joint penetration (CJP) welds.

AWS D1.5 2002, Section 3.13.2: "Groove welds made with the use of steel backing shall have the weld metal thoroughly fused with the backing."

RFI-002099R0: The remaining ends of the backing bar shall be tapered in with and in depth at a slope no steeper than 1:2.5, as shown in the sketch attached with the referenced RFI.

AWS D1.5 2002, Section 4.6.9: "CJP groove welds made without the use of steel backing shall have the root gouged to sound metal before welding is started from the second side."

Contractor will remove the backing bars in question, and repair the area as per Design's requirements ie. RFI-2099. Contractor will also provide NDT report to show the welds involved and also the repair areas are acceptable.

Contractor gouged off the defective backing bars, and ground the areas as per RFI 2099 requirements. NDT reports were provided proving the welds involved and the repair areas were free of defects. Considering the access difficults, and facilitate fabrication the repair has been accepted by Construction as "fit for purpose."

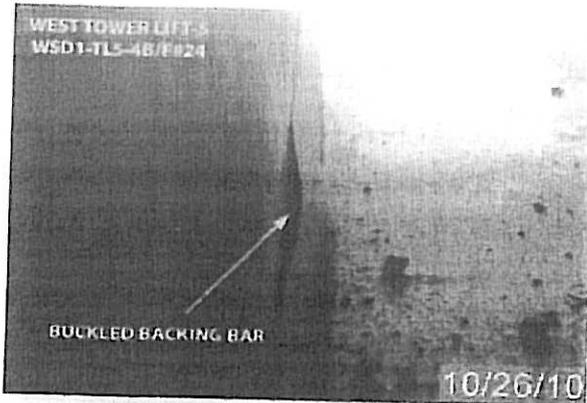
- 1) Non-Fused backing bar requires removal -joint -WSD1-TL5-4B/F#7,36
- 2) Non-Fused backing bar requires removal -joint-WSD1-TL5-4B/F#8,35
- 3) Buckled backing bar requires removal -joint-WSD1-TL5-4B/F#24
- 4) Non-Fused backing bar requires removal -joint-WSD1-TL5-4B/F#4

- 1) Area where backing bar has been removed requires back welding -joint ESD1-TL5-2B/F#23

-As per AWS D1.5 the RFI-002099R0 the groove welds made with steel backing shall have the weld metal thoroughly fused. The remaining ends of the backing bar shall be tapered in with and in depth at a slope no steeper than 1:2.5, as shown in the sketch attached with the referenced RFI.

-Above mentioned welds are T-joint complete joint penetration (CJP) welds.

AWS D1.5 2002, Section 3.13.2: "Groove welds made with the use of steel backing shall have the weld metal thoroughly fused with the backing."

RFI-002099R0: The remaining ends of the backing bar shall be tapered in with and in depth at a slope no steeper than 1:2.5, as shown in the sketch attached with the referenced RFI.

AWS D1.5 2002, Section 4.6.9: "CJP groove welds made without the use of steel backing shall have the root gouged to sound metal before welding is started from the second side."

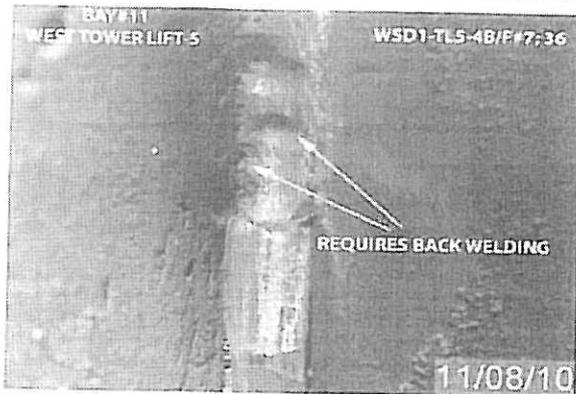
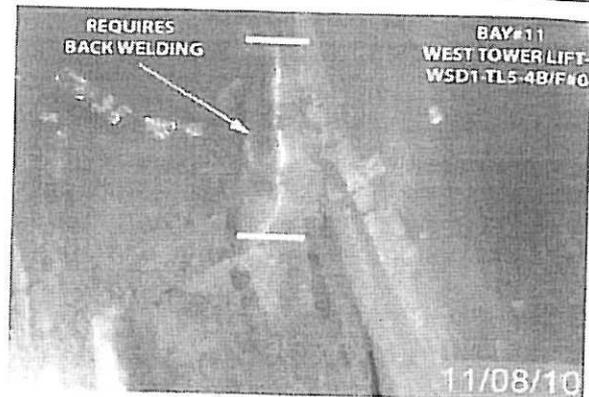
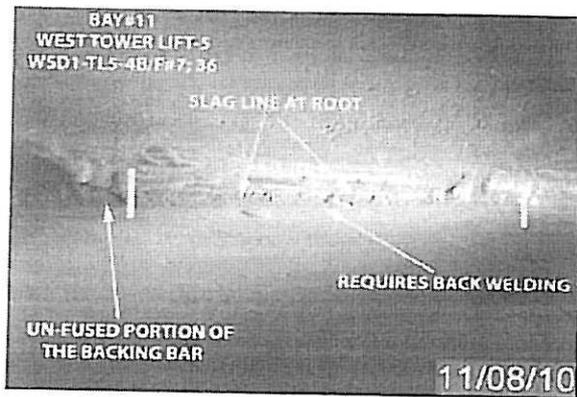
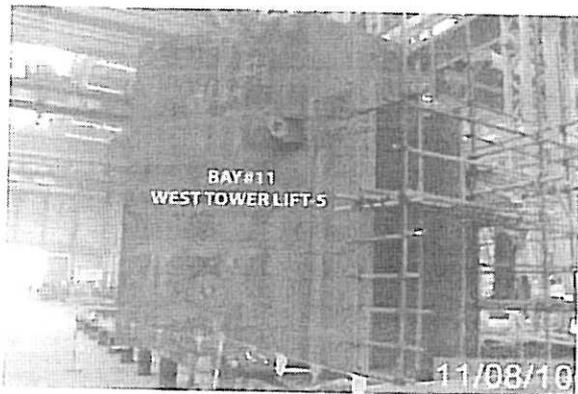
1) WSD1-TL5-4B/F#07; 36 – Non-fused backing bar has not been completely removed. There is a slag line at the entire visible root pass area.

2) WSD1-TL5-4B/F#04 – Root pass has been ground out to an average depth of 1.5mm. Back welding has not been performed.

-Welds are T-Joint Complete Joint Penetration (CJP) welds.

A Notice of Witness #007231 had been submitted on 11/4/10 for similar inspection for Lift 5, East Grillage, also assembled and inspected in Bay 11. The non-conforming retrofit work then was rejected. AB/F was made aware of the reason of rejection in the "Notification Daily Document Tracking" and Incident Report (IR 1662). This latest NWIT# 007275 was submitted for a request to inspect/ sign off unacceptable non-conforming retrofit works, not dissimilar to that in NWIT # 007231.

thoroughly fused with the backing.”

AWS D1.5 2002, Section 4.6.9: “CJP groove welds made without the use of steel backing shall have the root gouged to sound metal before welding is started from the second side.”
