QUALITY ASSURANCE -- NON-CONFORMANCE REPORT

Report No: NCR-000879

Component: Bikepath Assembly BK004A-056

Reference Description: Steel backing was not properly placed and held in Bikepath Assembly (BK004A-056)

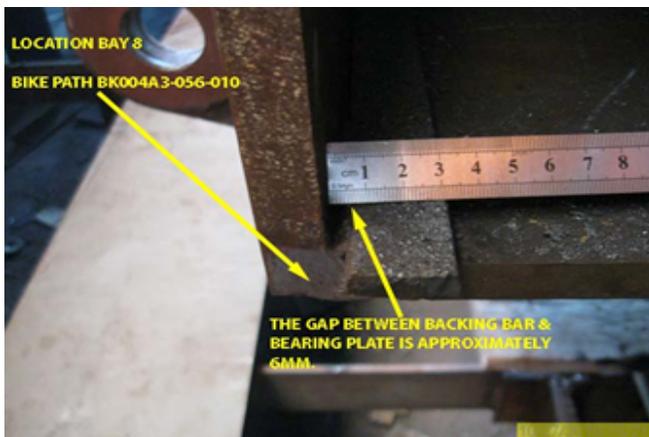
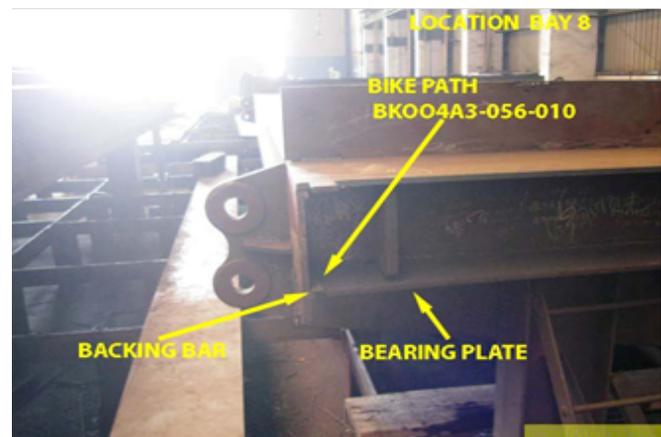
- Steel backing was not properly placed and held in intimate contact with the base metal.
- The gap between steel backing and bearing stiffener plate is observed approximately 6mm.
- The weld is Complete Joint Penetration (CJP) with steel backing joining the Bearing Plate and End Plate (side plate) of bike path.
- The weld was already completed.
- The weld is identified as: BK004A3-056-010.
- The member is located in bay # 8.

-AWS D1.5 2002, Section 3.13.5: "Steel backing shall be placed and held in intimate contact with the base metal. The maximum gap between steel backing and the base metal at the weld root shall be 2 mm."

ZPMC has removed the backing bar not in contact with the weld and performed NDT of the weld area where the backing bar was removed and found it acceptable. ABFJV has instructed all inspectors to pay more attention during joint fit up to ensure that the backing bar is in contact and properly welded to the plates before accepting the joint fit up. Based on this ZPMC requests closure of this NCR.

The defective backing bar has been removed and NDT done on the affected weld. Result was found acceptable. QC inspectors were instructed to pay special attention to joint fit-up to ensure the backing bars are intact.

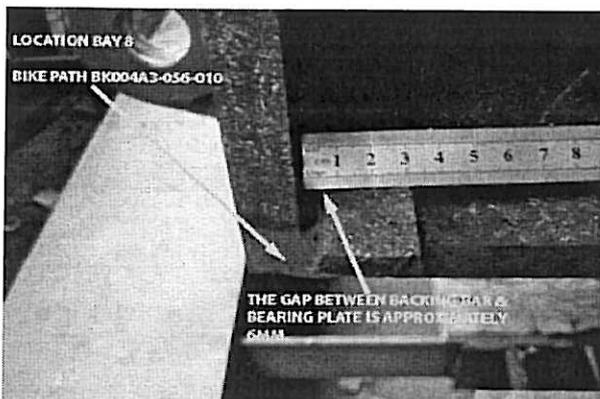
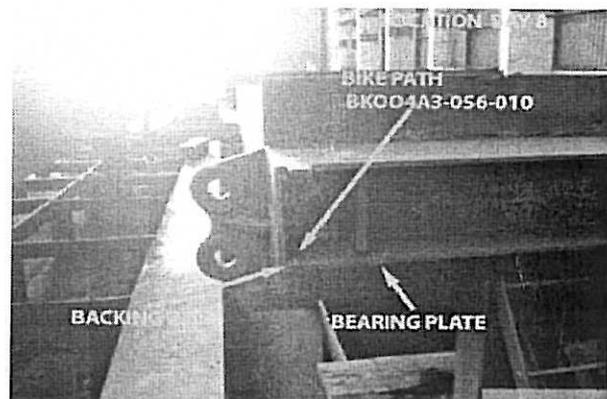
- Steel backing was not properly placed and held in intimate contact with the base metal.
- The gap between steel backing and bearing stiffener plate is observed approximately 6mm.
- The weld is Complete Joint Penetration (CJP) with steel backing joining the Bearing Plate and End Plate (side plate) of bike path.
- The weld was already completed.
- The weld is identified as: BK004A3-056-010.
- The member is located in bay # 8.

-AWS D1.5 2002, Section 3.13.5: "Steel backing shall be placed and held in intimate contact with the base metal. The maximum gap between steel backing and the base metal at the weld root shall be 2 mm."
