Contract #: 04-0120F4  
 Cty: SF/ALA Rte: 80 PM: 13.2/13.9  
 File #: 69.25B

**QUALITY ASSURANCE -- NON-CONFORMANCE REPORT**

**Reference Description:** The fabricated dimension of a plate on Steel Barrier E5-SB6-001 is different from the approved shop drawing dimension and the bolt hole size

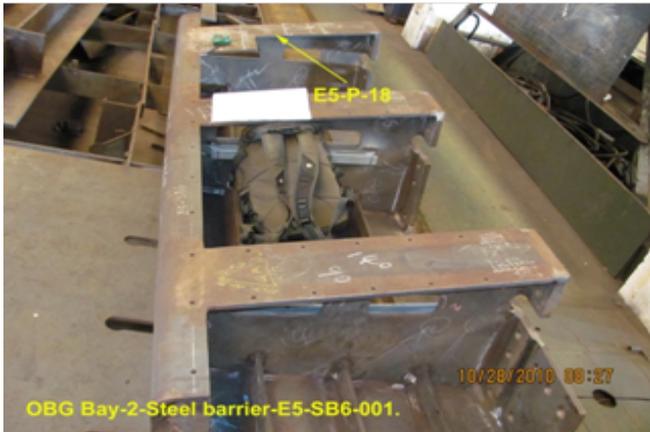
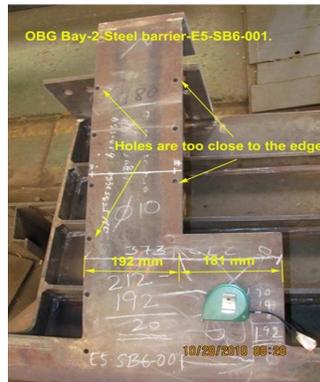
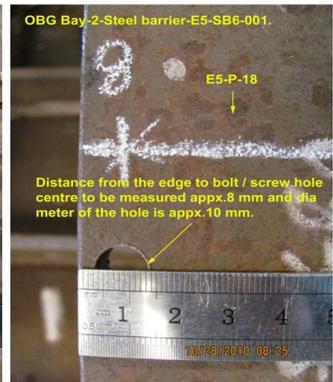
- The measured dimensions of the flange of the plate identified as E5-P-18 on approved shop drawing E5 SBX2 does not match that detailed. The width of the flange was measured at 192mm, in contrast to the 212mm detailed width.
- Bolt holes detailed as 13.5mm diameter holes were measured to be 10mm in diameter. A total of eight bolt holes did not conform to the detailed diameter.
- Additionally, the edge distance from the center of the bolt hole to the edge of the flame cut flange was measured at approximately 8mm when a minimum of 24mm is required by Contract for the detailed hole size.
- The flange plate Material thickness is 12 mm.
- Steel Barrier E5-SB6-001 is currently located in Bay 2.

-Contract Plan Sheet 625C, 'Typical Girder Details No. 1', Bolt Dimension Table specifies minimum edge distance of 1.75d for flame cut edges.

**Reference Resolution:** ZPMC has repaired the issues noted in the NCR through addition of weld metal to the flange to increase the edges distance from the bolt hole.

Leave the flange plate as-built upon approval by the Engineer. ZPMC to make up the required bolt hole edge distance by buttering. Perform NDT to prove the built up area is acceptable.

Construction/Design considered the incorrect dimensions of the flange plate are acceptable and can be left as-built. The inadequate edge distance has been made up by buttering. NDT report submitted by Contractor showed the repair is satisfactory.

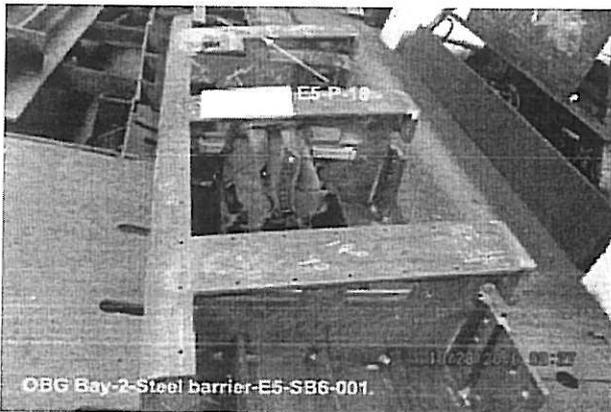
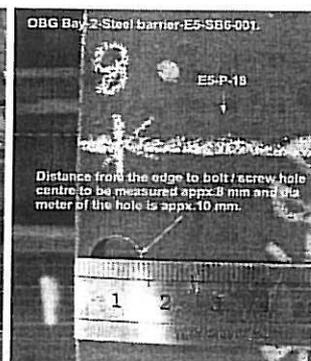
- The measured dimensions of the flange of the plate identified as E5-P-18 on approved shop drawing E5 SBX2 does not match that detailed. The width of the flange was measured at 192mm, in contrast to the 212mm detailed width.
- Bolt holes detailed as 13.5mm diameter holes were measured to be 10mm in diameter. A total of eight bolt holes did not conform to the detailed diameter.
- Additionally, the edge distance from the center of the bolt hole to the edge of the flame cut flange was measured at approximately 8mm when a minimum of 24mm is required by Contract for the detailed hole size.
- The flange plate Material thickness is 12 mm.
- Steel Barrier E5-SB6-001 is currently located in Bay 2.

-Contract Plan Sheet 625C, 'Typical Girder Details No. 1', Bolt Dimension Table specifies minimum edge distance of  $1.75d$  for flame cut edges.
