## QUALITY ASSURANCE -- NON-CONFORMANCE REPORT

**Report No:** NCR-000882

| <b>Joint fit-up</b> | <b>Coating</b> | <b>Other</b> | <b>Component:</b> Bikepath Assemblies BK004A |

**Reference Description:** Steel backing bars are not continuous for the full length of some welds in Bikepath Assemblies

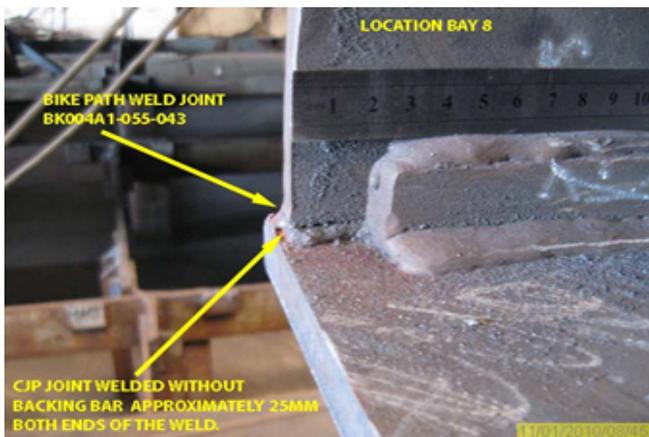
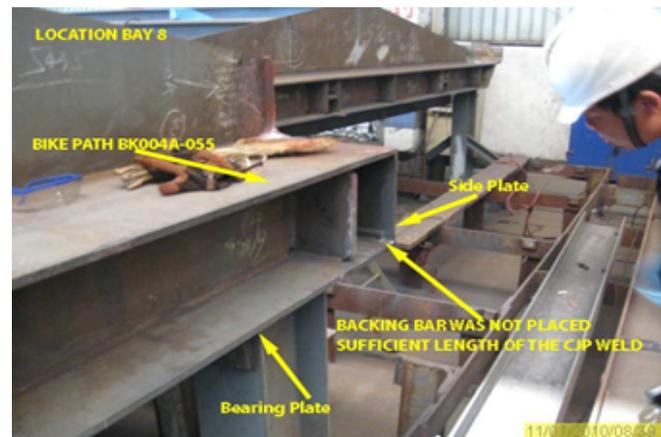
During the Quality Assurance (QA) in process observations of Fabrication of OBG Bike Path BK4A-055, 58, & 61, this QA Inspector discovered the following issue:

- ZPMC welded the root pass of a weld detailed as Complete Joint Penetration (CJP) with backing.
- ZPMC personnel welded the CJP Joint without approximately 25mm of backing at both ends.
- The weld is joining the Bearing Plate and End Plate (side plate) of bike path.
- AWS D1.5 specifies steel backing shall be continuous for the full length of the each weld made with backing.
- The weld is identified as: BK004A1-055-043, BK004A1-058-043 & BK004A1-061-043.
- The material thickness for this backing bar plate is 10 mm.
- This OBG Bike Path is located in Sub assembly Bay #08.

AWS D1.5 2002, Section 3.13.2: "Groove welds made with the use of steel backing shall have the weld metal thoroughly fused with the backing. Steel backing shall be continuous for the full length of each weld made with

Contractor propose to repair the backing bar as per per TC-RFI114R0. Contractor will discipline and fine the production team and inspectors involved to reinforce the importance of adhering to the code to prevent future occurrence.

Contractor repaired the welds as per TC-RFI114R0, and provided the documents confirming the welds are acceptable. The involved production team and inspectors were heavily fined, setting an example to others to prevent future occurrences.

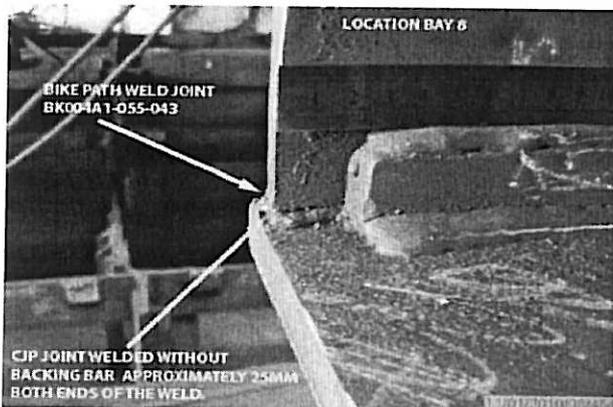
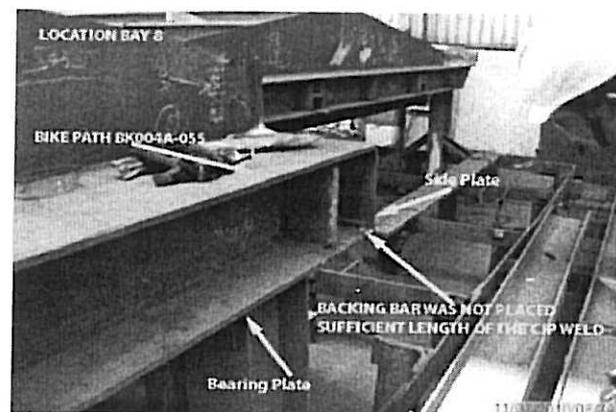
During the Quality Assurance (QA) in process observations of Fabrication of OBG Bike Path BK4A-055, 58, & 61, this QA Inspector discovered the following issue:

- ZPMC welded the root pass of a weld detailed as Complete Joint Penetration (CJP) with backing.
- ZPMC personnel welded the CJP Joint without approximately 25mm of backing at both ends.
- The weld is joining the Bearing Plate and End Plate (side plate) of bike path.
- AWS D1.5 specifies steel backing shall be continuous for the full length of the each weld made with backing.
- The weld is identified as: BK004A1-055-043, BK004A1-058-043 & BK004A1-061-043.
- The material thickness for this backing bar plate is 10 mm.
- This OBG Bike Path is located in Sub assembly Bay #08.

AWS D1.5 2002, Section 3.13.2: "Groove welds made with the use of steel backing shall have the weld metal thoroughly fused with the backing. Steel backing shall be continuous for the full length of each weld made with

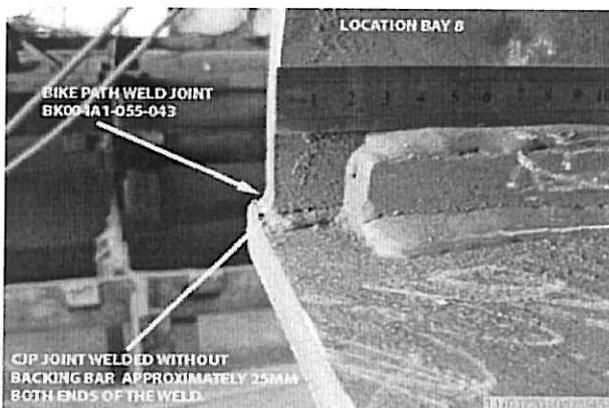
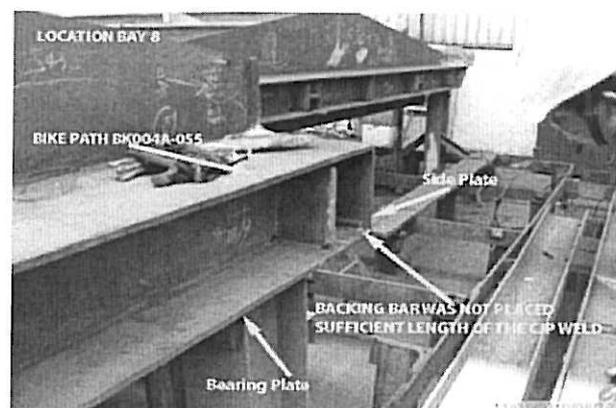
During the Quality Assurance (QA) in process observations of Fabrication of OBG Bike Path BK4A-055, 58, & 61, this QA Inspector discovered the following issue:

- ZPMC welded the root pass of a weld detailed as Complete Joint Penetration (CJP) with backing.
- ZPMC personnel welded the CJP Joint without approximately 25mm of backing at both ends.
- The weld is joining the Bearing Plate and End Plate (side plate) of bike path.
- AWS D1.5 specifies steel backing shall be continuous for the full length of the each weld made with backing.
- The weld is identified as: BK004A1-055-043, BK004A1-058-043 & BK004A1-061-043.
- The material thickness for this backing bar plate is 10 mm.
- This OBG Bike Path is located in Sub assembly Bay #08.

AWS D1.5 2002, Section 3.13.2: "Groove welds made with the use of steel backing shall have the weld metal thoroughly fused with the backing. Steel backing shall be continuous for the full length of each weld made with
